An Archaeological Excavation at Stanley Bank, St Helens, Merseyside

August 2007

An Archaeological Evaluation Excavation at 'Stanley Bank Mill', Stanley Bank, St Helens, Merseyside.

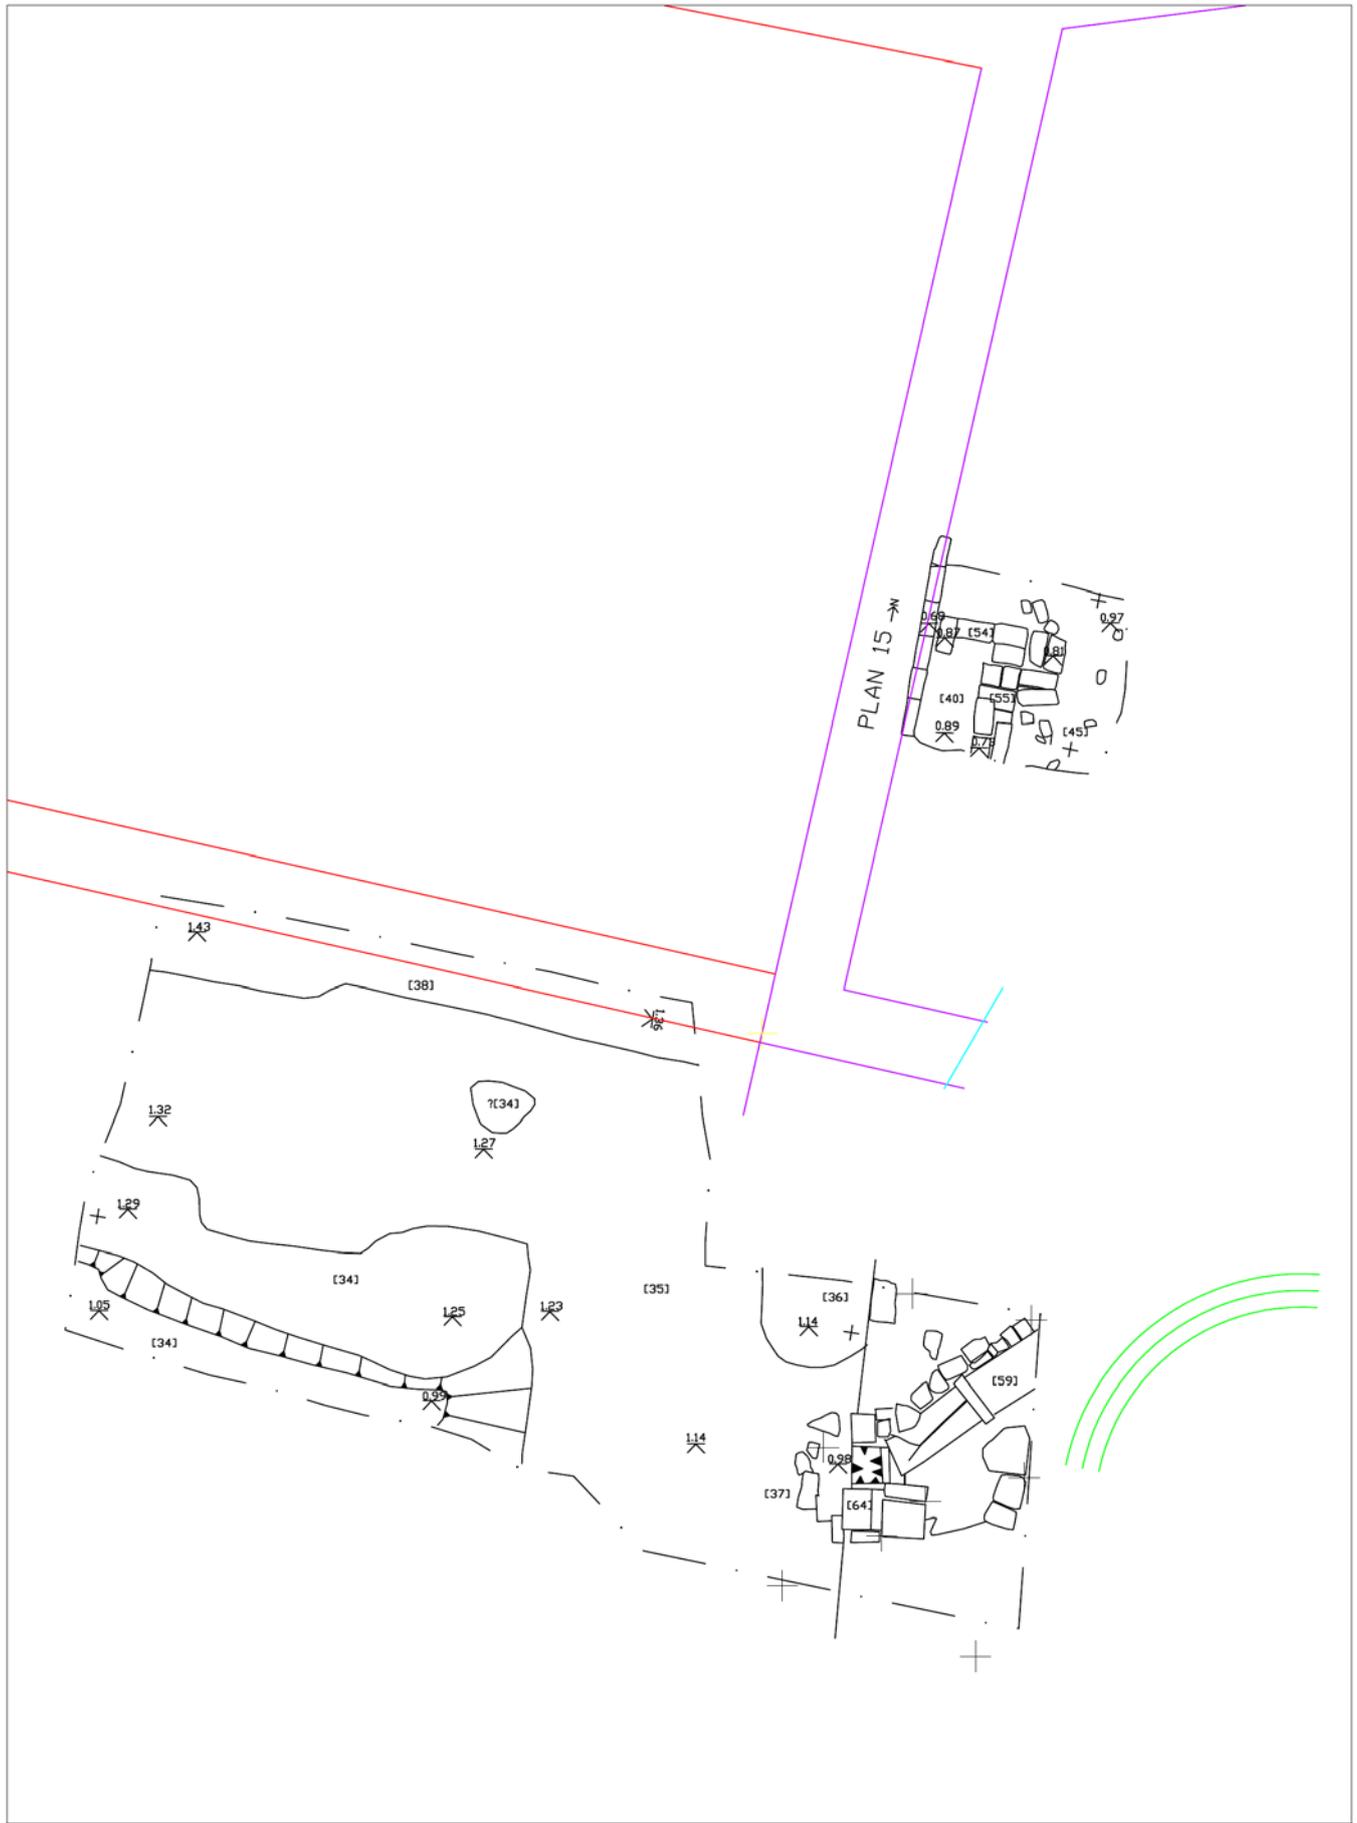
Figure 3. Trenches V and VI.
Deposits exposed following excavation of top soil.

After the removal of undergrowth and humic topsoil [28], [31] and [35] it was found that the bank was composed of redeposited reddish brown clay [30], [34] (Plate 1, Figure 3), which also appeared at the eastern side of the trench. The clay appeared to be sealing a layer of demolition debris. An east-west aligned flagstone floor [38] was exposed directly below [35], running parallel to the northern edge of the trench and the brick wall to its north (Figure 4).

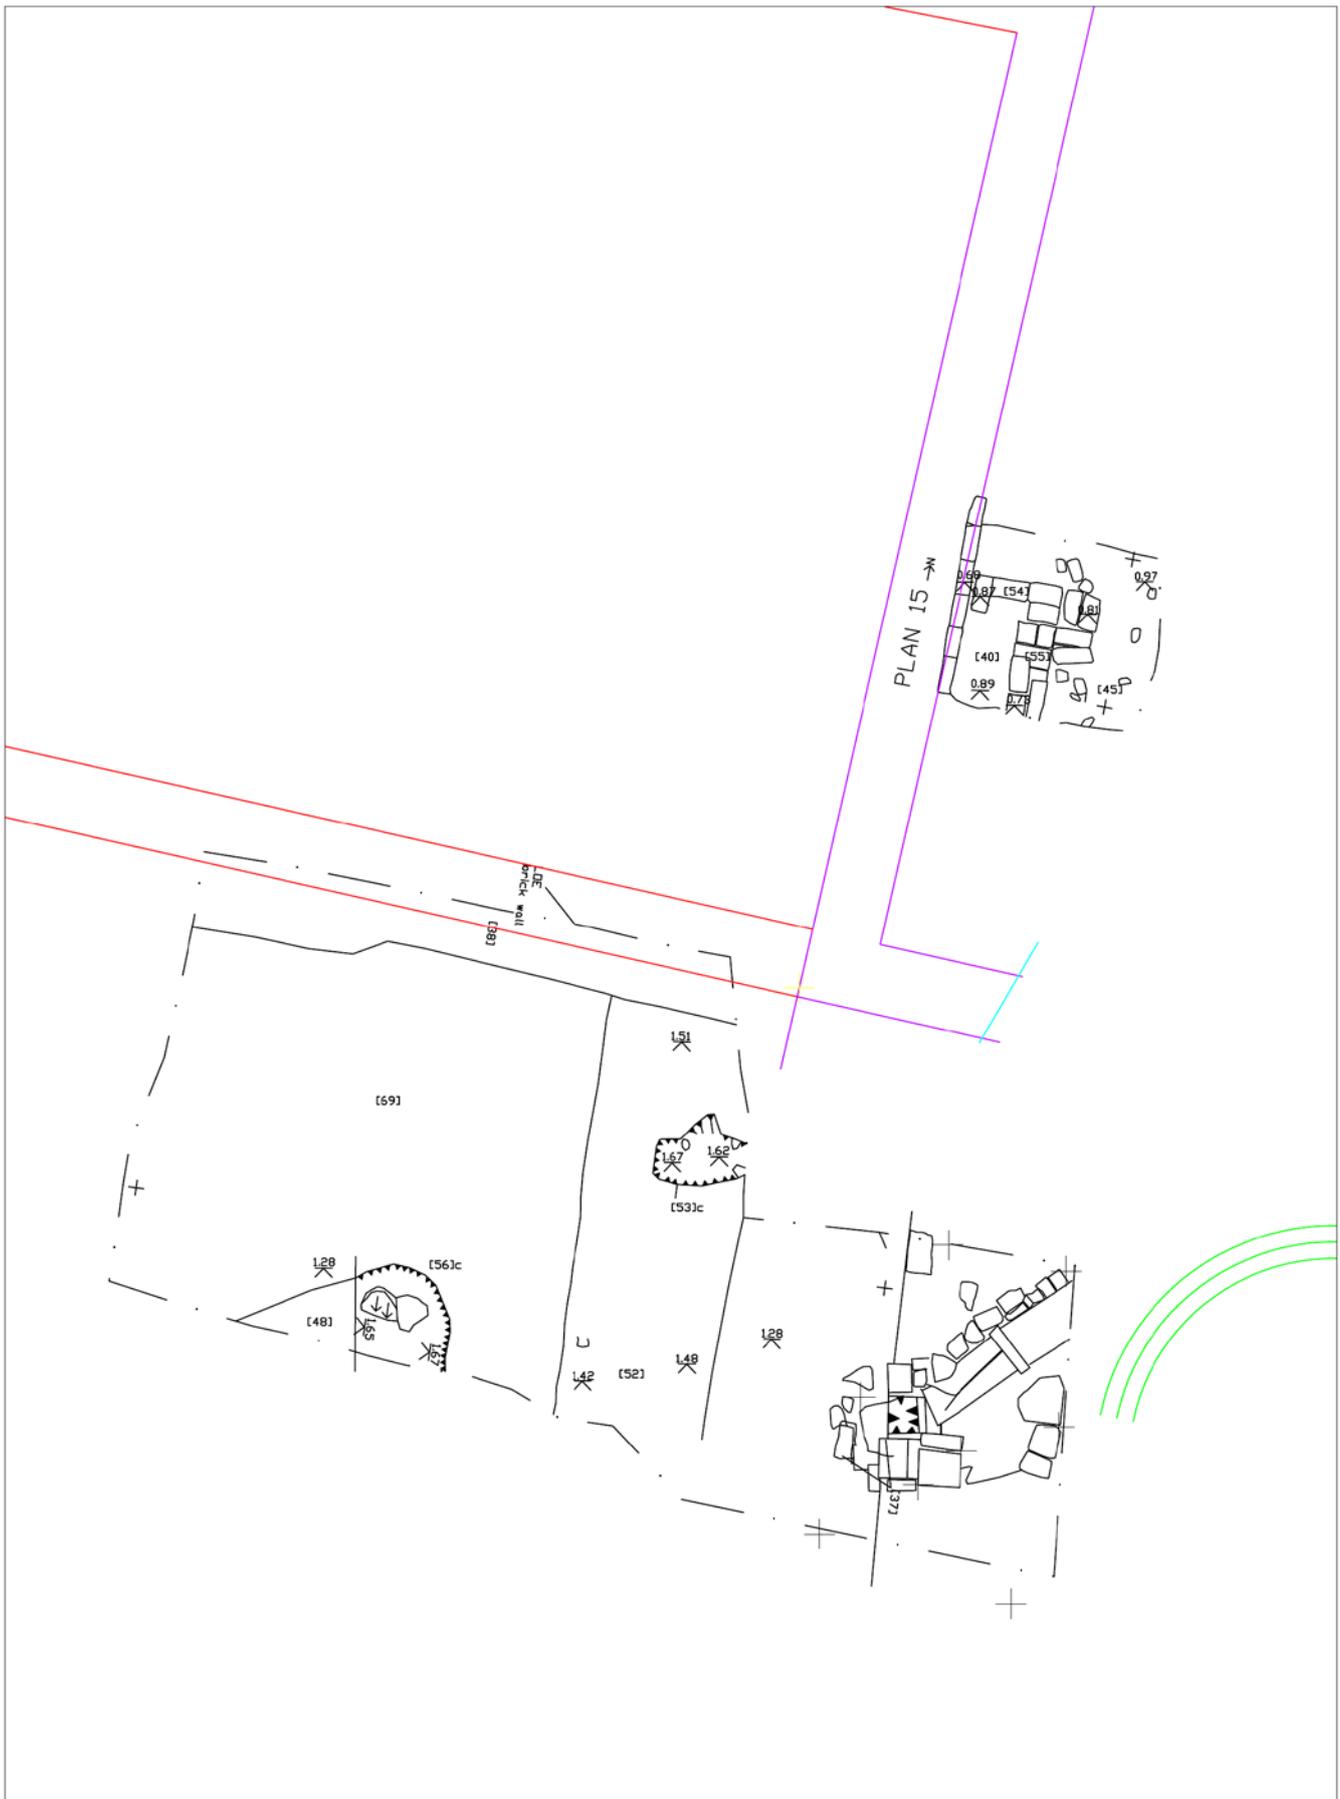
Figure 4. Trenches V and VI.
Deposits exposed following removal of layer [34].

South of the sondage clay layer [34] was excavated to expose an oval area, 0.65m across, of dark grey gritty clayey sand [48] with inclusions of brick, mortar, coal and flagstone fragments (Figure

4). This was not fully excavated but reached a depth of 0.50m. The base of the cut [56] was very poorly defined and it is possible that this feature was in fact significantly deeper than as excavated. The function of this feature is uncertain.

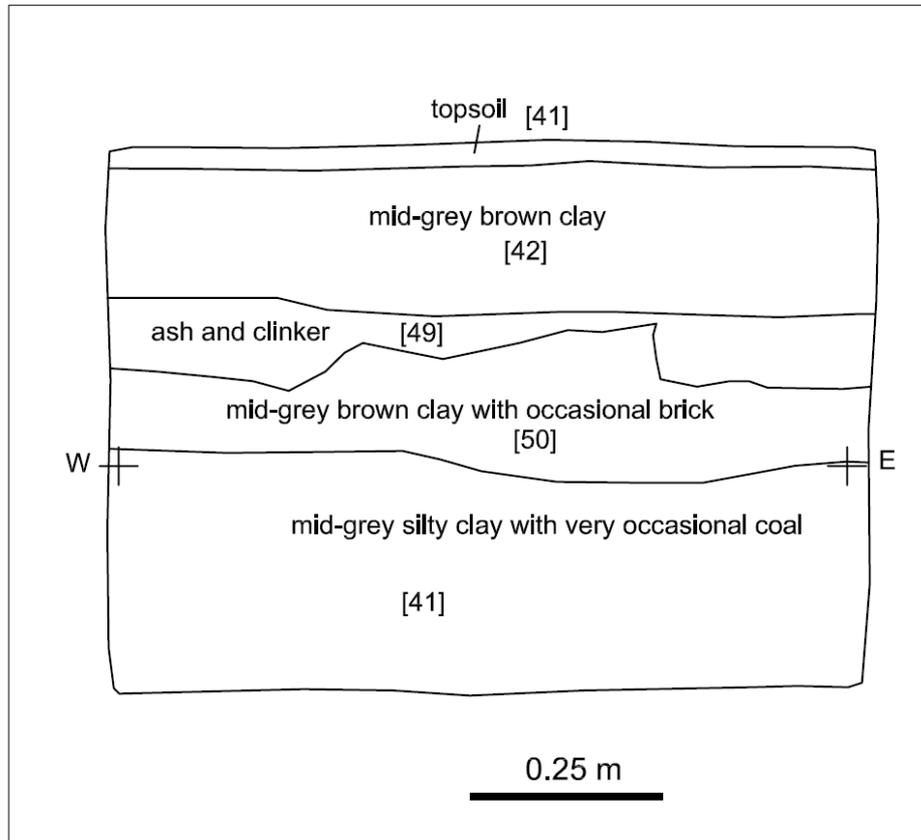
Figure 5. South facing section through deposits excavated in Trench VII.

Topsoil [41] was excavated to a compact clay surface [42] (Figure 5). Beneath this, a clay layer [49] containing a higher concentration of bricks and brick fragments was excavated onto a distinctly darker layer of ash and clinker [50]. This in turn was excavated onto a layer of mid-grey silty clay with occasional flecks of coal which was at least 0.30 m thick. There were no significant archaeological features in this trench.

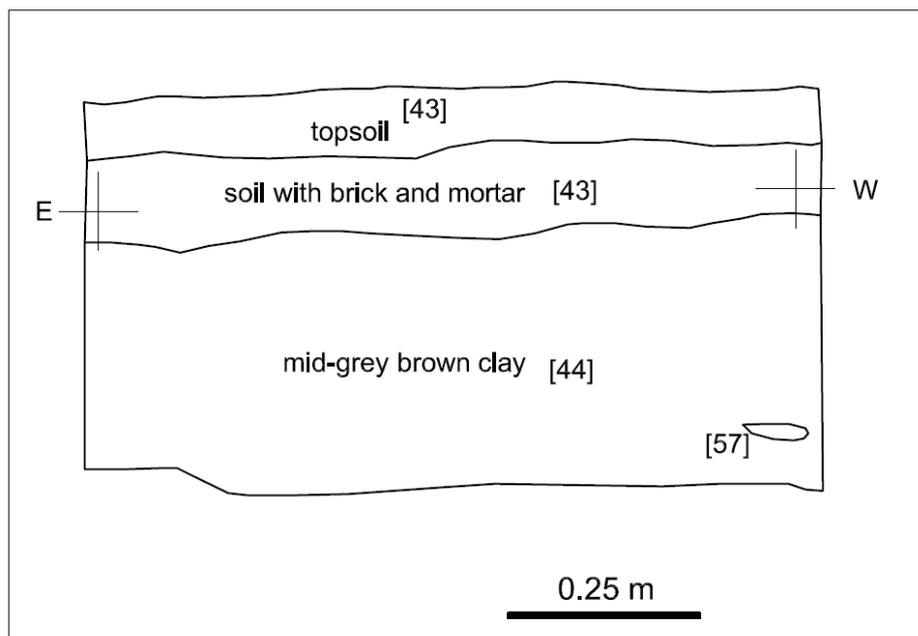
Figure 6. North facing section through deposits excavated in Trench VIII.

This trench was located on the eastern side of the site, to the north of Trenches V and VI (Figure 2). After the removal of topsoil [43] (Figure 6) a similar clay deposit [44] to that found in Trench VII was exposed. The excavation of this trench was halted when a north-south aligned wall [57] was encountered at the western side of the trench at a depth of 0.60 m (Plate 6). The wall was composed of handmade bricks at the northern end and flagstones at the southern end. Another flagstone and a piece of charred wood lay at the eastern side, above a layer of silts and clays at the unexcavated base of the trench. This trench was not excavated further and the wall left *in situ*.

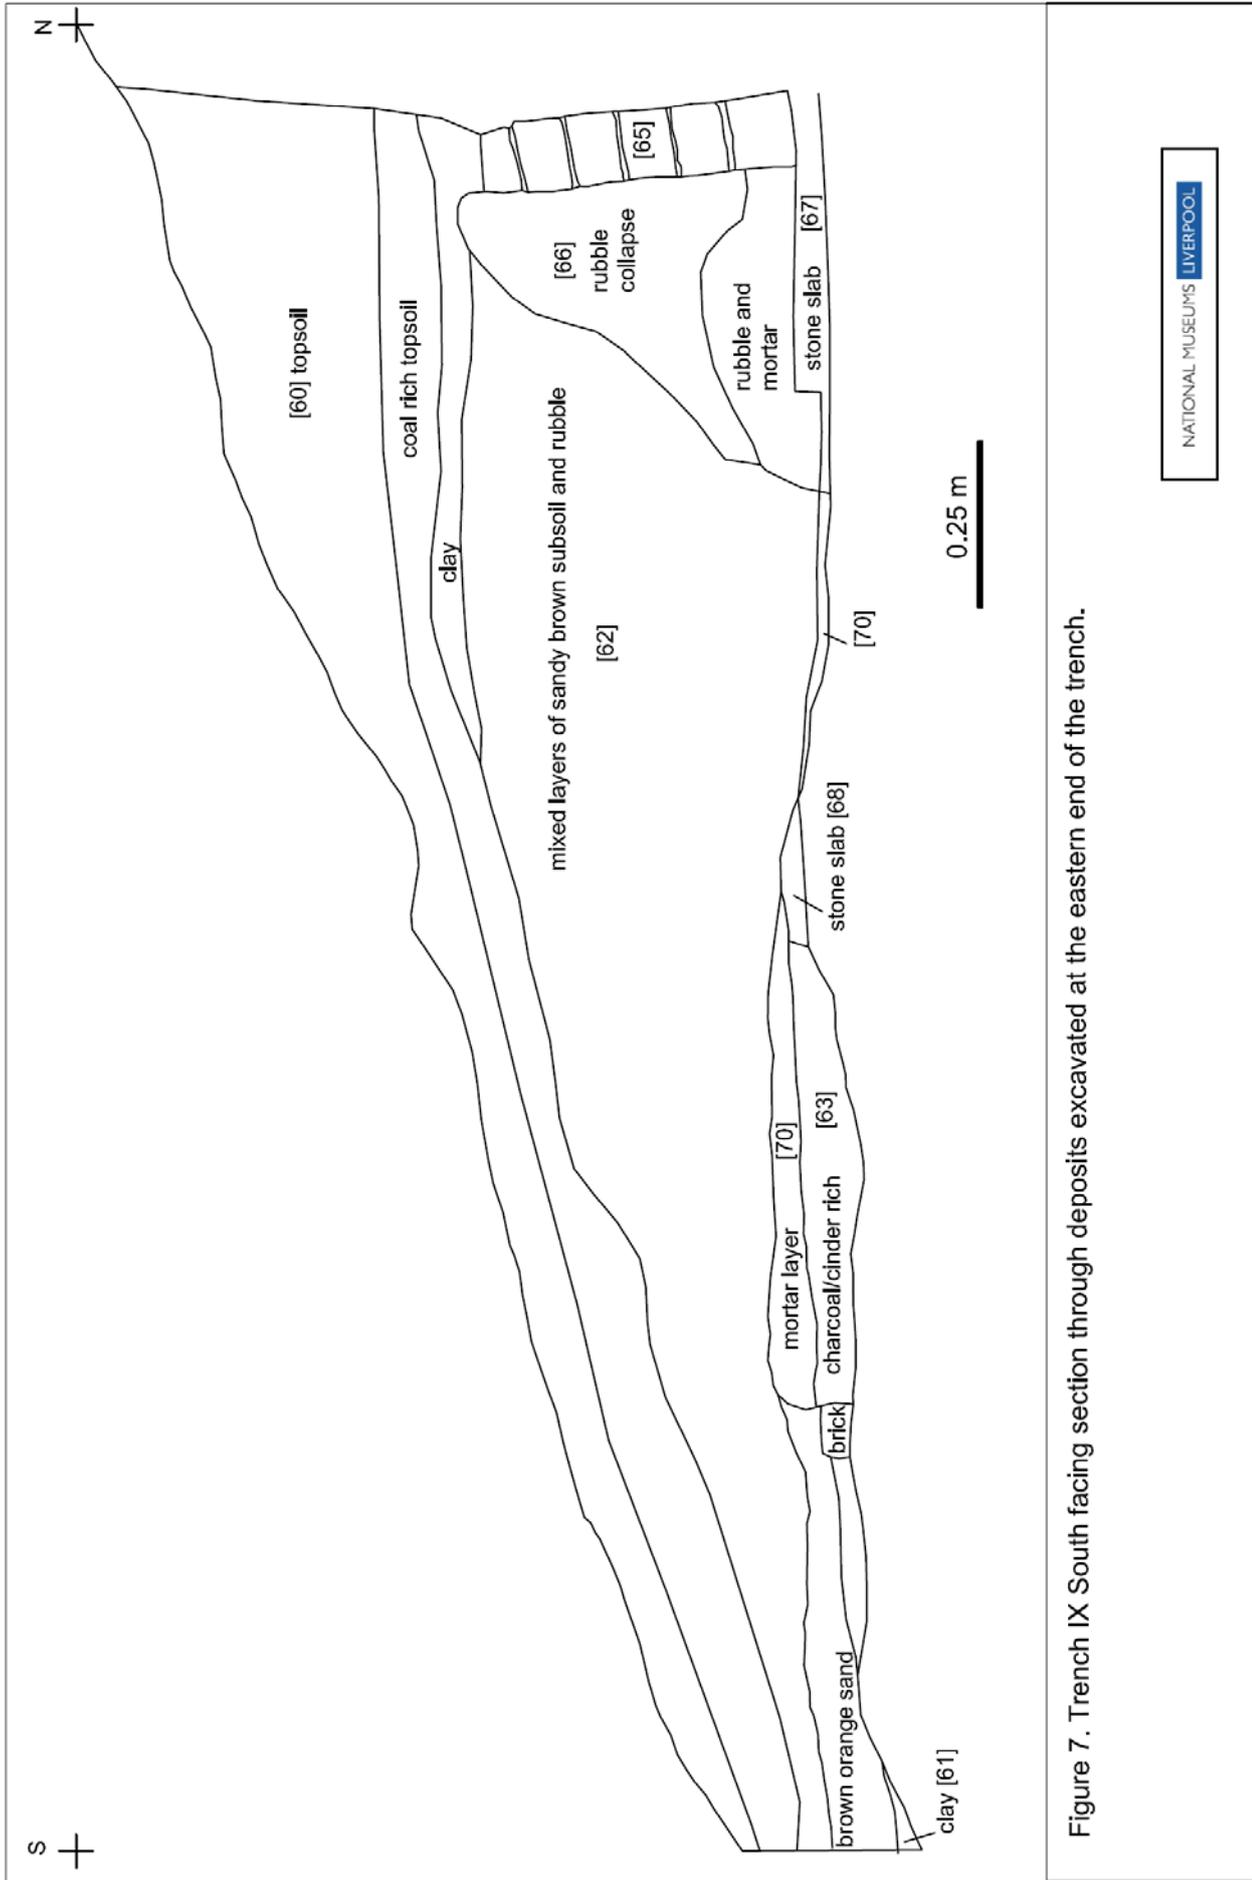
Figure 7. Trench IX South facing section through deposits excavated at the eastern end of the trench.

A thin layer of topsoil [60], which contained frequent inclusions of large pieces of 19th century ceramics, particularly black glaze ware was excavated to a layer of orange brown clay [61] which appeared to be the makeup for the slope (Figure 7). The clay at the east end of the trench only appeared to be a thin layer 0.05m thick in section but was more persistent and much deeper at the western end of the trench. Below the clay [61] at the eastern half of the trench was a layer of loose sandy loam [62] approximately 0.67m thick, which contained large amounts of ceramics, broken brick and tile. Excavation of this subsoil revealed a more compact coal rich layer [63] in the middle third of the trench, measuring c. 1.10m x 1.0m.

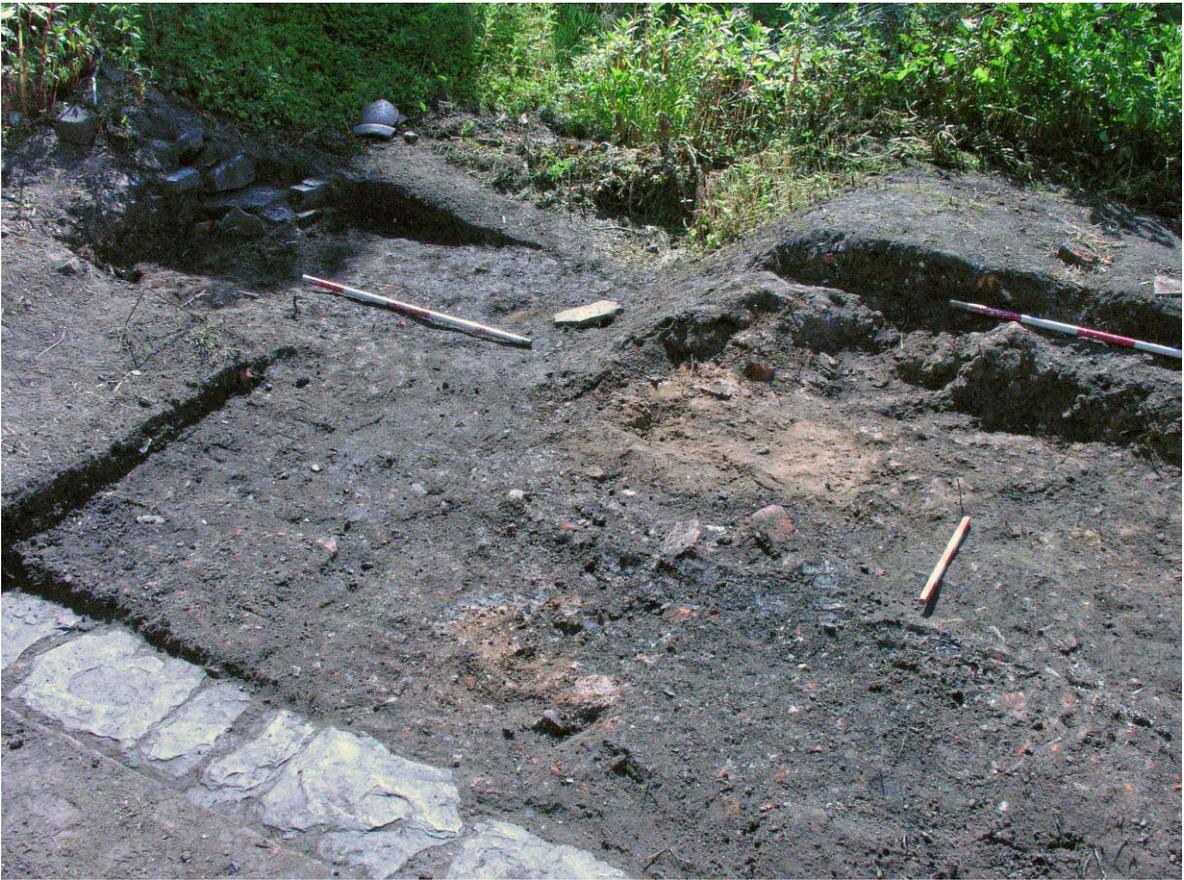
Plate 1. Trench V following removal of top-soil. View looking south-east.

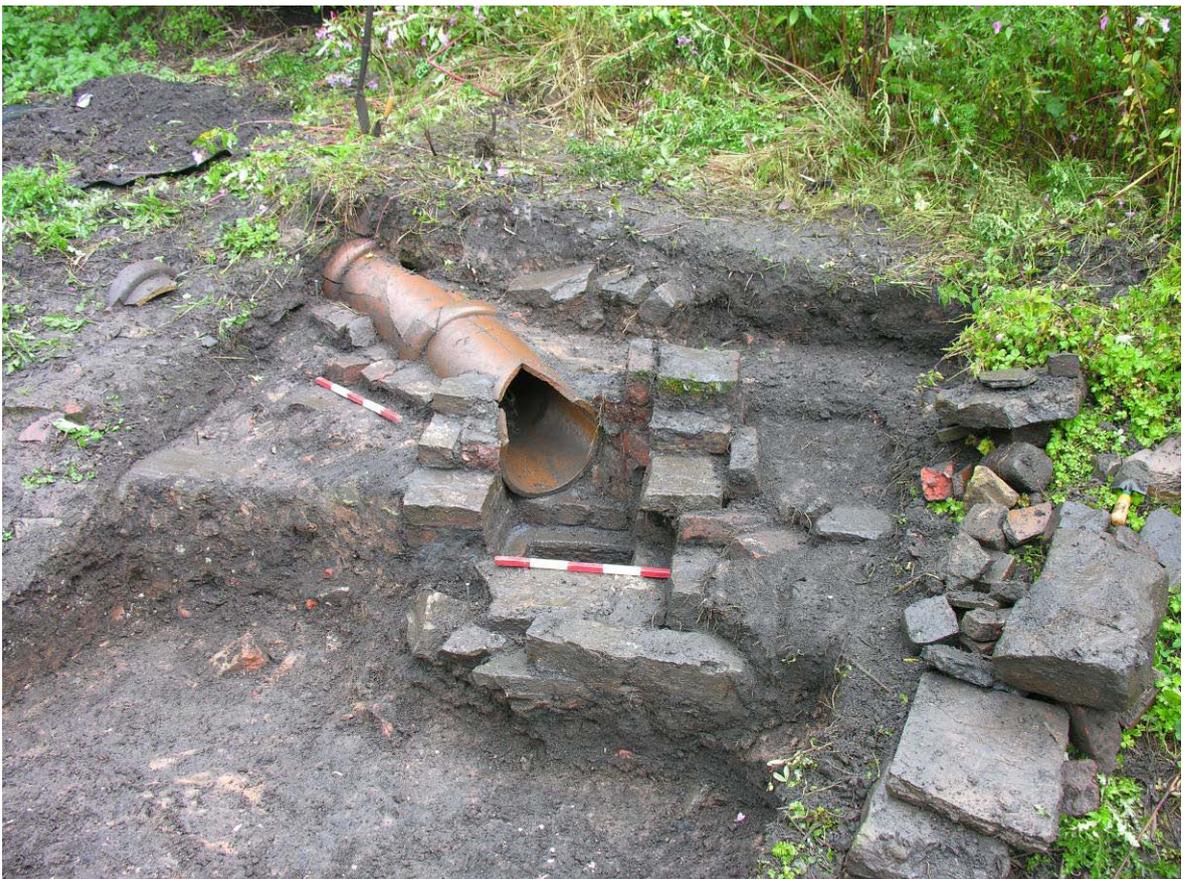
Plate 2. Trench V, pipe [59] and sump [64] from the south-west.

A small cluster of stones [37] was exposed in the eastern side of the trench, which further excavation revealed it to be a well constructed sump in brick and stone [64], fed by a ceramic pipe [59] running diagonally into the north east corner of the trench (Plate 2). The sump was 0.8 m deep from the lower lip of pipe [59]. Another pipe of uncertain diameter ran northwards from the base of the sump for an unknown distance.

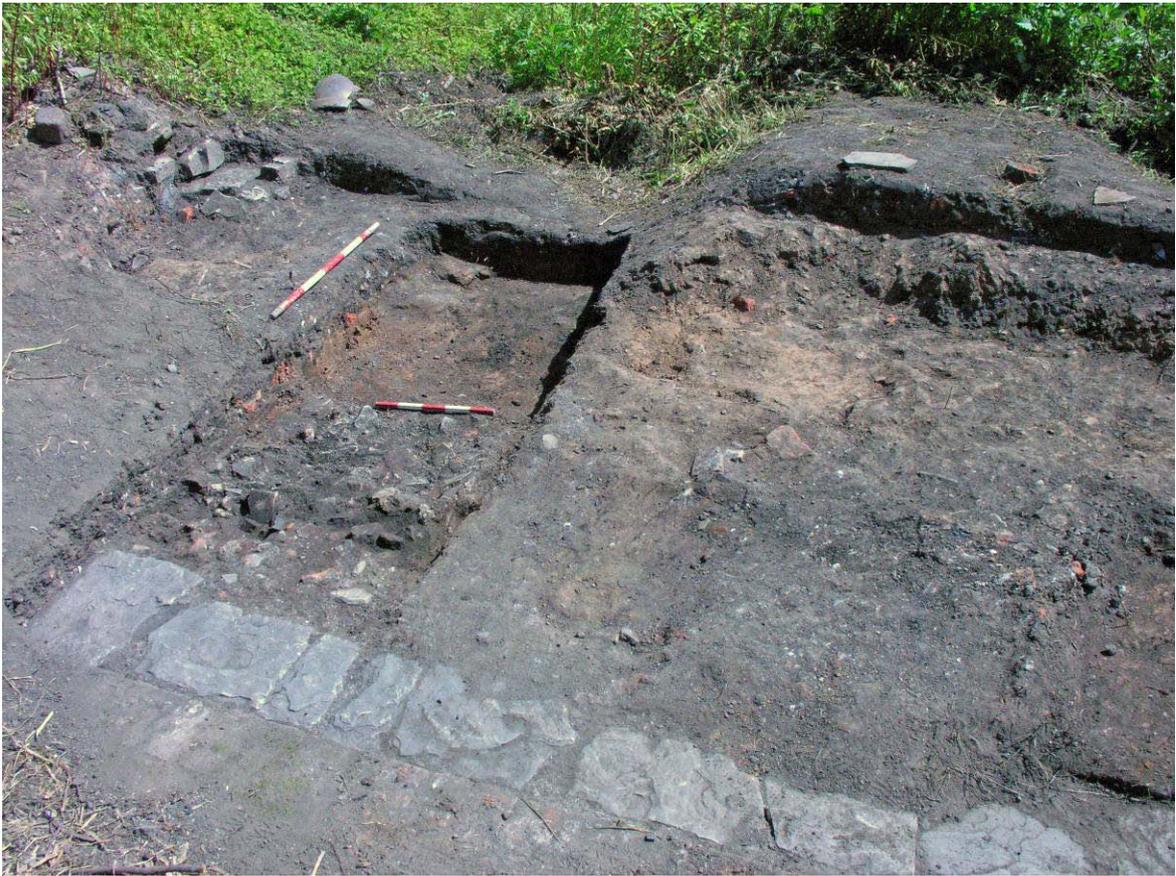
Plate 3. Trench V following excavation of sondage. View looking south-east.

A 1m wide sondage (Plate 3) running north-south was also excavated across the trench through clay deposit [34] where it was c. 10-20 mm thick. This revealed a 0.12 m thick layer of dark grey humic loam with frequent brick and mortar fragments [47] at the northern end which extended underneath flagstones [38]. It also exposed a dark greyish brown deposit [51], filling cut feature [53]. It measured 0.6m x 0.5m x 0.12m and was possibly a square cut post hole, the function of which was uncertain. Three iron lumps were found at the base and left in situ. Another distinctive dark greyish brown spread [52], heavily flecked with charcoal also lay in the clay to the south of [53] but was not excavated.

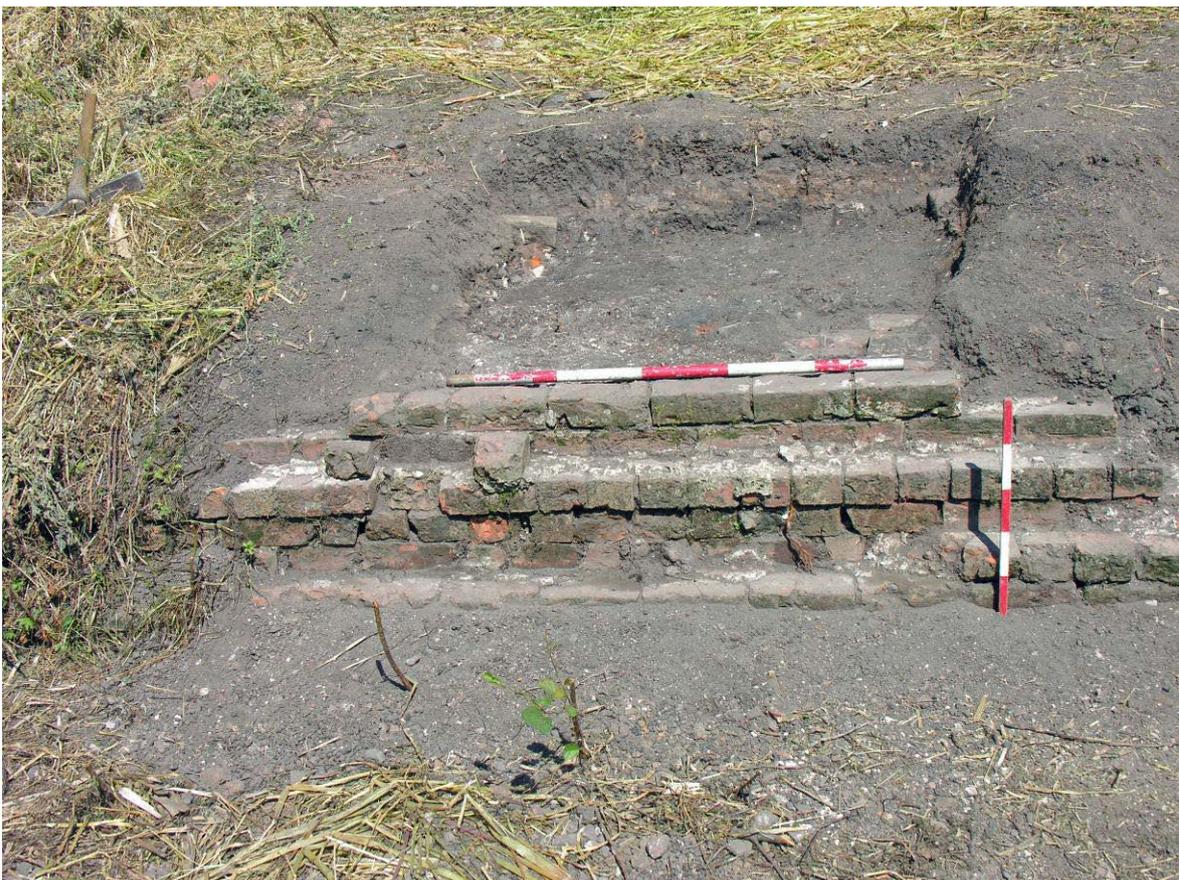
Plate 4. Trench VI following removal of top-soil. View looking east.

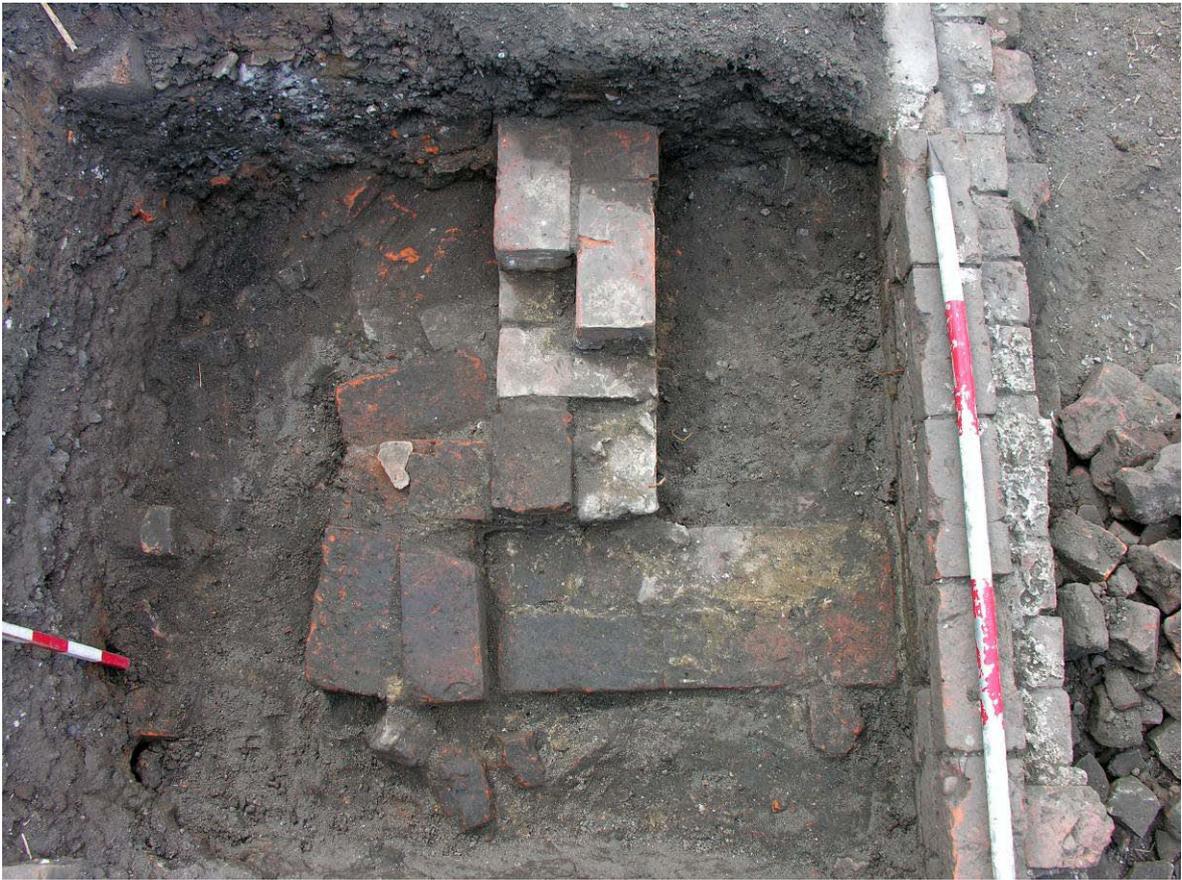
Plate 5. Trench VI. Walls [55] and [54]. View looking south.

An area of 1.46m by 1.35m was cleared of loosely compacted topsoil and vegetation [29] from the top of the terrace. Following the removal of topsoil, it became clear that the reason for the terrace was a brick wall [55] 6 courses high and running north-south along the western edge of the bank (Plate 4, Figure 3). The terrace sloped up from the top of the wall [55] towards the dam wall to the east, although all the deposits below this were laid horizontally. Below the topsoil was a compact layer of dark grey sandy loam [32]. This was only a thin layer and quickly revealed a layer of redeposited clay [33] and demolition layers of rubble and soil [39], [40], [45]. After removal of rubble layer [45], an "L" shaped brick wall structure [54] appeared, with just 2 courses remaining, although lime mortar on top of the bricks suggested this had been a higher construction originally. Wall [54] butted against wall [55] (Plate 5) which suggests that one was later than the other, though given the limited extent of the trench it was impossible to establish the correct sequence.

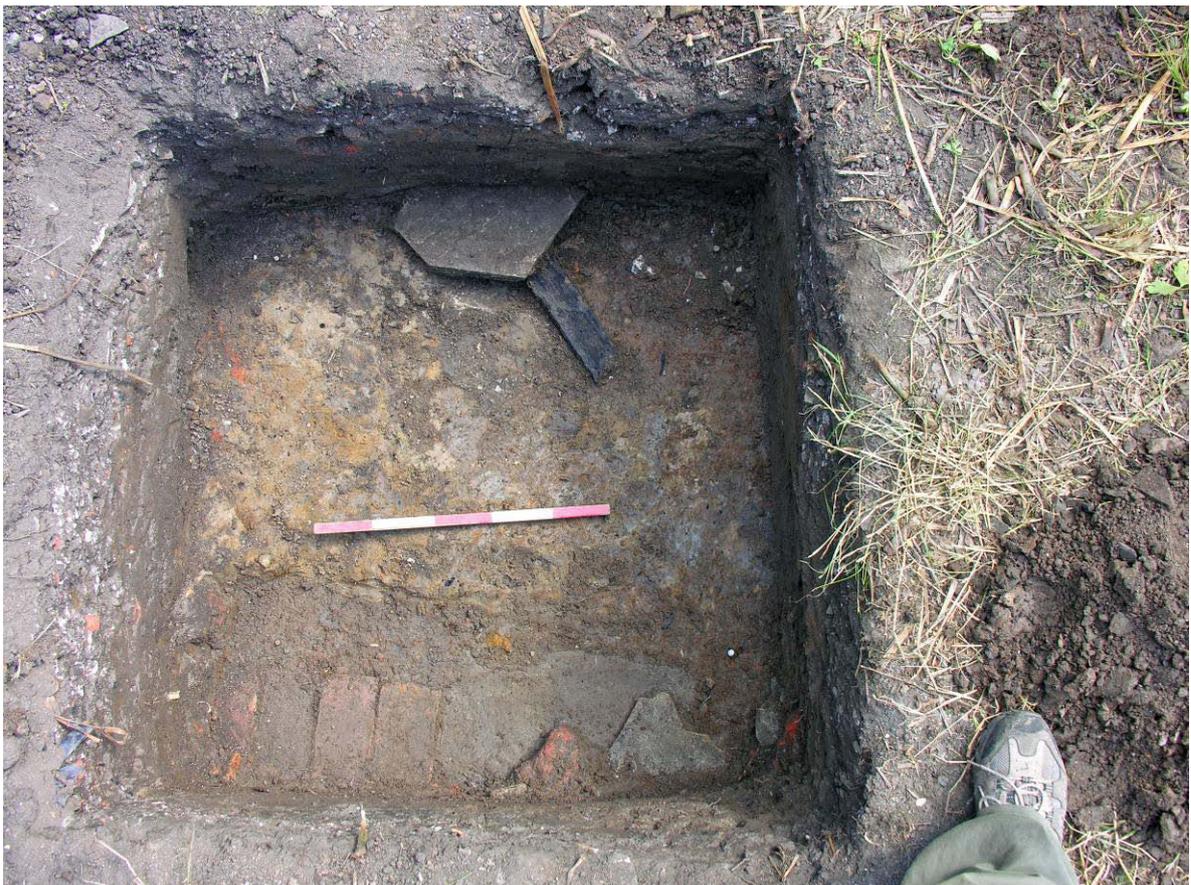
Plate 6. Trench VIII, north-south aligned wall at base of trench. East is at the top.

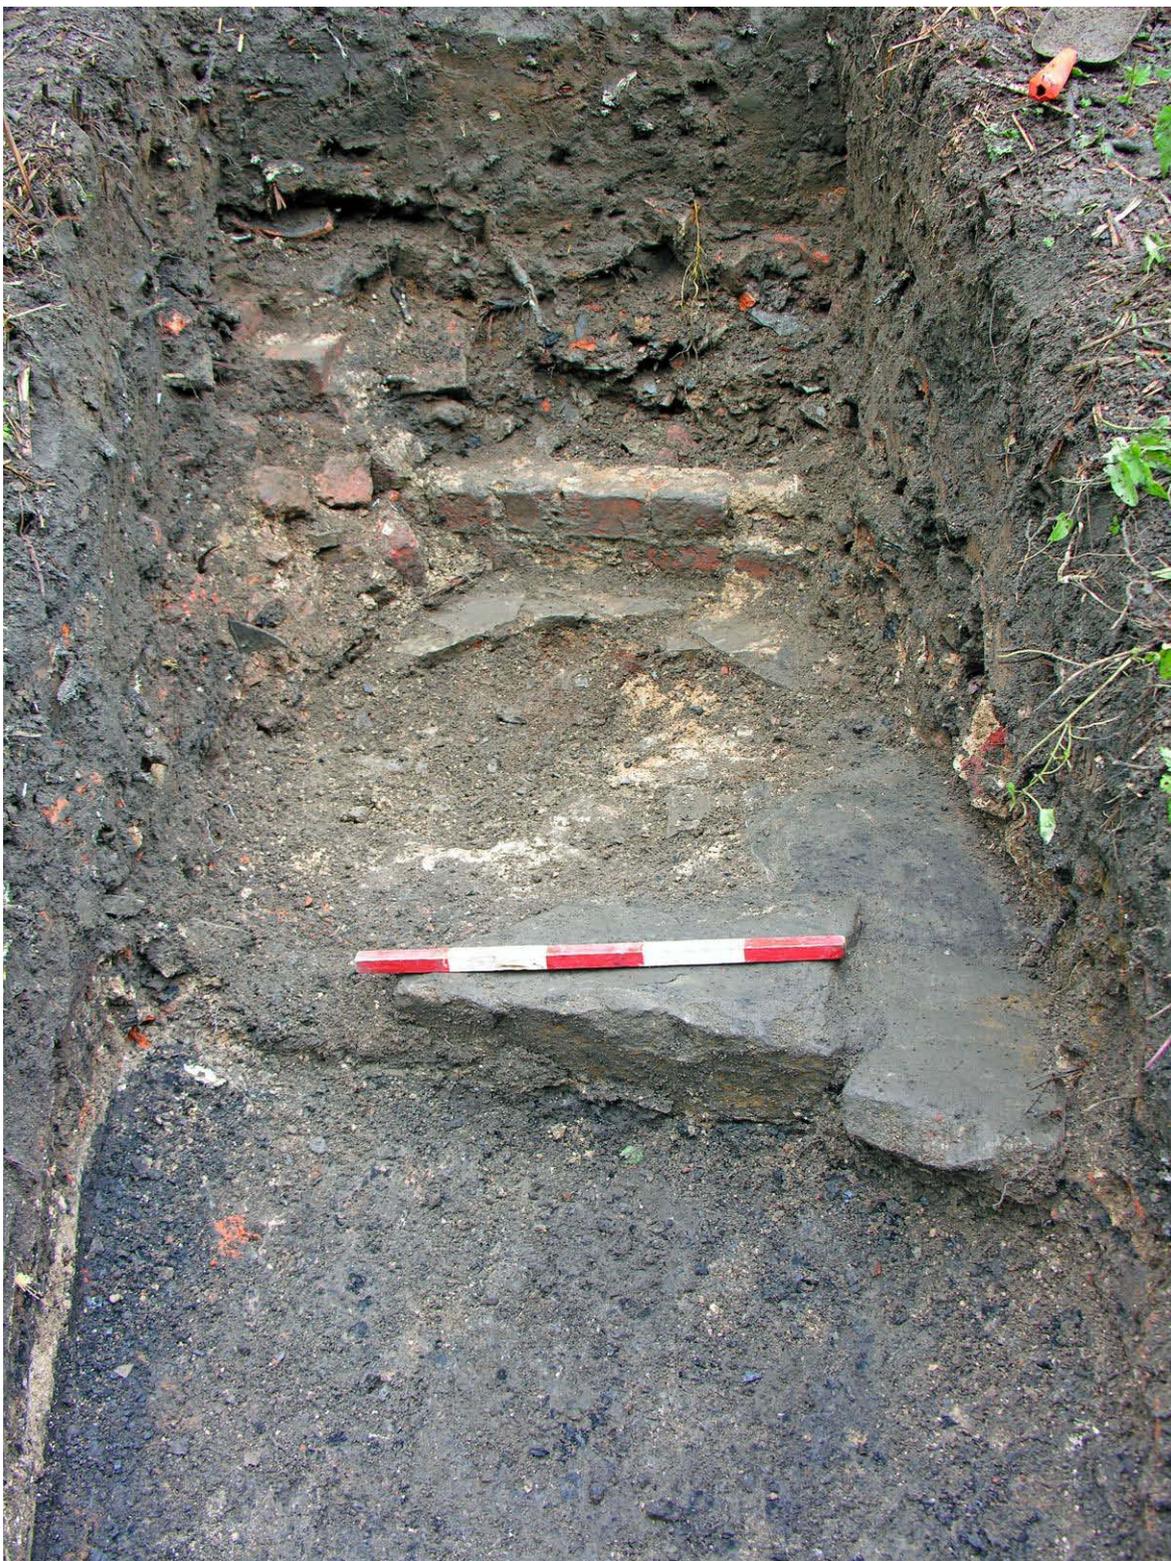
Plate 7. Trench IX. Wall [67] and flags [65]. View looking east.

The removal of a rubble layer [66] in the north east corner of the trench revealed more of wall [65] and also a layer of broken flagstones [67] laid onto a buff coloured sandy lime mortar bedding [70] (Plates 7 & 8). Only the flagstones closest to the wall [65] remained, running under the wall, but it is presumed that they belonged to a larger floor area approximately 1.2m x 1m, as the mortar bedding [70] covered this eastern third of the trench. It is possible that [68], a grey stone slab formed a stone step onto the floor area [67] [70], as there was a distinctive step a few centimetres high down onto [63]. The removal of [66] also revealed a second wall behind [65] to the east. This wall [84] was mostly obscured by the trench edge but it was clear that it was constructed of the same handmade bricks laid as headers. A cavity between [65] and [84] was filled with loose mortar and rubble. The angle of the leaning wall [65] was more apparent after this as [84] had remained vertical.

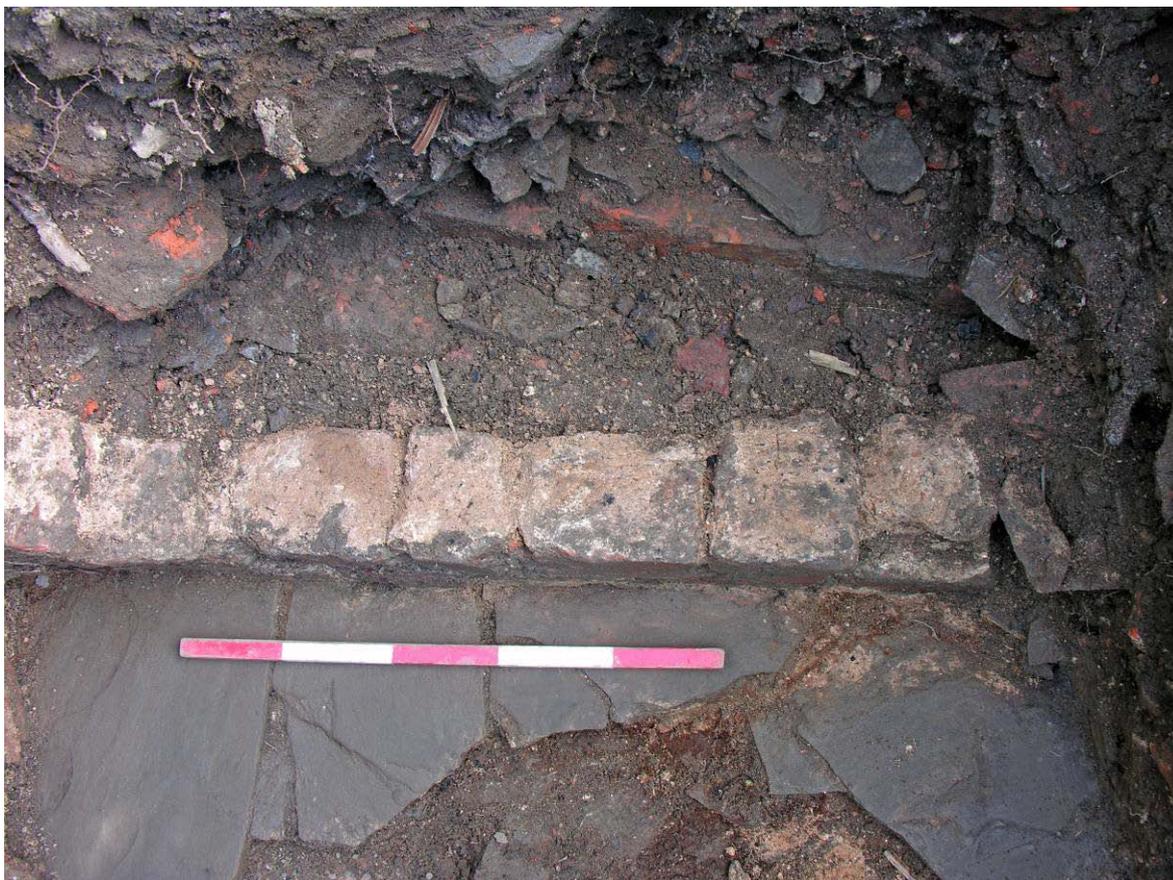
Plate 8. Detail of east end of Trench showing walls [65] and [84].

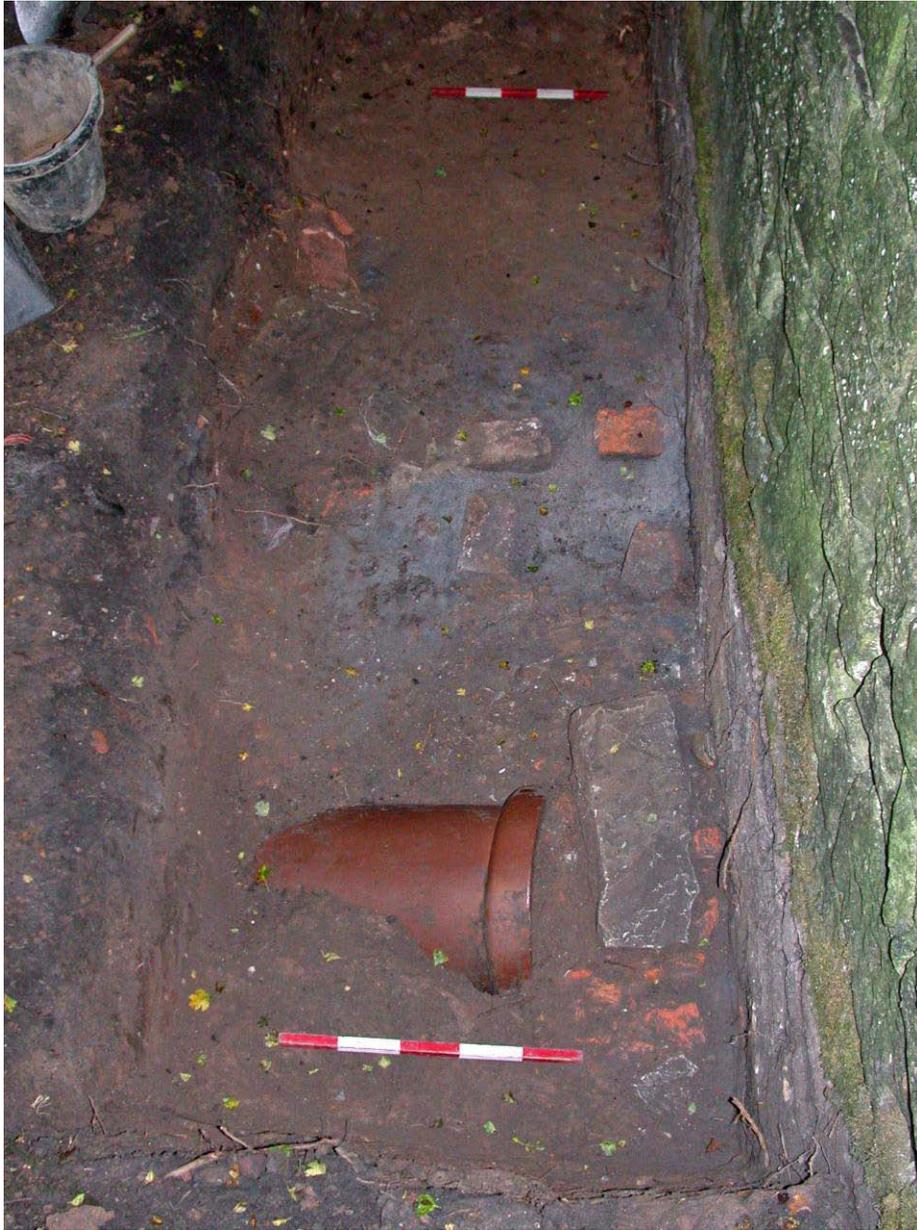
Plate 9. Trench X. Pipe [59] in foreground, brick footings to slab [78] to rear. View looking north.

The removal of topsoil [71] exposed a very stiff brown clay layer [72] with a single sandstone slab [78], 0.54 x 0.60m set within the clay. The slab was removed to reveal that it capped a square, brick feature [79], which bounded a grey gritty sand [80] and acted as a bedding for the slab. The pipe [59] was exposed at the southern side of the trench and appeared to run in the same alignment as in Trench V though it was not bonded into the dam in any way and there was no obvious feed into it (Plate 9).

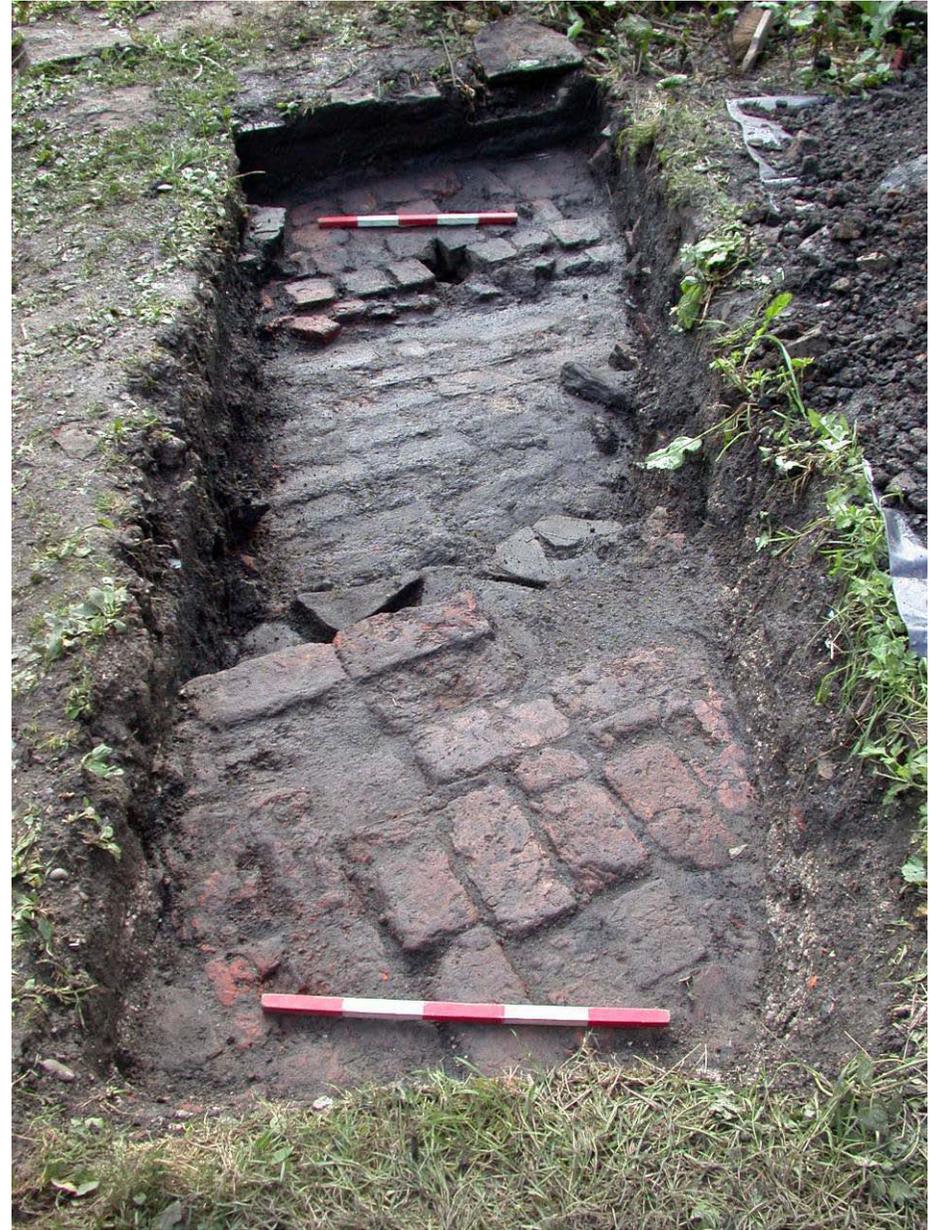
Plate 10. Trench XI. Brick floor [76] in foreground, the arched head to the tail race in the rear. View looking south.

A distinctive crushed mortar layer [75] was uncovered below the topsoil [74] and it was surmised that this was probably demolition debris. To the south of this layer, two bricks were initially exposed which, after removal of [75], became a neatly laid brick floor [76], composed of a single layer of handmade brick laid north-east south-west on a bedding of ash and cinders [77] (Plate 10). This was probably a brick floor to the mill building and was aligned with the tail race. The tail race itself was exposed below [77] as a slightly arched brick structure running north-east south-west over a water channel feeding from the dam. Excavation was halted at this point and the exposed features left *in situ*.
