An Archaeological Excavation at Stanley Bank, St Helens, Merseyside

August 2007

An Archaeological Evaluation Excavation at 'Stanley Bank Mill', Stanley Bank, St Helens, Merseyside.

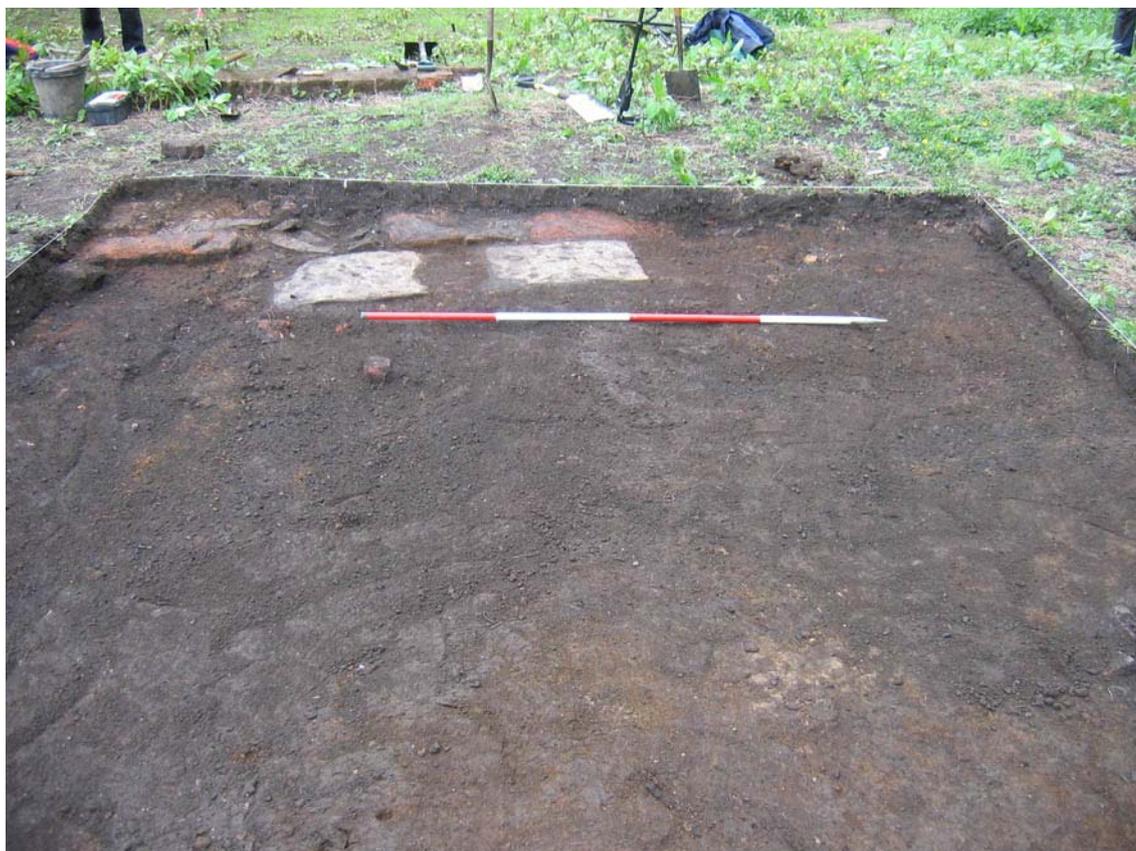
Plate 11. Wall [101] as first exposed in Trench XIII. View looking North.

Topsoil [100] was removed to a depth of c. 0.15m to expose the top of a sandstone wall [101] running northeast – southwest in the north-west corner of the trench. Two Yorkstone flags [102], c. 0.60m x 0.50m x 0.06m, lay adjacent to [101] on the southern side and were probably the remains of a flagged floor (Plate 11).. A thin, loose clinker/cinder layer [103] covered the central area of the trench.

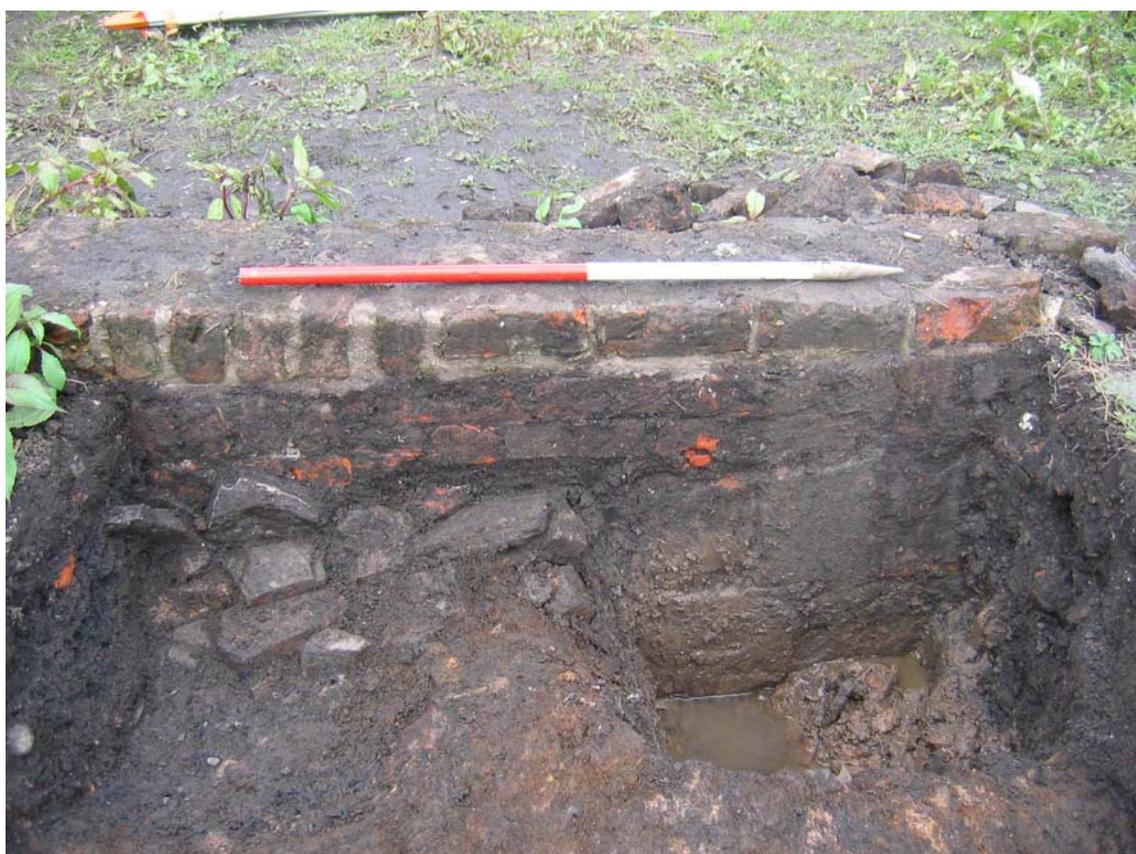
Plate 12. Sondage excavated against wall [121], Trench XIII. View looking north.

At ground level wall [121] was a linear red brick wall. As contexts [115] and [116] were excavated it became apparent that the brick wall consisted of three courses to a depth of around 0.34 m and overlay an earlier sandstone wall of ashlar masonry (Plates 12 and 13).. The top course of brick had evidence of later mortar pointing presumably to stabilise the brickwork at ground level. The brick courses appear to represent a later addition for the corn mill overlying the original sandstone block foundations for the earlier slitting mill.

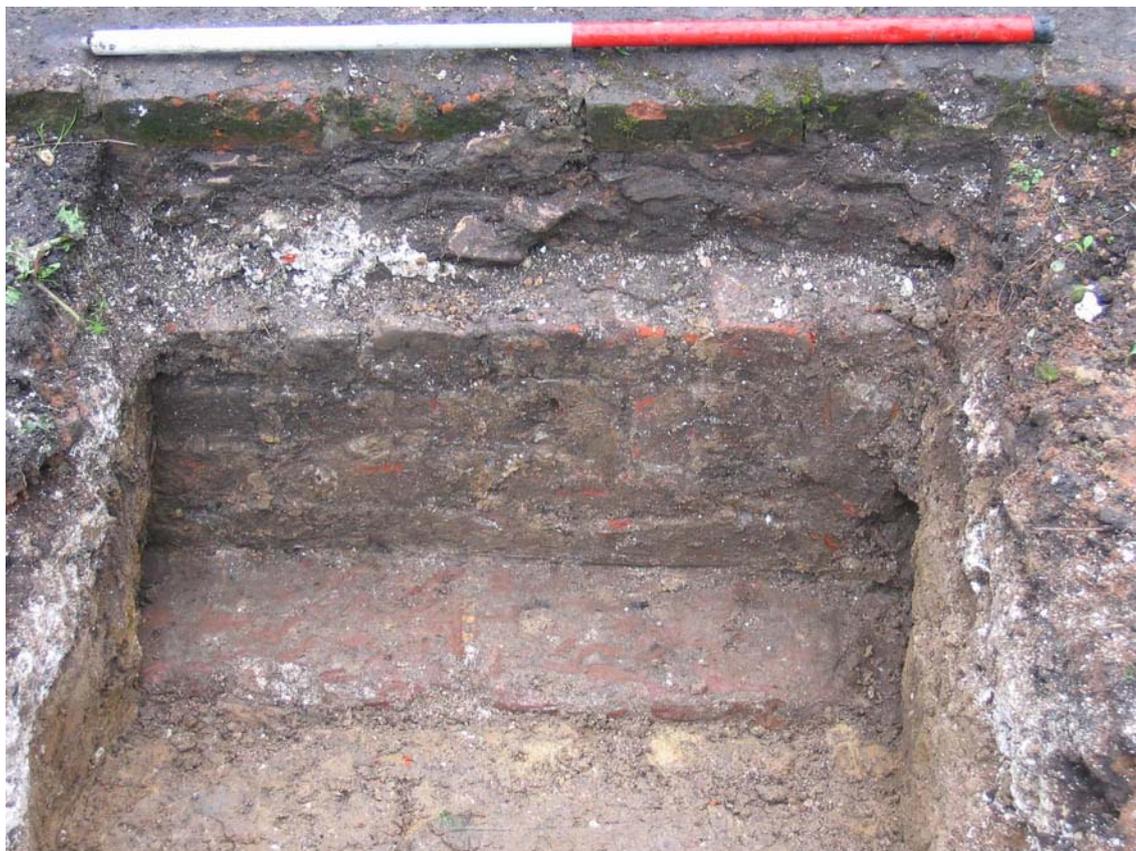
Plate 13. Sondage excavated against wall [121], Trench XIV. View looking South.

Whilst excavating this trench the north facing elevation of wall [121] was exposed (Plate 13).
