An Archaeological Excavation at Stanley Bank, St Helens, Merseyside

March 2009

Produced for St Helens MBC

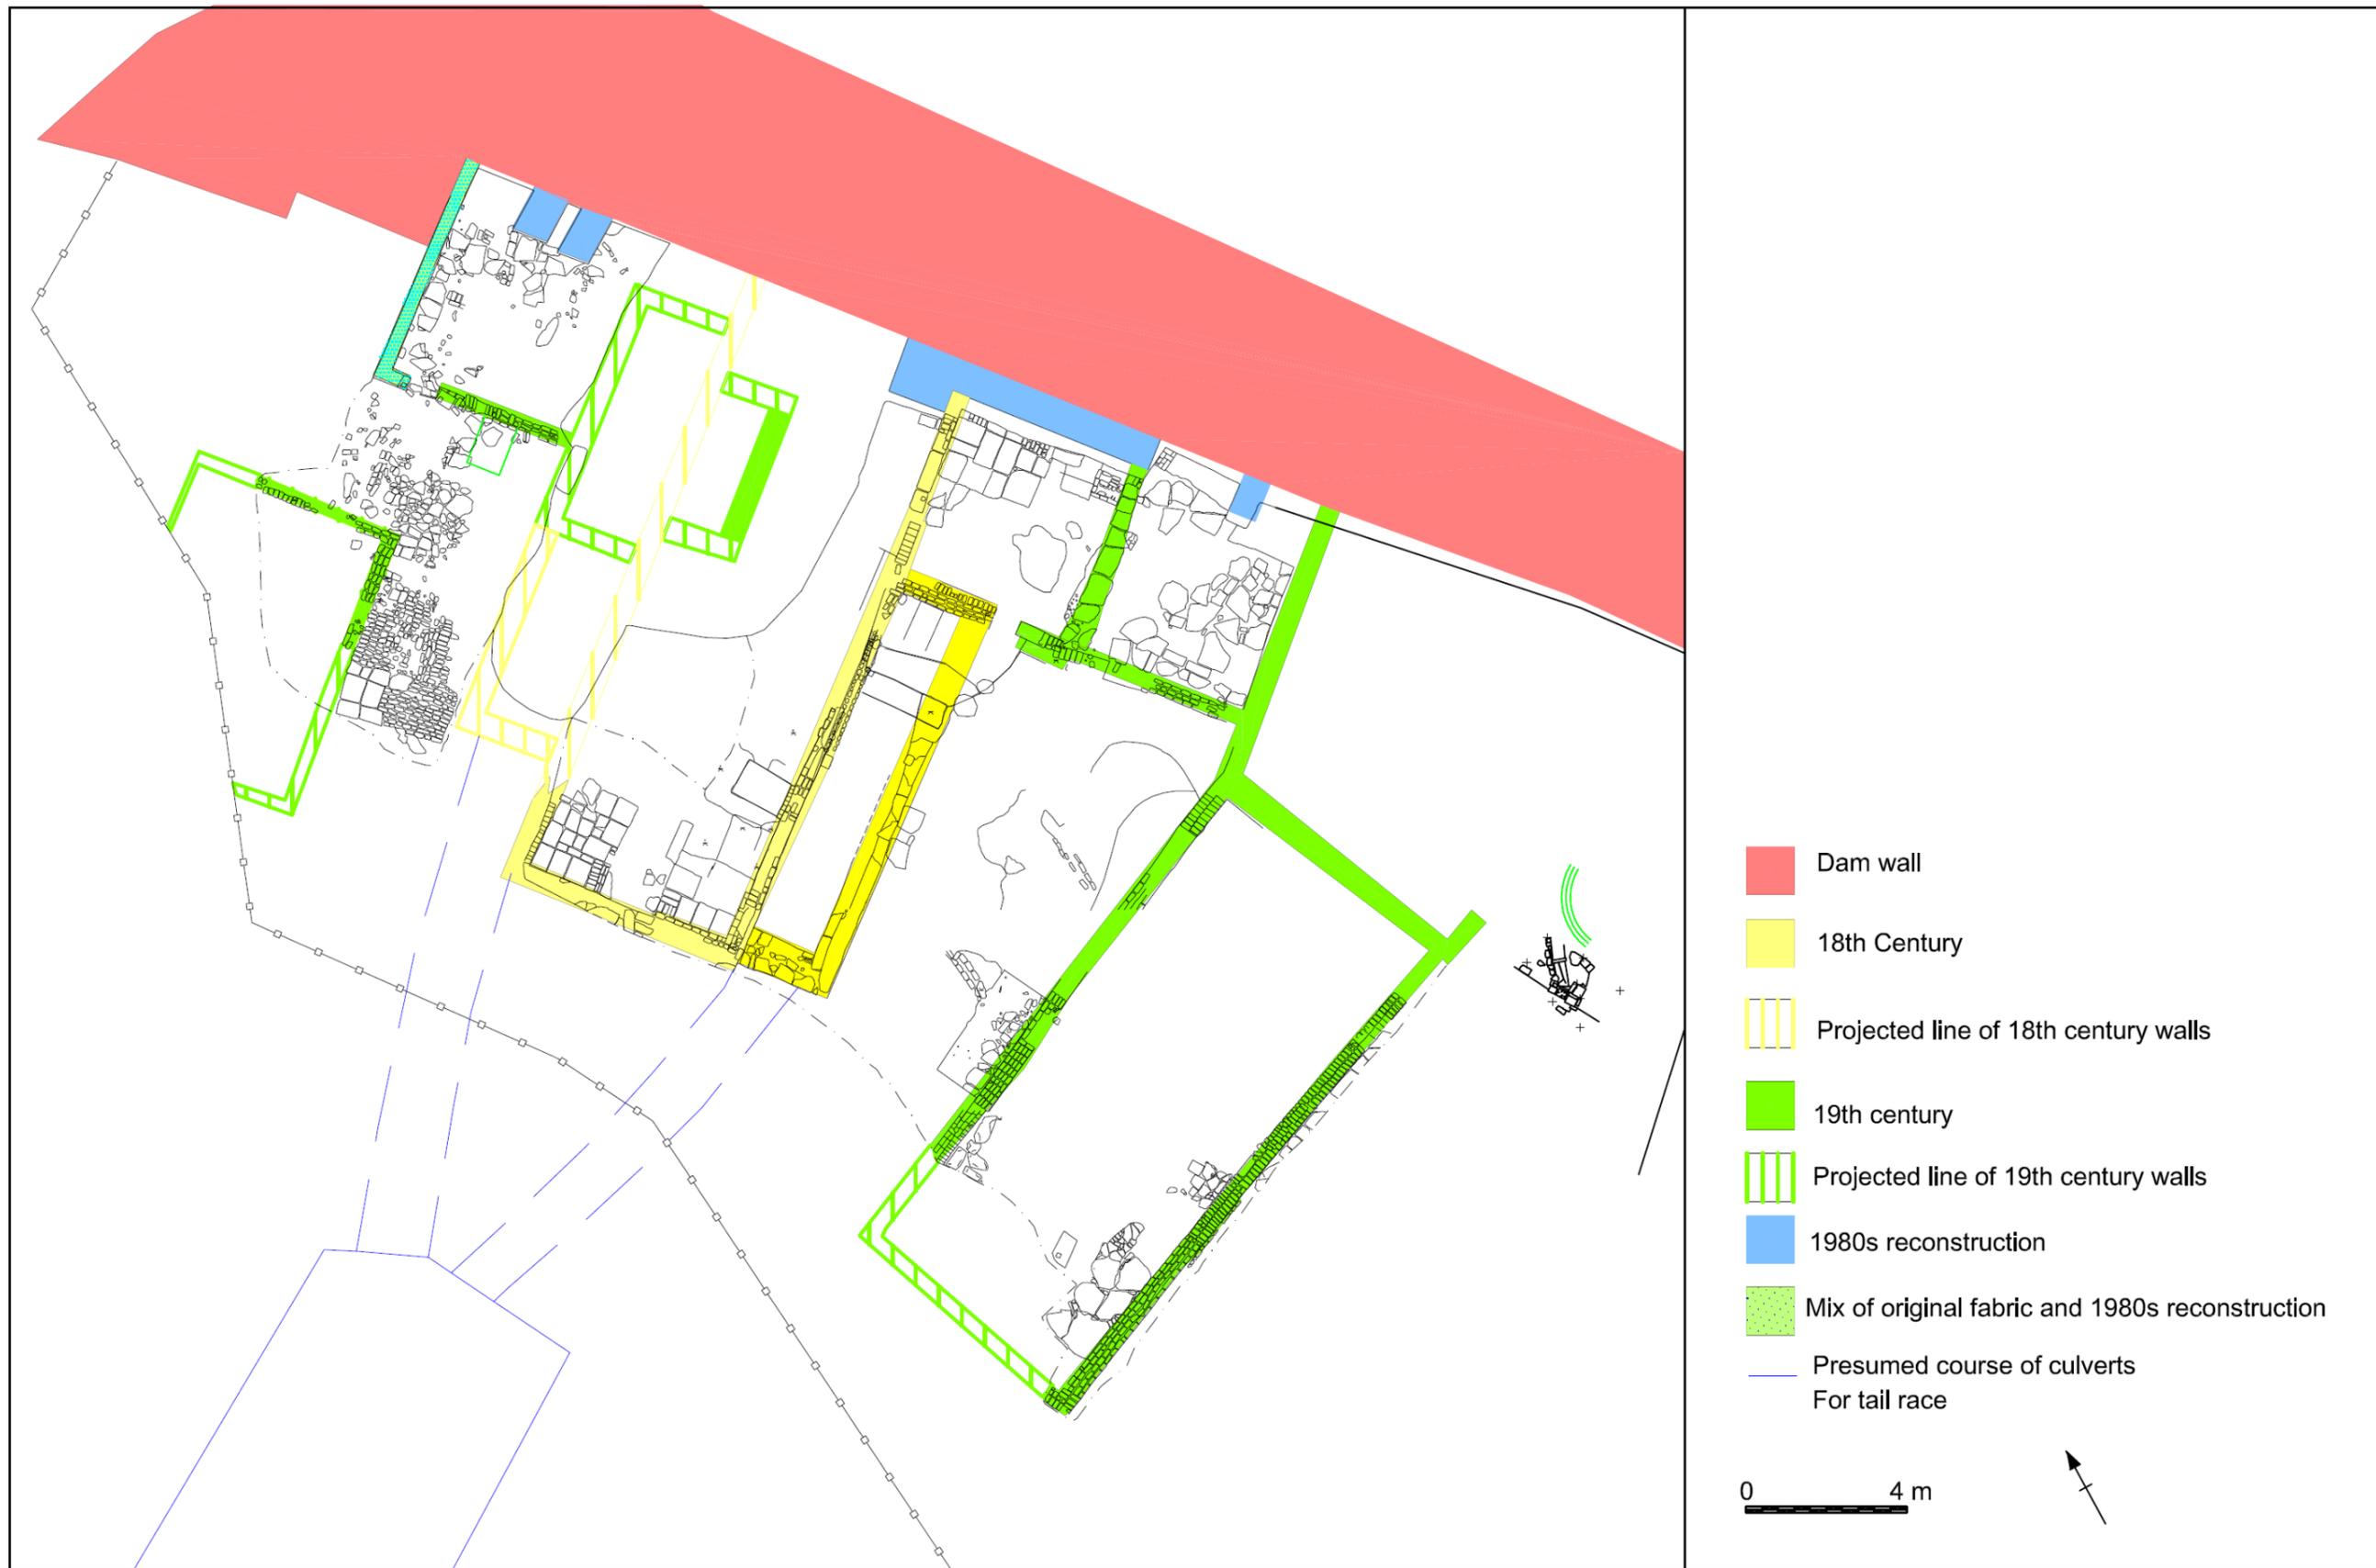
Fig. 2. Plan of excavated area and suggested phasing.

In general the strategy defined in the Project Design was adhered to. A single open area (XVII) measuring approximately 30 x 30 m was excavated and numbered in a sequence consecutive with that used in previous seasons (Fig. 2, Plates 1 and 2). Excavation was largely confined to the removal by machine of modern deposits which had accumulated since the 1980s and cleaning to aid interpretation. Selected areas were excavated more intensively to aid understanding and to obtain dating evidence as required. However, frequent heavy rain meant that some aspects of the project were curtailed.

The excavated deposits are described from north to south. Although a broad stratigraphic sequence has been established, this is incomplete and relies upon partial excavation, the interpretation of map evidence and the reinterpretation of evidence from the 1982-3 excavation. A suggested dating scheme is given in (Fig. 2). Structure numbers have been assigned where possible, running in a sequence from north to south.

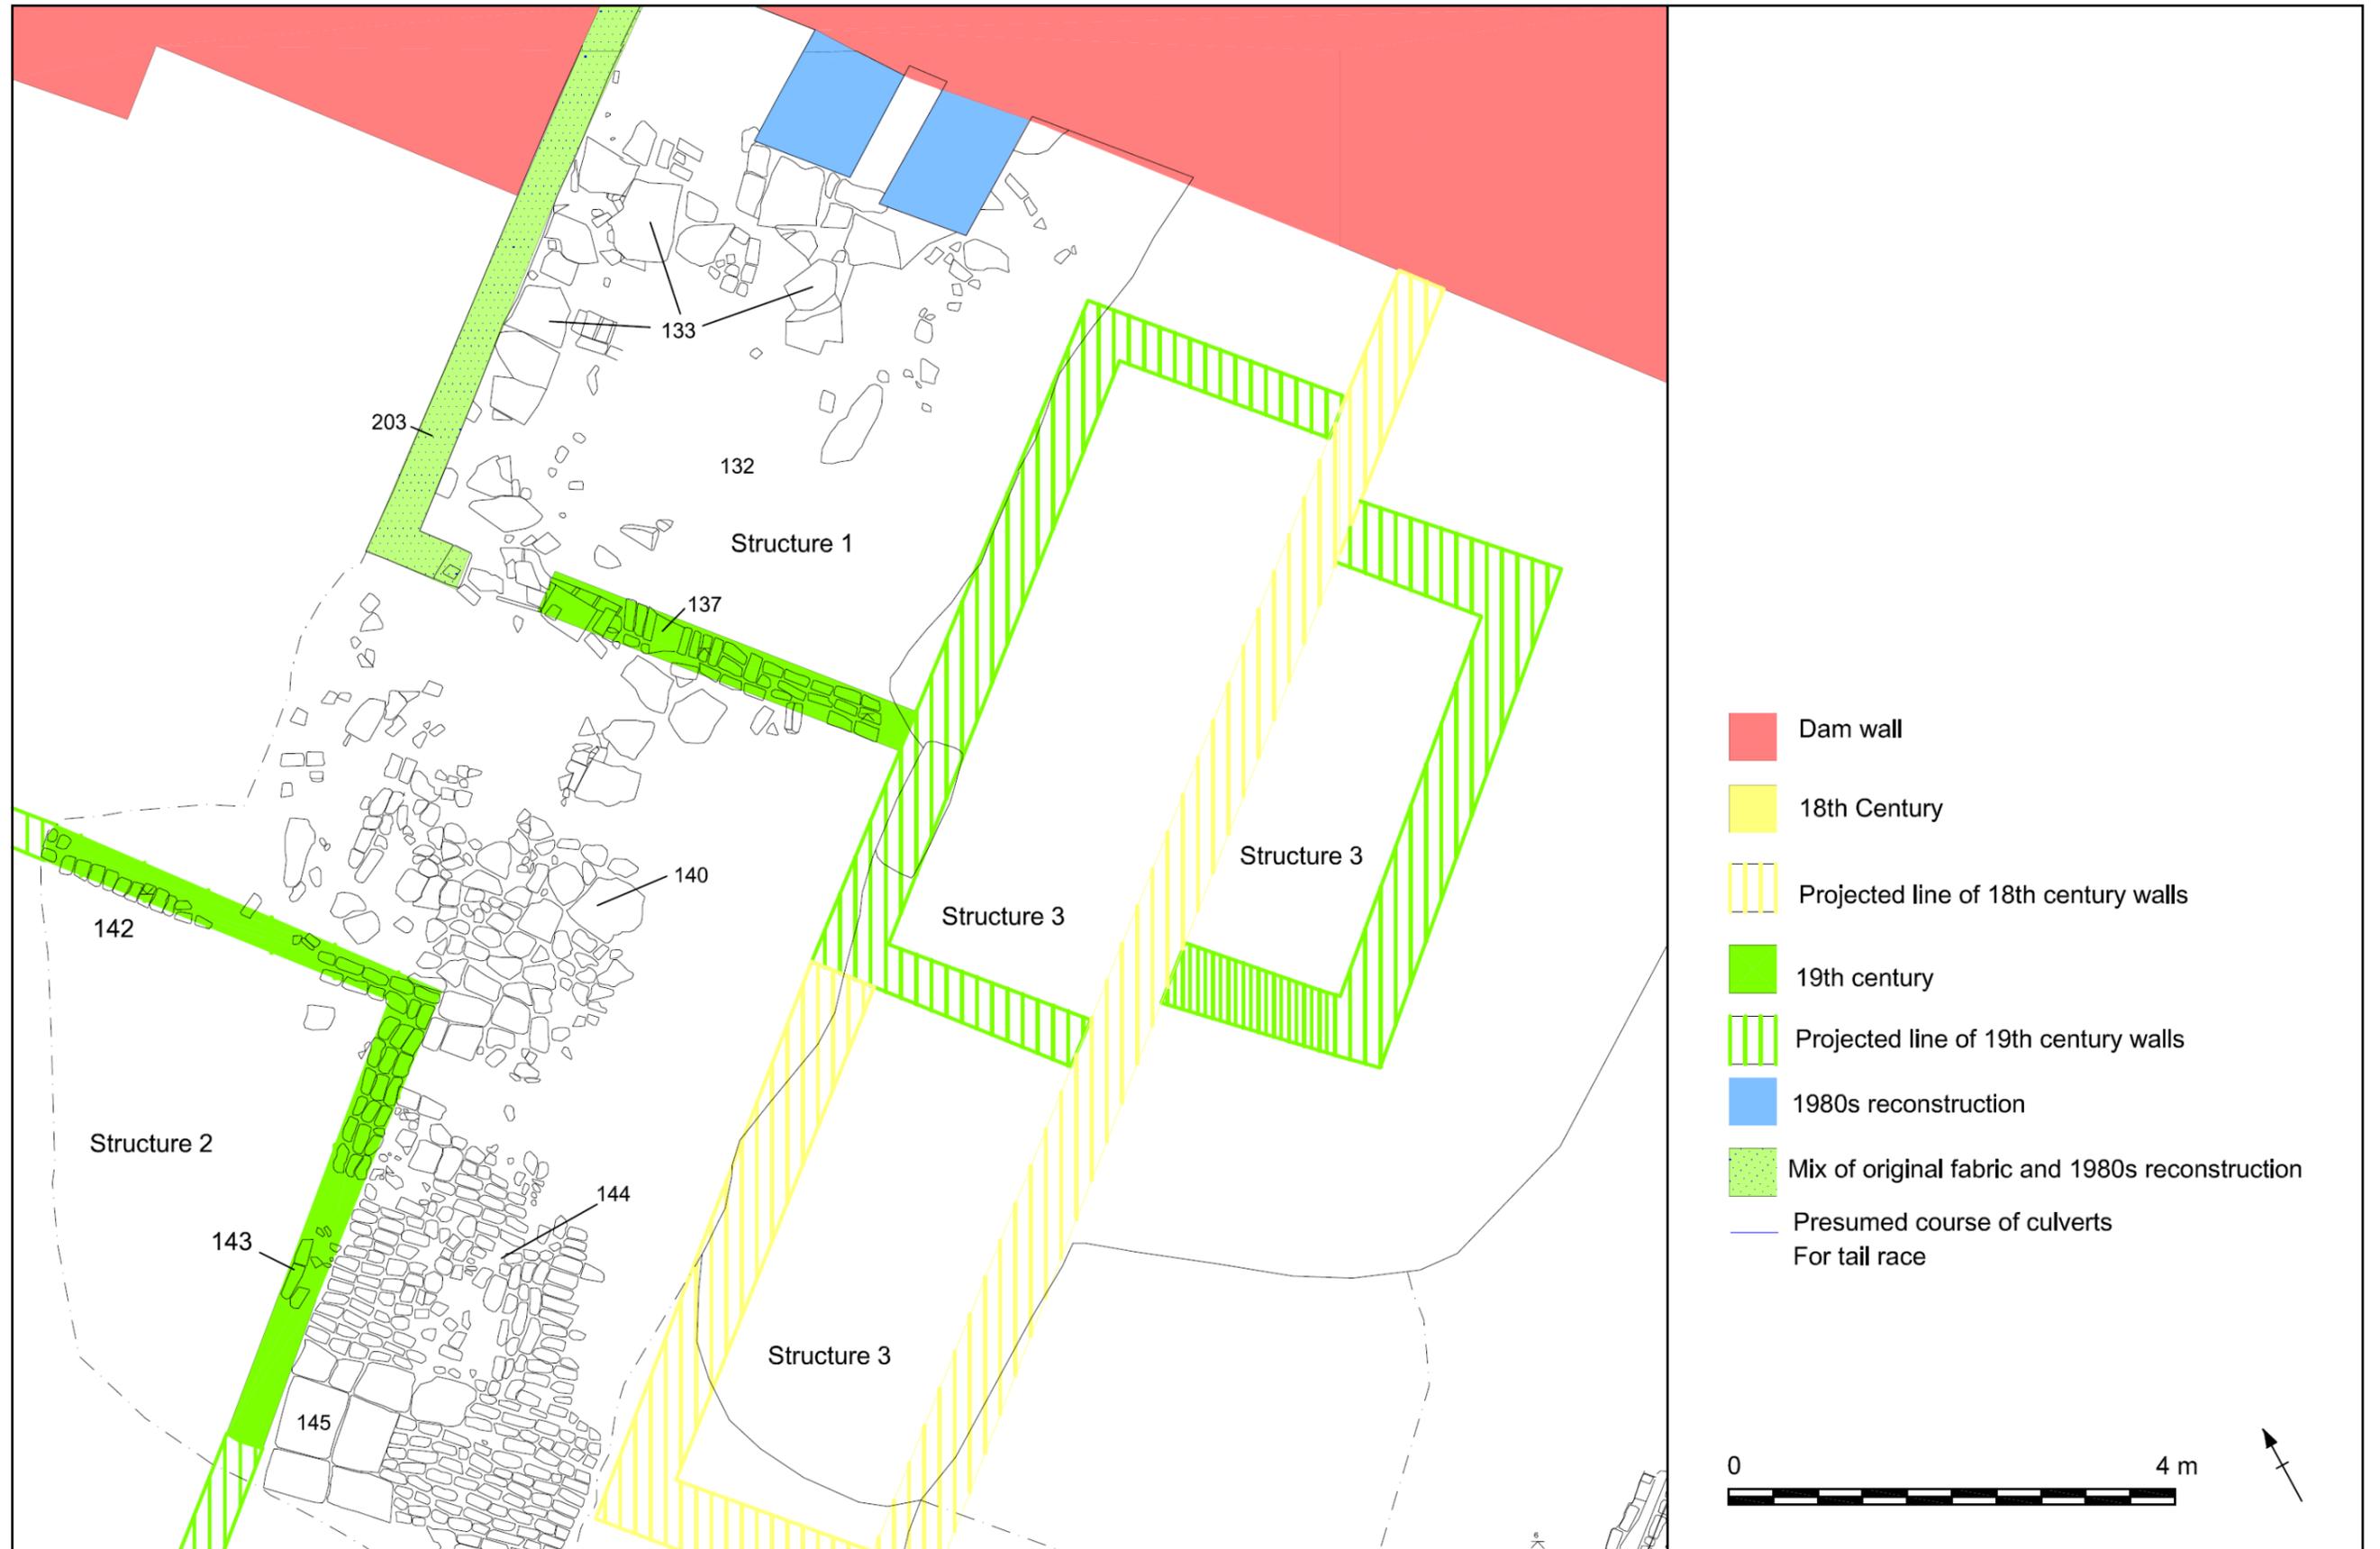
Fig. 3. Plan of north end of excavated area.

The area to the north of the flooded wheel pit was excavated to a set of floor levels associated with two structures, both part of the 19th century corn mill. Structure 1 (Fig. 3, Plate 3) was defined by the dam wall, east-west aligned brick wall 203, north-south aligned brick wall 137 and the northern wall of the wheel pit. The latter was not exposed during this phase of excavation but is visible on photographs taken in 1982-3. At this point it is constructed in a mix of coursed (gritstone?) rubble and brick (Plates 4 and 5), though to the west there is evidence that it was constructed in ashlar (see below). The entrance to this structure was via a door way set into the northern end of wall 137 and defined by two sandstone blocks 136 with recesses cut to receive timber jambs. Wall 203 showed evidence of extensive repointing and may have been totally rebuilt, there being a slight discrepancy between the alignment of the wall and its foundations.

Immediately west of Structure 1 was an L-shaped area of brick and flagstone paving (140, 144, 145) Fig. 3, Plate 1) which to be original elements of the mill rather than reconstructions, the character of the paving being subtly different from that within Structure 1. The available historic mapping suggests that this area was external to the mill (Fig. 4). They were set over 139 which was very similar in character to 132.

Structure 2 was situated in the north-western corner of the excavated area and was defined by north south aligned brick wall 142 and east-west aligned brick wall 143 (Fig. 3, Plate 1). The internal floor did not survive in this area.

The northern wheel pit excavated in the 1980s was not investigated on this occasion but has been designated Structure 3 to assist interpretation. The plan shown in Fig. 3 is based partly upon photographic evidence from the 1982-3 excavation (e.g. Plates 4, 5, 6) and partly upon the layout of other water-powered mills. The waterwheel for the slitting mill was probably situated within the linear feature which is now culverted over in brick at its western end (Plate 4) and is now visible as an arm extending west from the pond on this portion of the site. The brick vault which culverts the tail race is probably an addition or partial rebuild dating to the conversion to a corn mill. The justification for this interpretation is that the opening to the tail race to the west is in stone and both walls within the wheel pit at this point are in red sandstone ashlar (Plate 4) in a very similar style to that used in the southern wheel pit. The outlet to the tail race in the southern wheel pit is arched in stone and it would seem unlikely that different materials would be used in the original construction. There is a change in materials at some point along the northern wall to coursed (gritstone?) rubble at the eastern end, though unfortunately the junction between the two elements is obscured on the available photographic evidence. The extreme eastern end of the north wall is in brick (Plate 5). The reason for these rebuilds is unclear but is likely to be related to the conversion to grinding corn. One possibility is that the slitting mill wheel was set further to the west, this would explain the need to culvert over what was once an open wheel pit, and that on conversion to corn it was moved east closer to the dam. However, there is no obvious evidence on the available

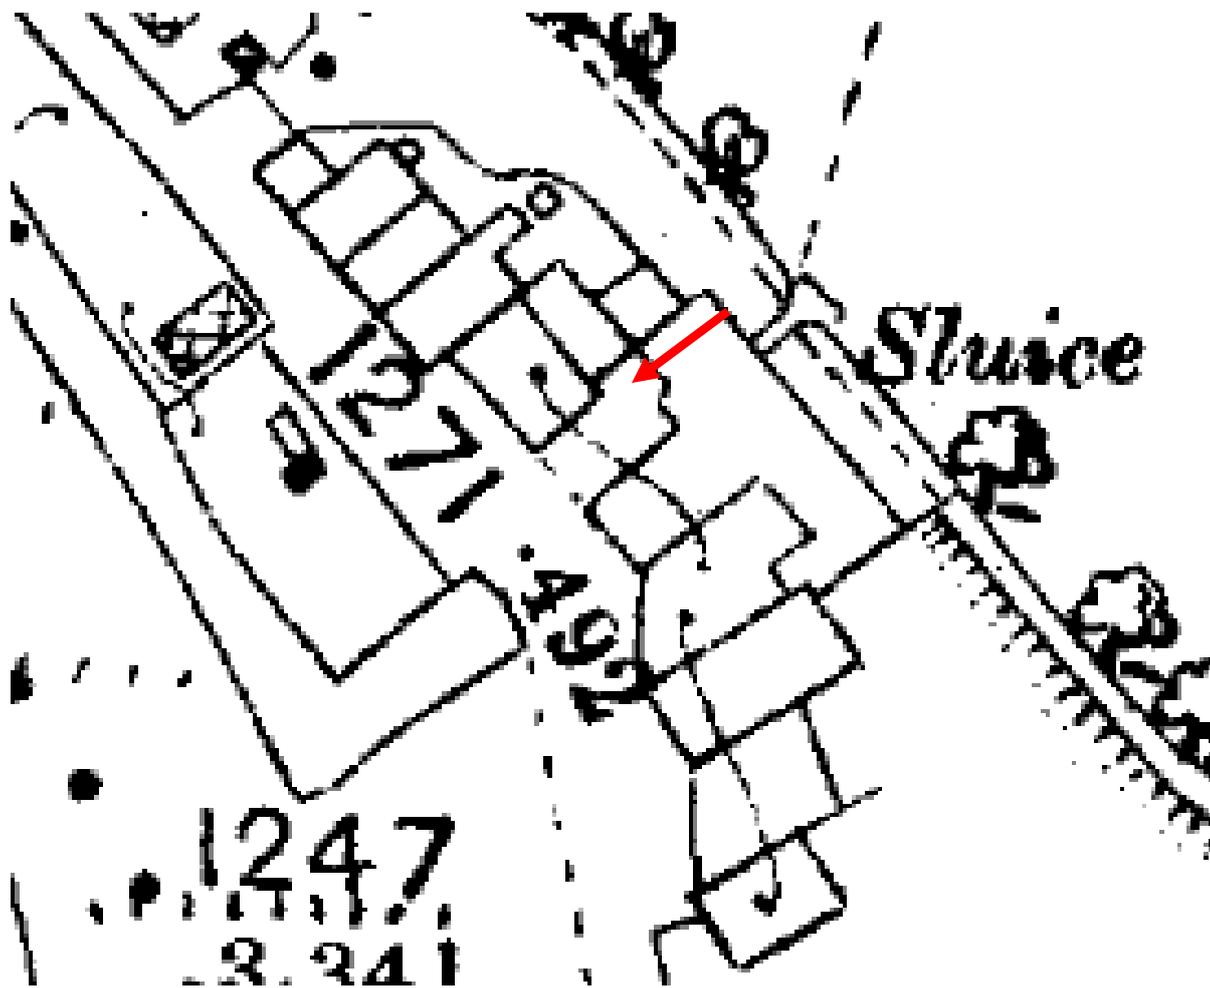
Fig. 4. Part of the 1894 OS 25 inch to 1 mile survey. The arrow is pointing to the open area occupied by 140, 144 and 145.

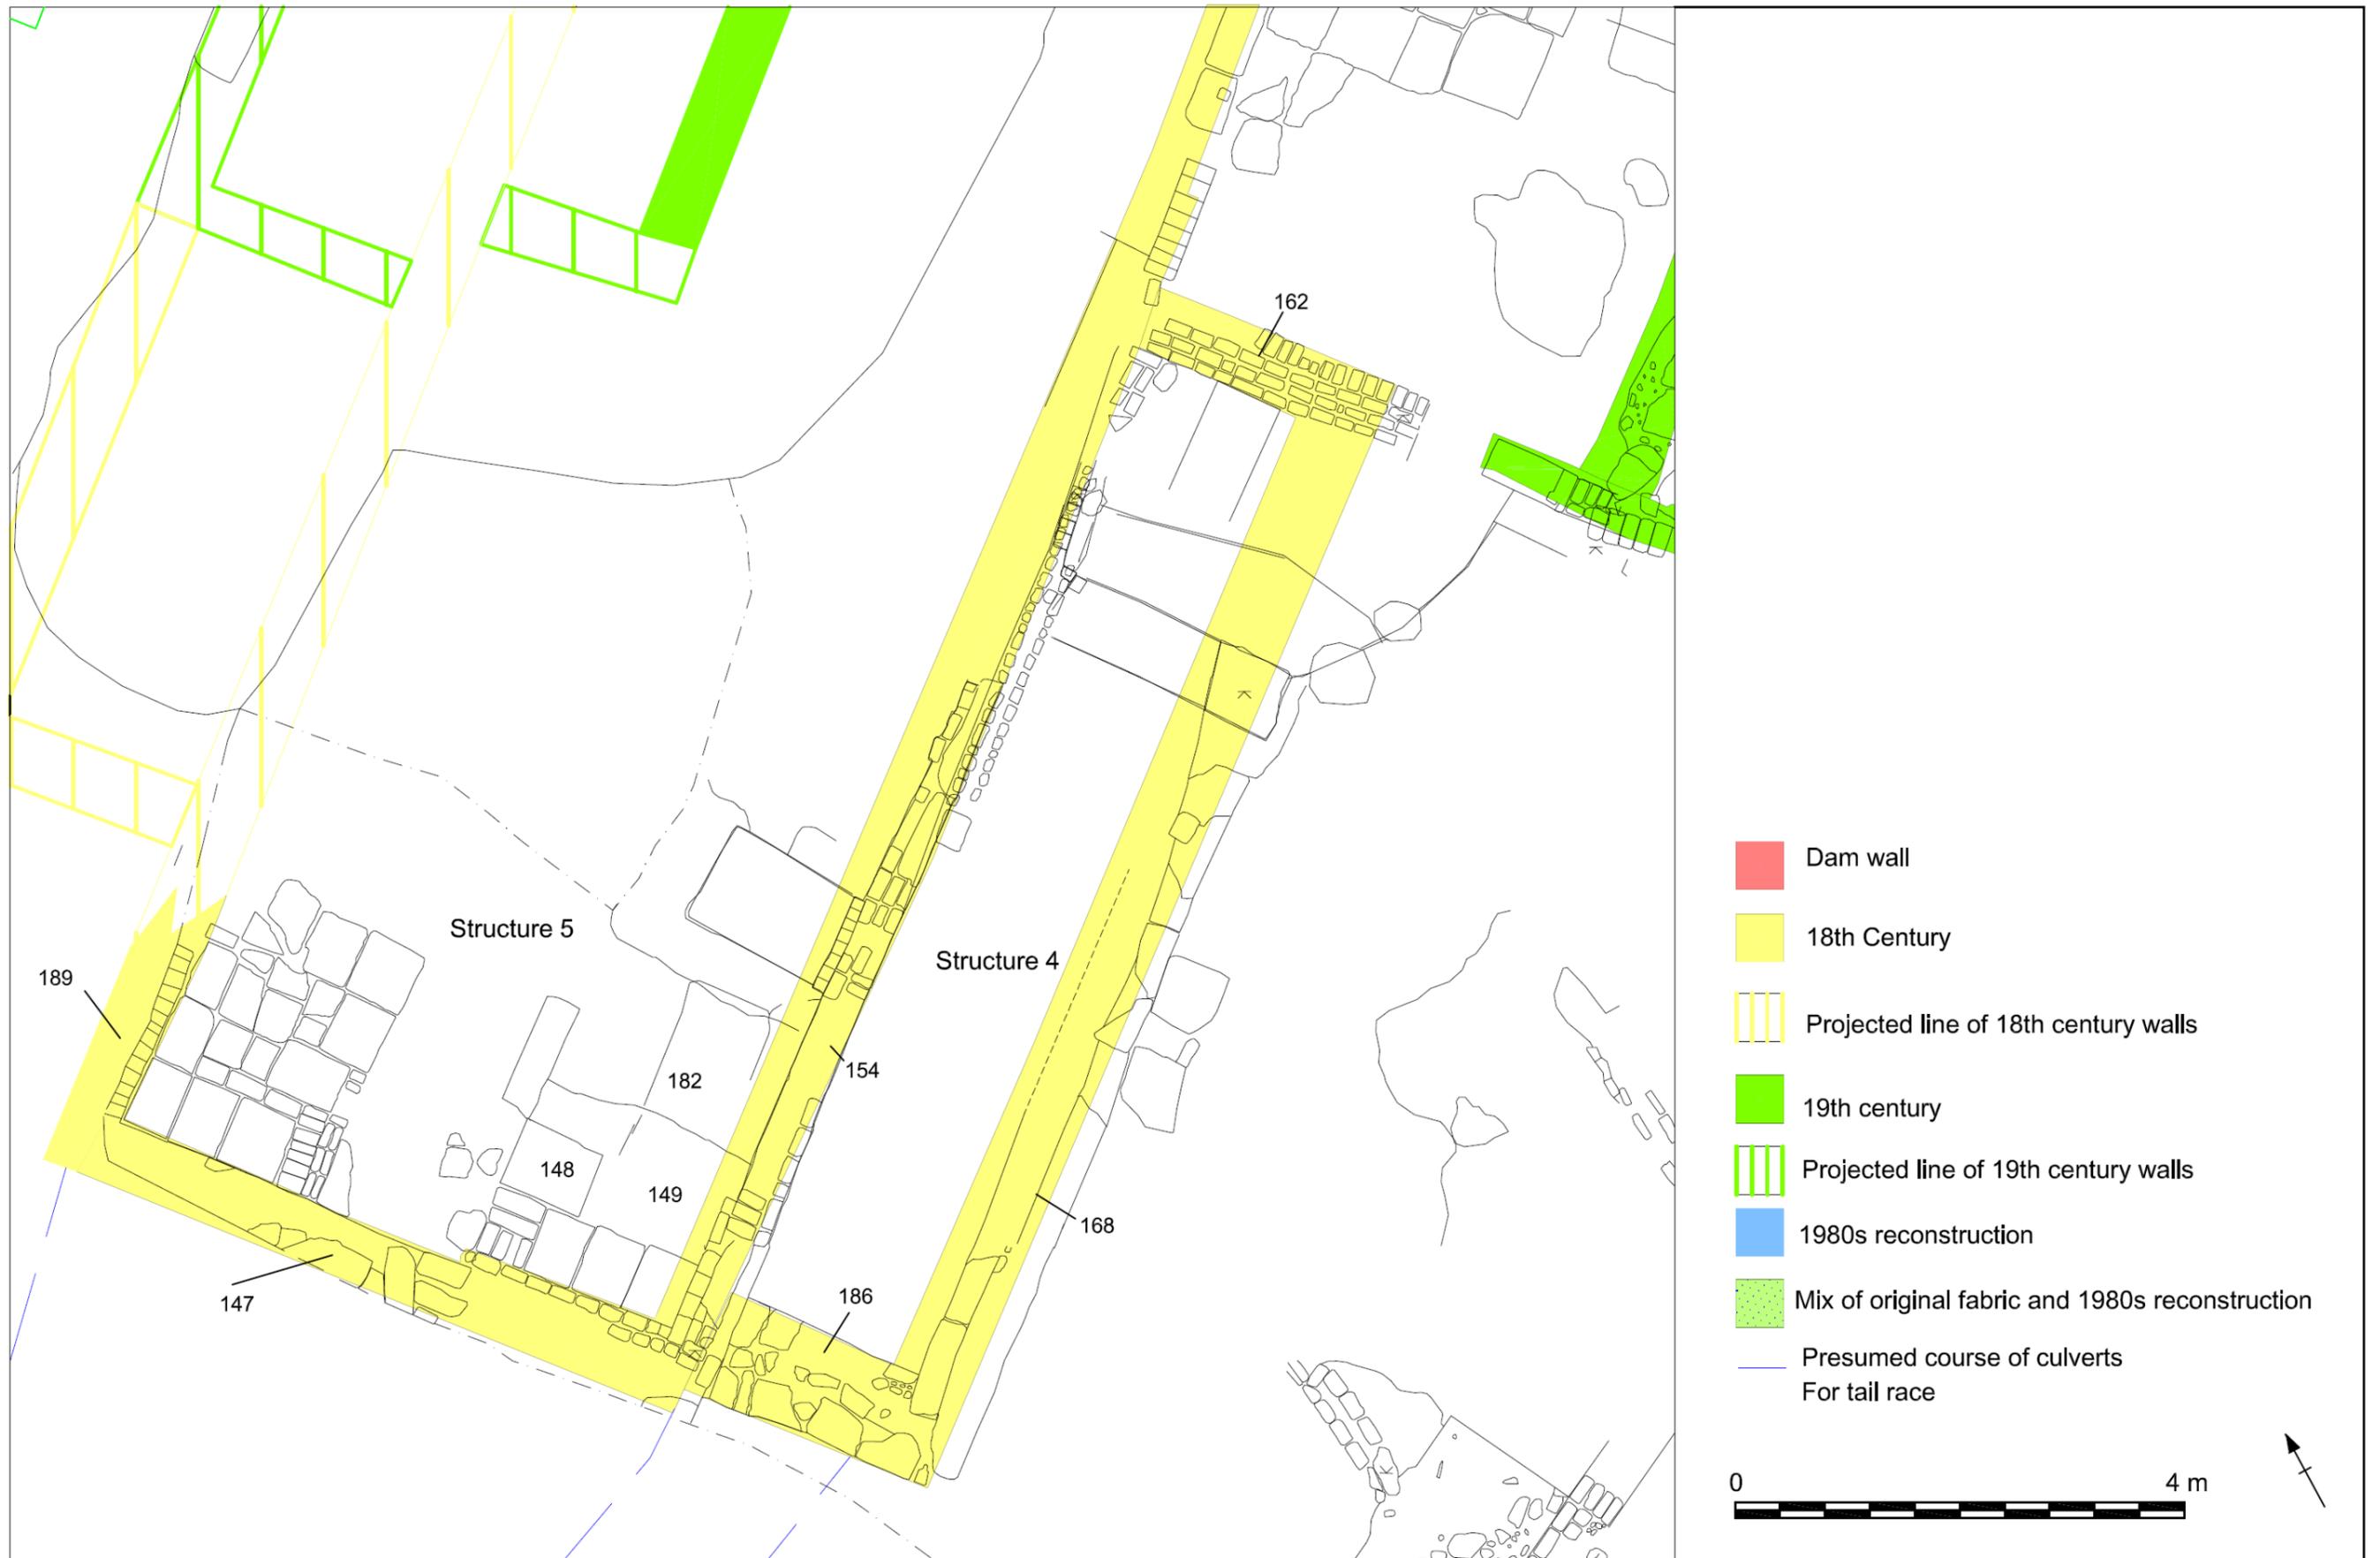
Fig. 5. Plan of central section of excavated area around southern wheel pit.

To the south of this area a complex of structures was revealed. Perhaps the most significant of these was Structure 4, the southern wheelpit, which to date is the only excavated feature which can be positively associated with the slitting mill phase (Fig. 5). It was sealed by brick built drains (Plate 8) relating to the corn mill which prove that it was filled in upon once iron slitting ceased on the site between 1800 and 1824, though no finds evidence was recovered from the fill (predominantly clay) to confirm this.

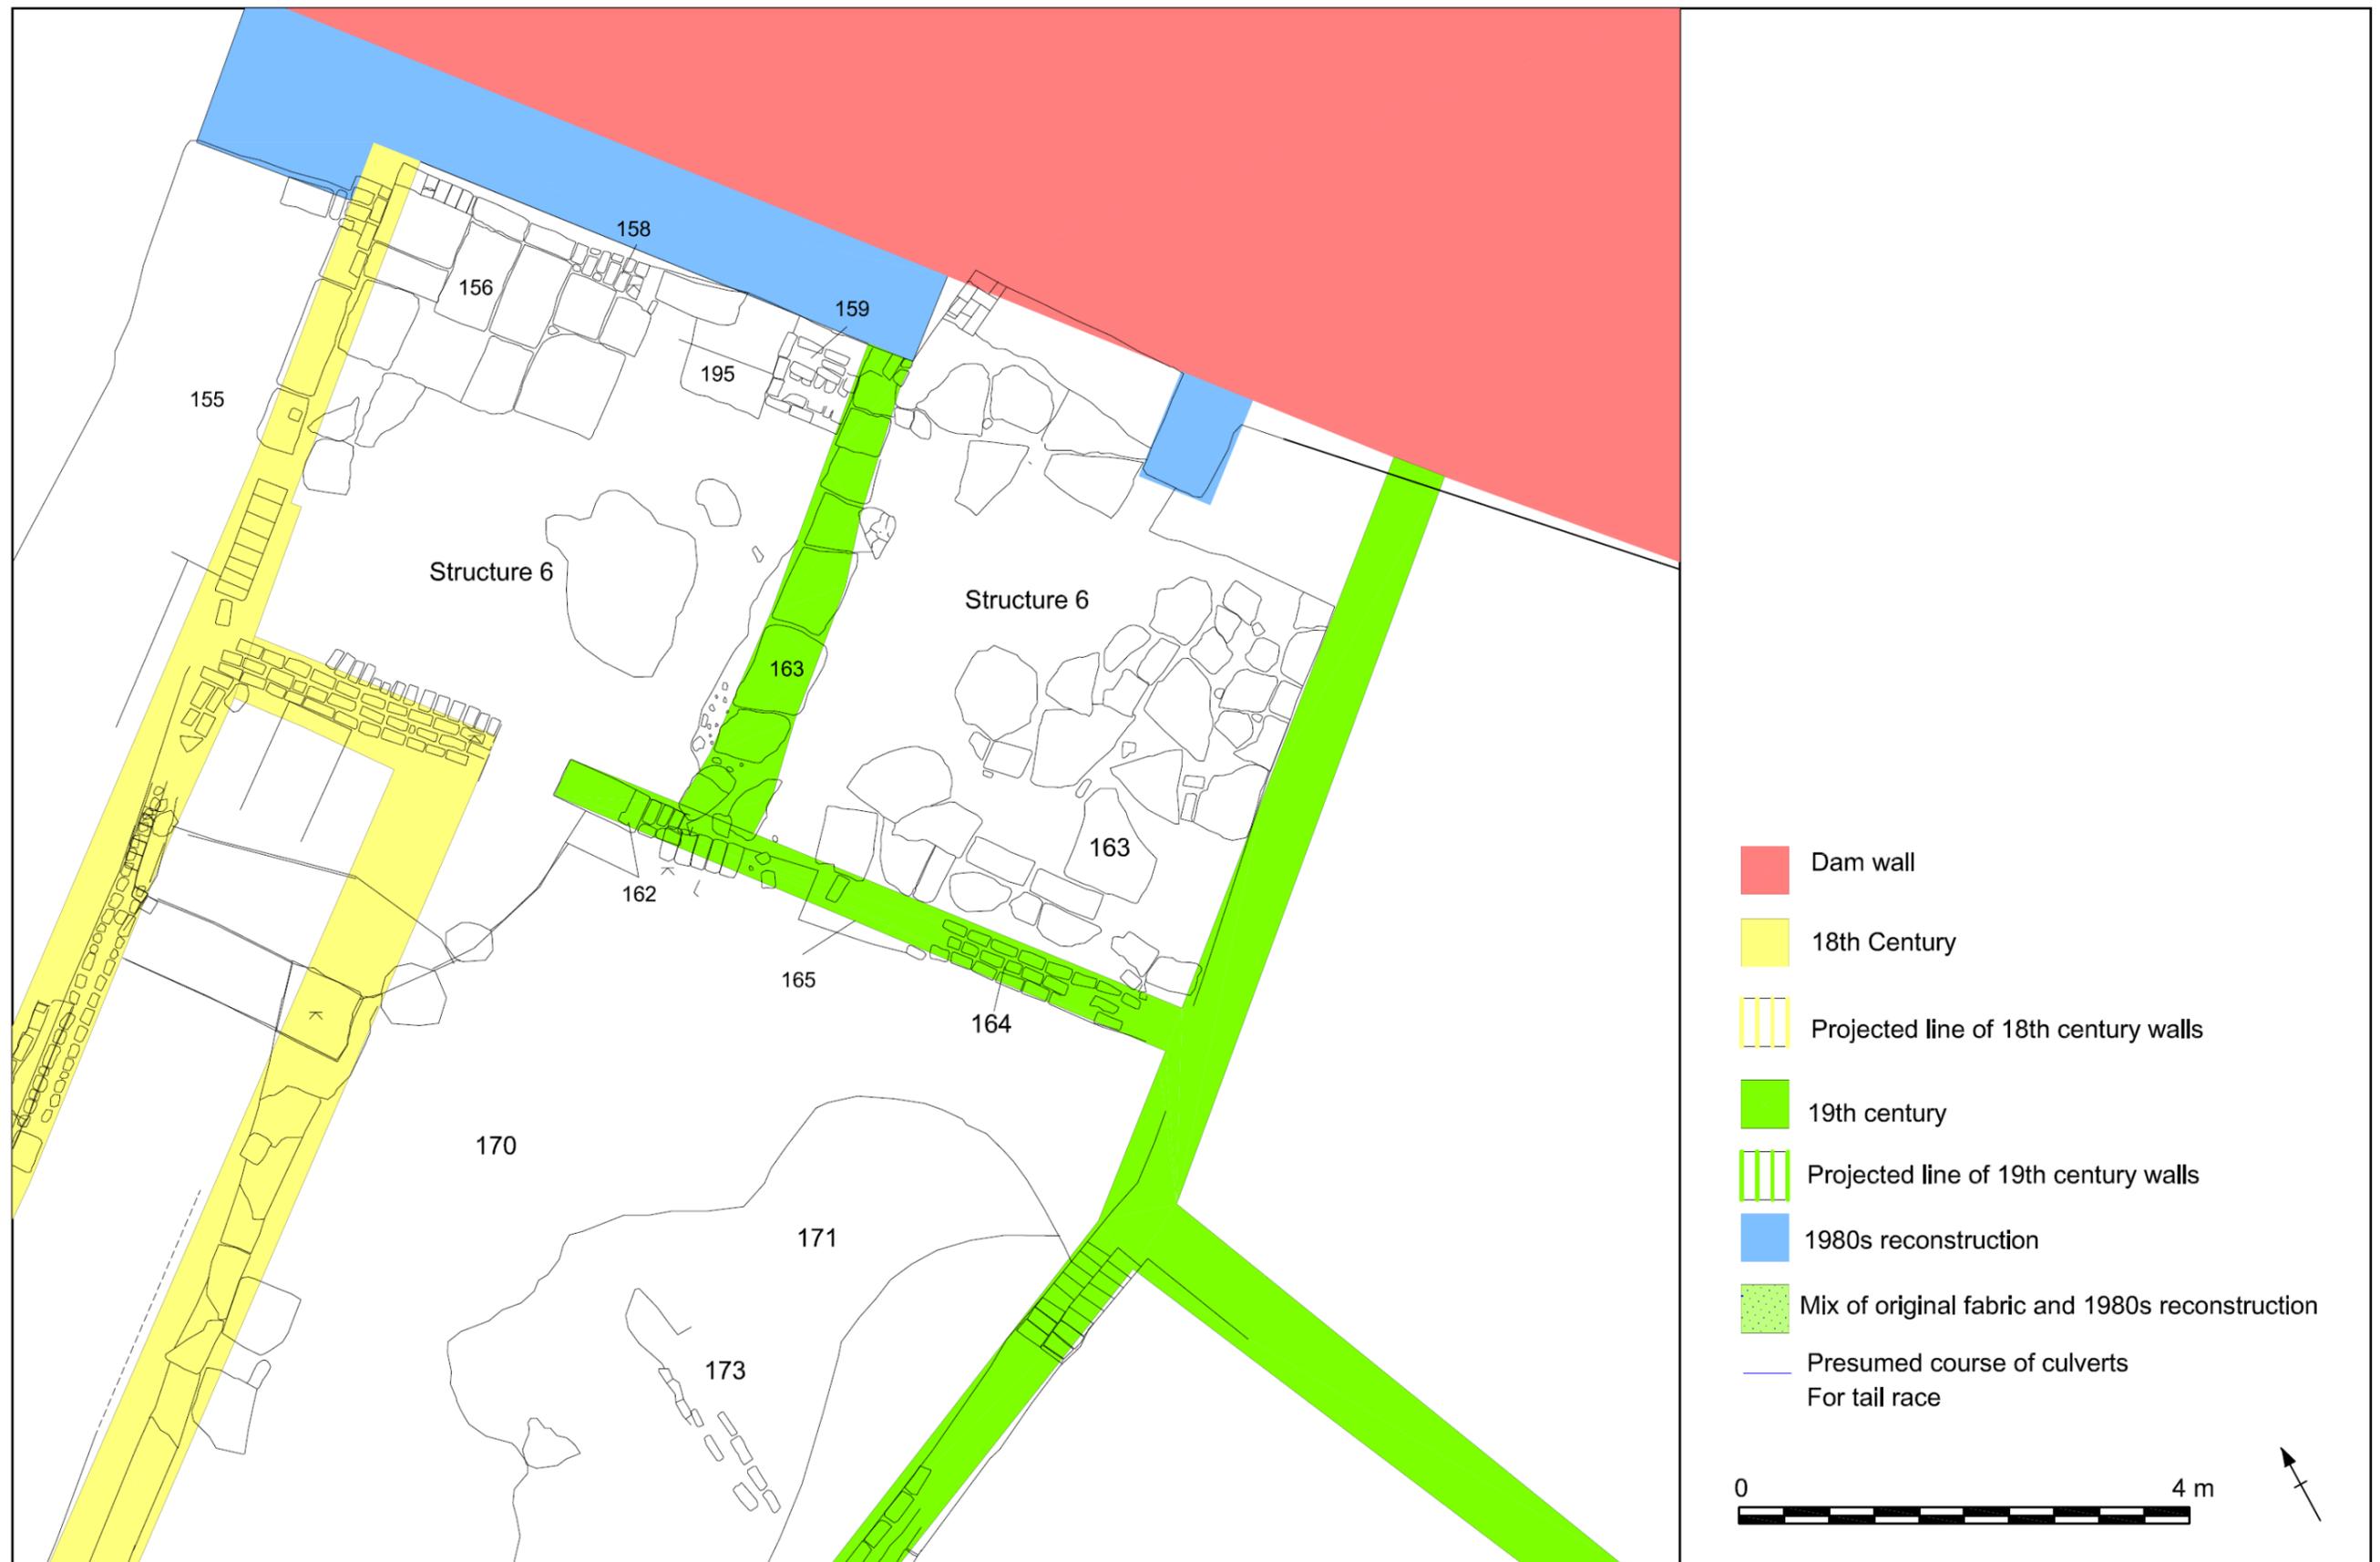
Fig. 6. Plan of Structure 6.

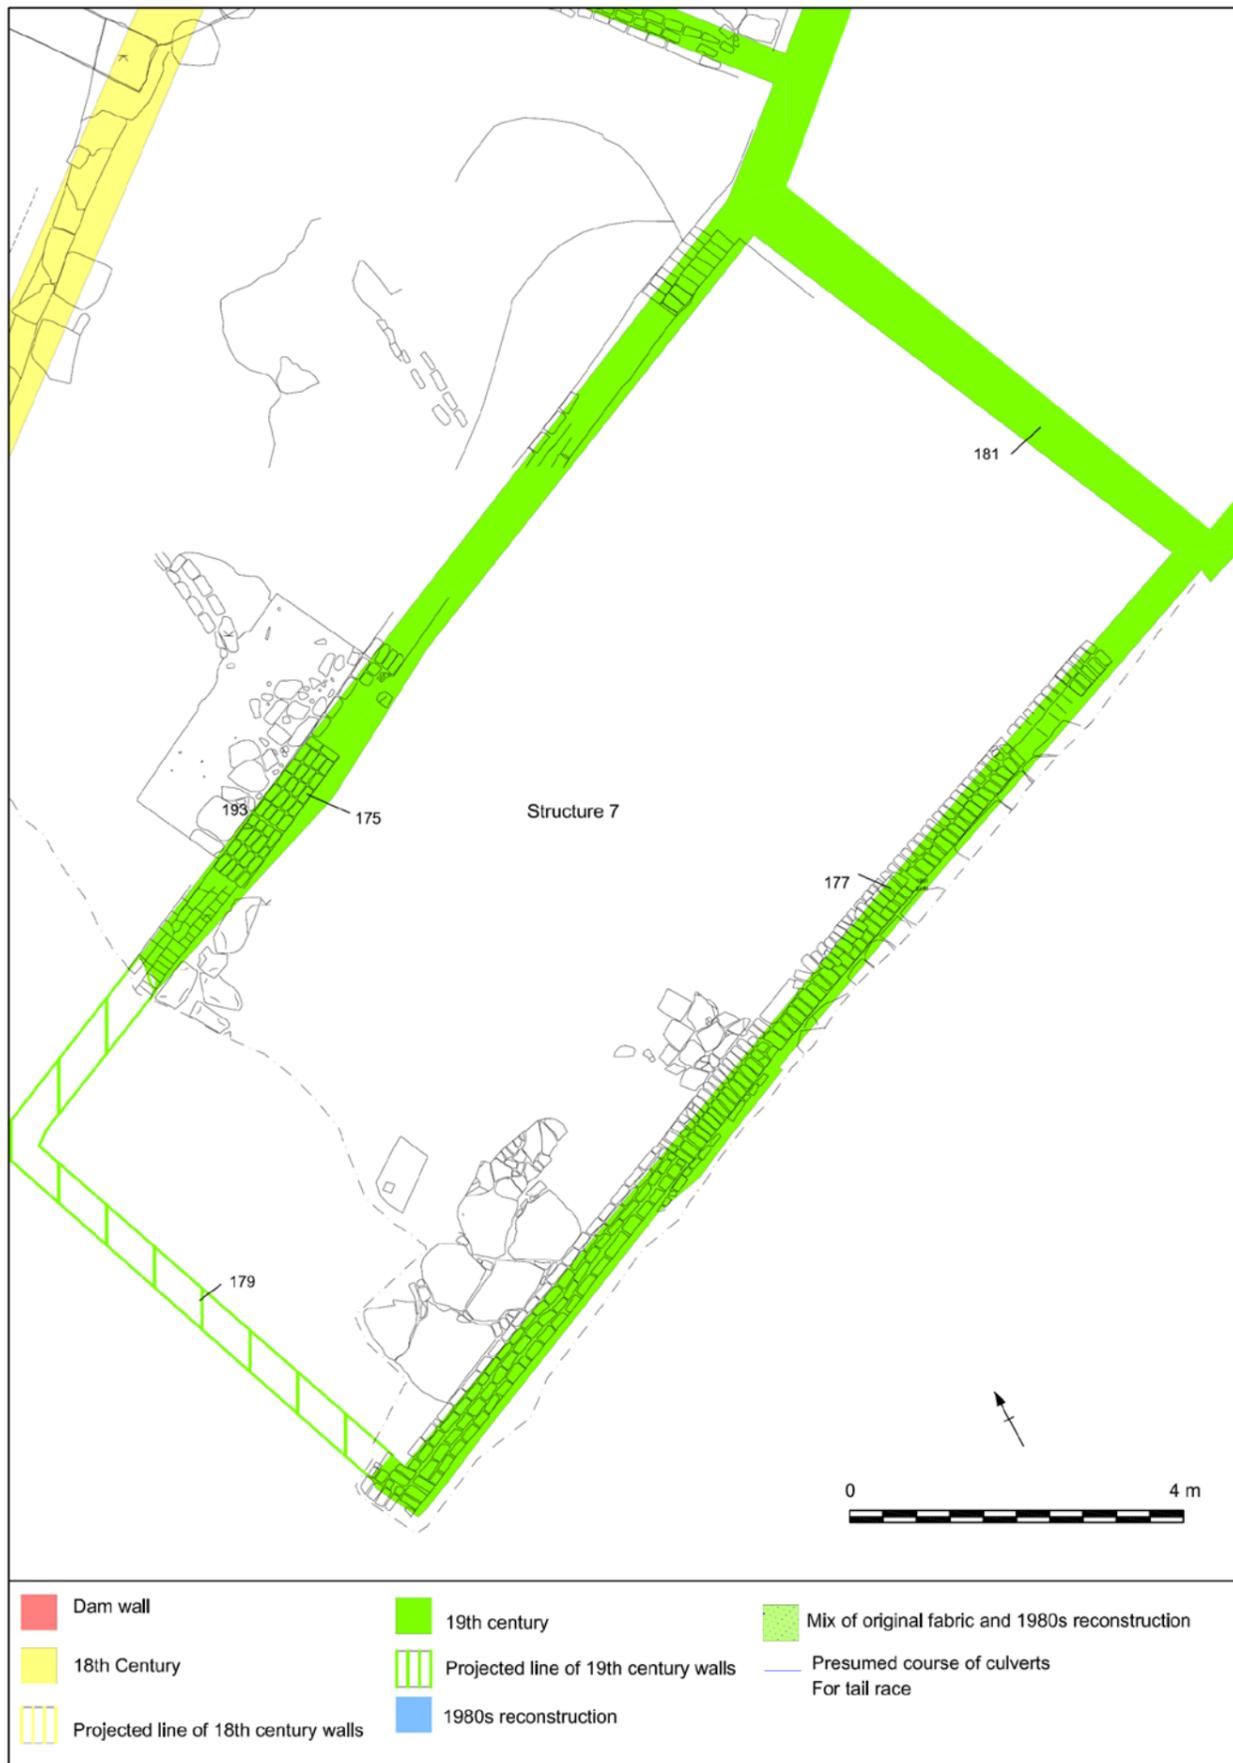
Fig. 7. Plan of southern end of trench.

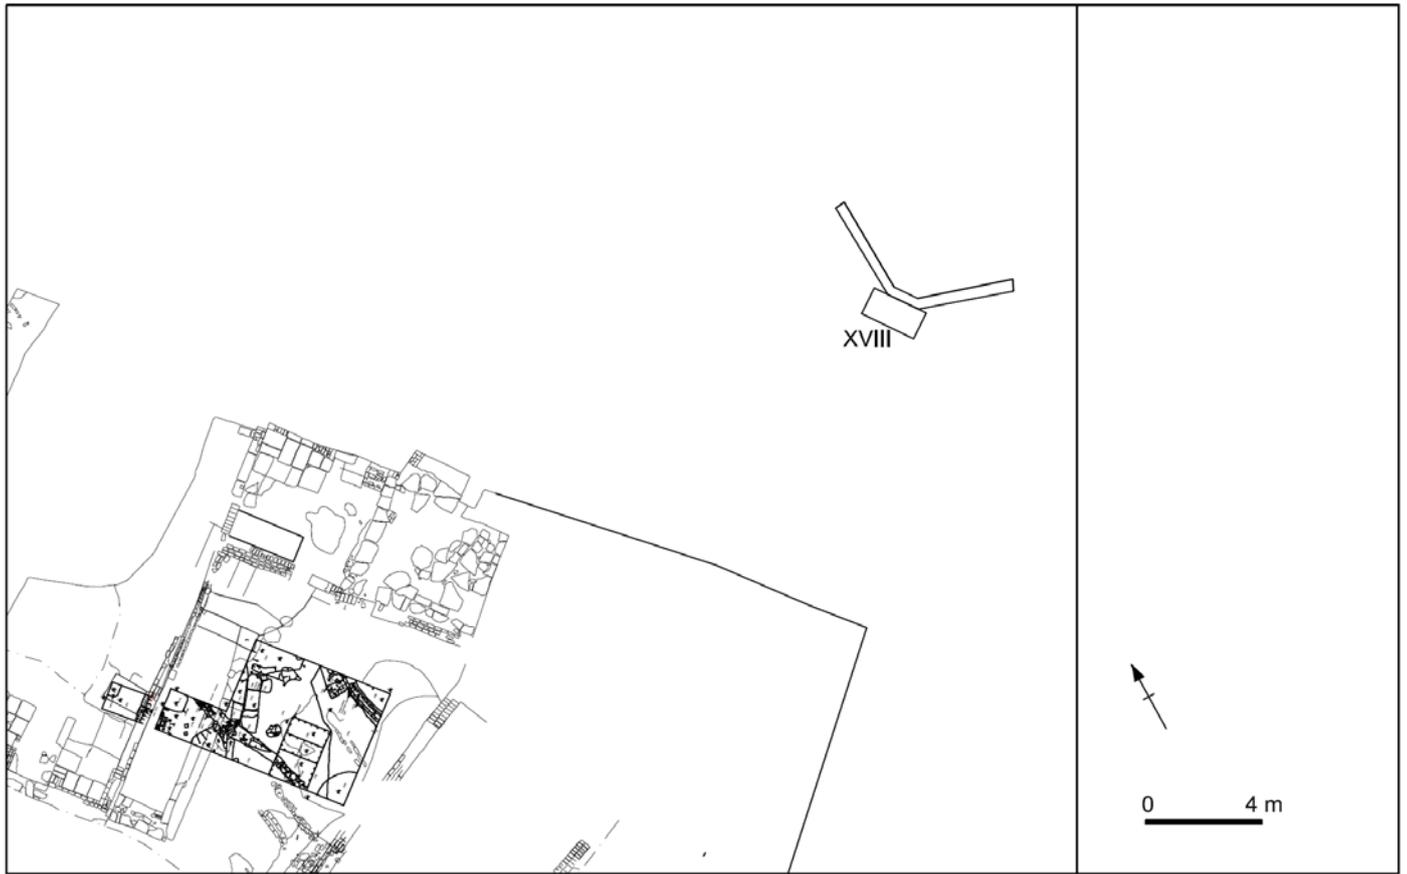
Fig. 8. Location of Trench XVIII.
