An Archaeological Excavation at Stanley Bank, St Helens, Merseyside

March 2009

Produced for St Helens MBC

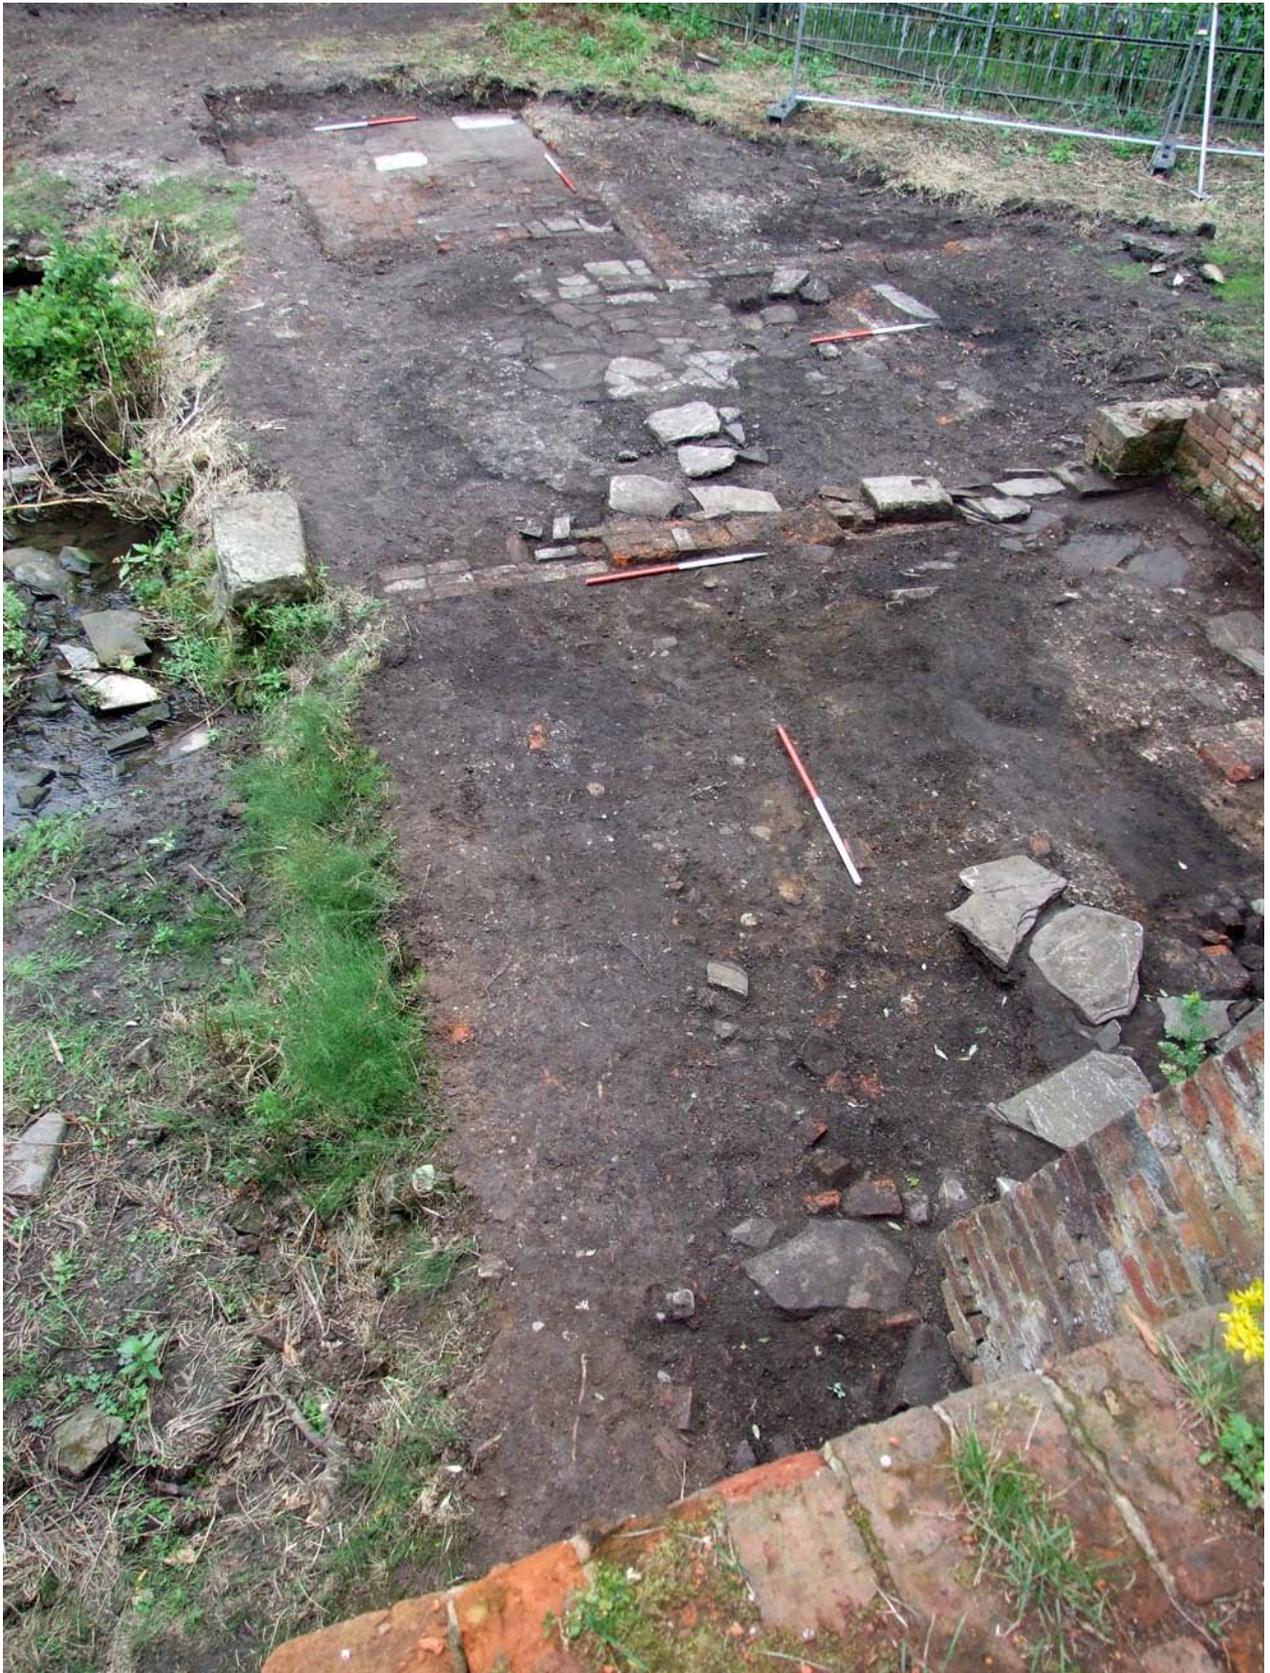
Plate 1. Area north of northern wheel pit after removal of modern deposits. View looking west from top of dam wall.

In general the strategy defined in the Project Design was adhered to. A single open area (XVII) measuring approximately 30 x 30 m was excavated and numbered in a sequence consecutive with that used in previous seasons (Fig. 2, Plates 1 and 2). Excavation was largely confined to the removal by machine of modern deposits which had accumulated since the 1980s and cleaning to aid interpretation. Selected areas were excavated more intensively to aid understanding and to obtain dating evidence as required. However, frequent heavy rain meant that some aspects of the project were curtailed.

Immediately west of Structure 1 was an L-shaped area of brick and flagstone paving (140, 144, 145) Fig. 3, Plate 1) which to be original elements of the mill rather than reconstructions, the character of the paving being subtly different from that within Structure 1. The available historic mapping suggests that this area was external to the mill (Fig. 4). They were set over 139 which was very similar in character to 132.

Structure 2 was situated in the north-western corner of the excavated area and was defined by north south aligned brick wall 142 and east-west aligned brick wall 143 (Fig. 3, Plate 1). The internal floor did not survive in this area.

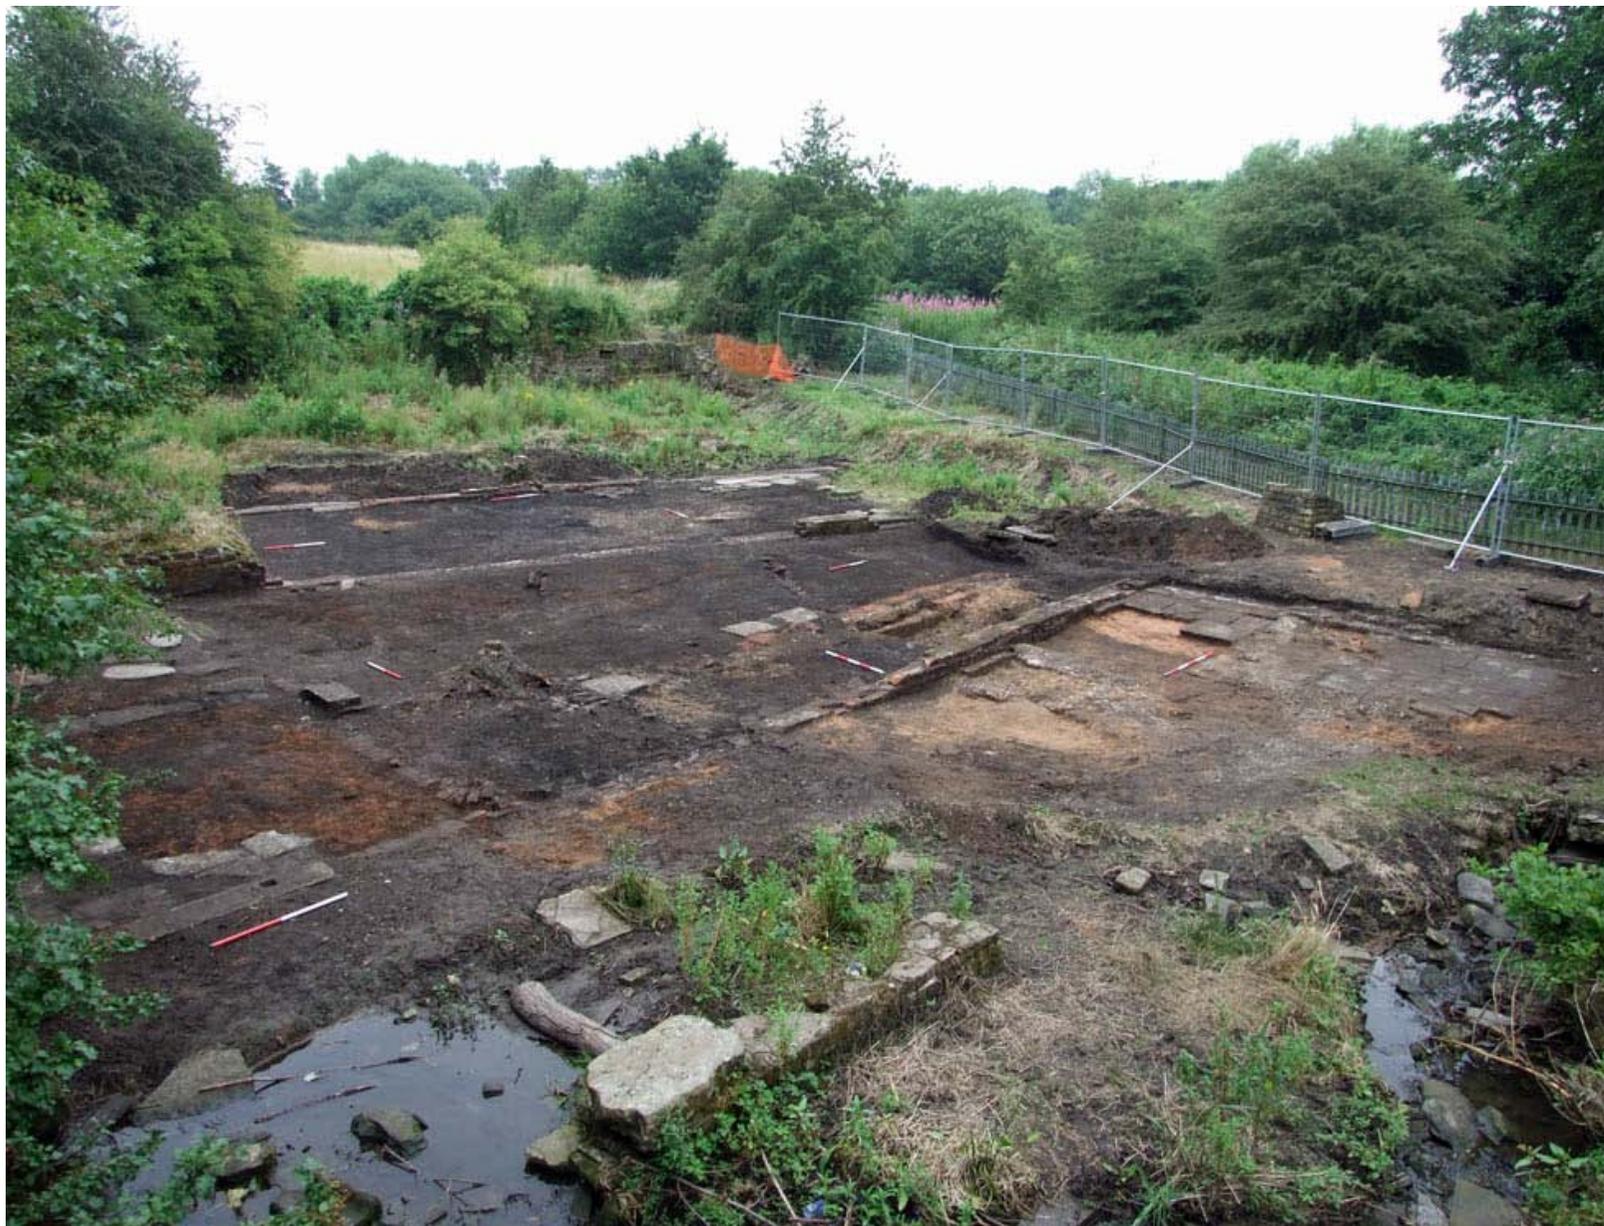
Plate 2. Area south of northern wheel pit after removal of modern deposits. View looking south-west from top of dam wall.

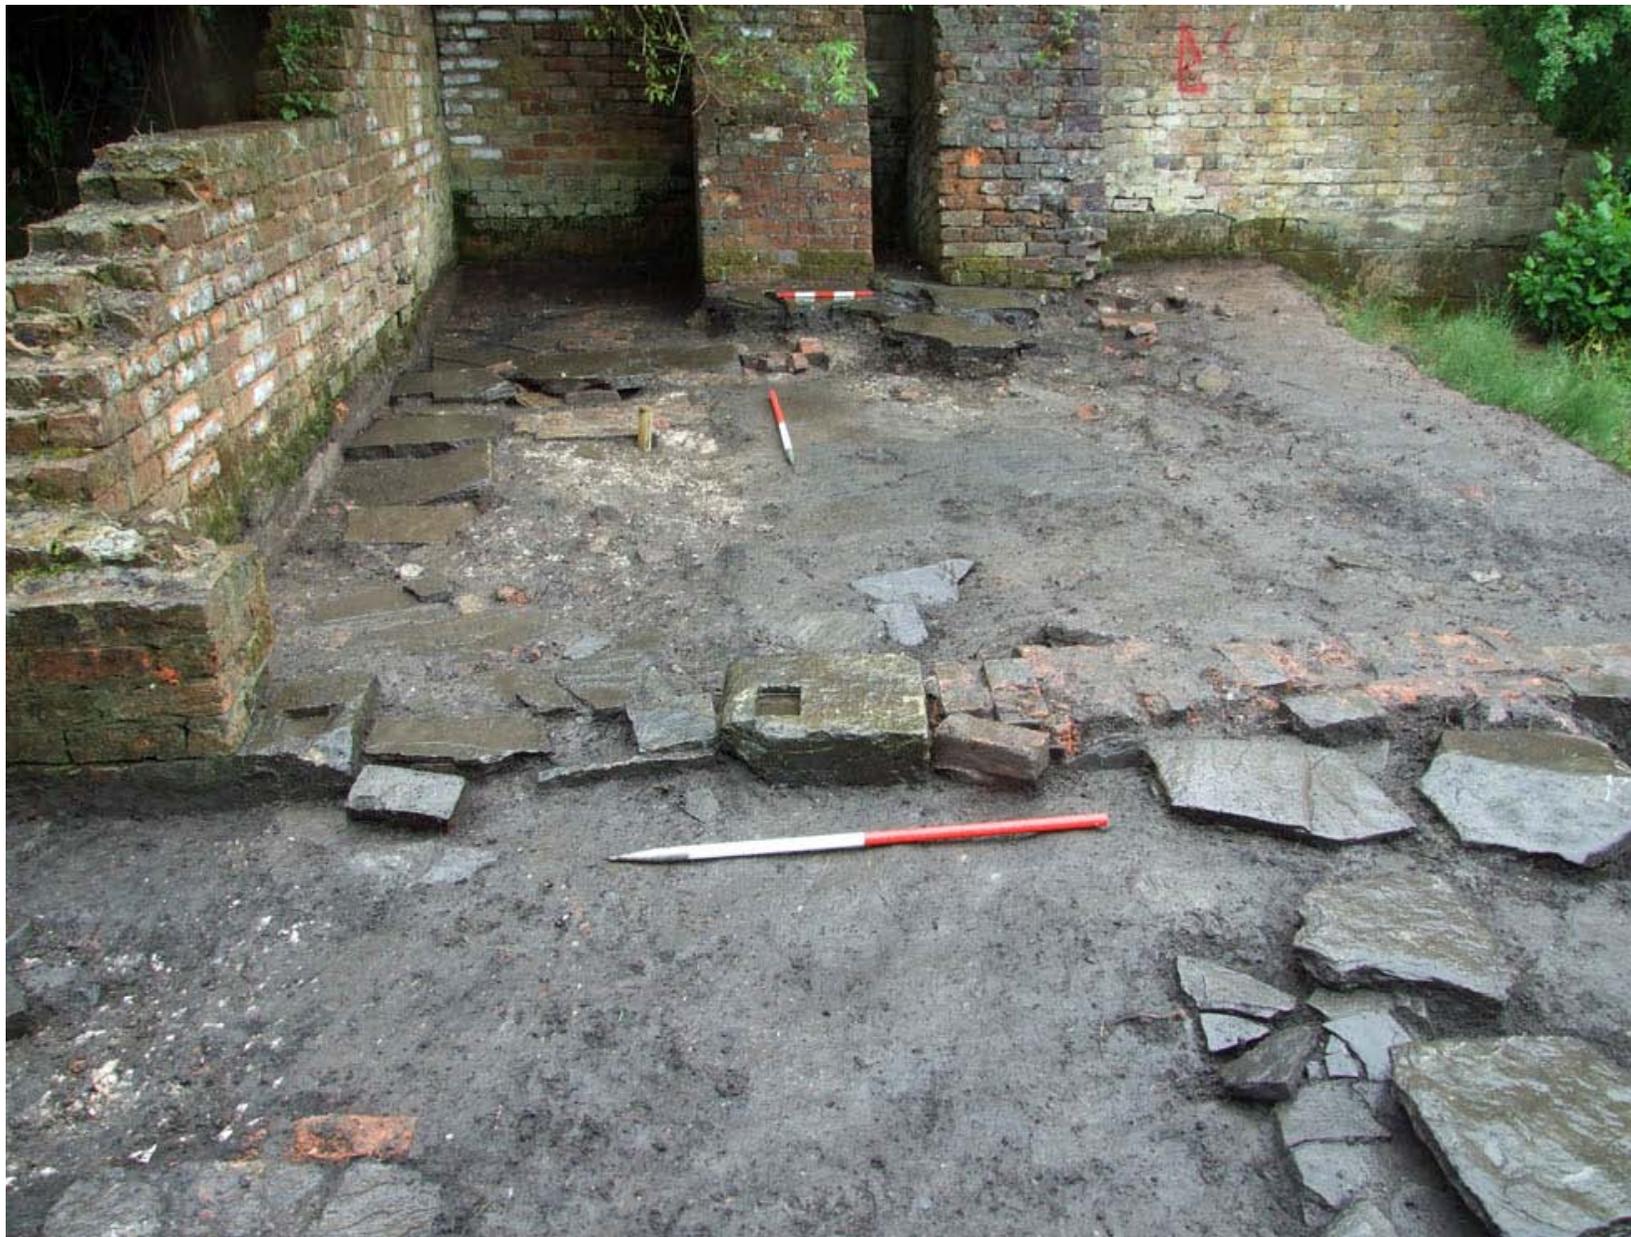
Plate 3. Structure 1, view looking east . Door way 136 and wall 137 are in the foreground.

The area to the north of the flooded wheel pit was excavated to a set of floor levels associated with two structures, both part of the 19th century corn mill. Structure 1 (Fig. 3, Plate 3) was defined by the dam wall, east-west aligned brick wall 203, north-south aligned brick wall 137 and the northern wall of the wheel pit. The latter was not exposed during this phase of excavation but is visible on photographs taken in 1982-3. At this point it is constructed in a mix of coursed (gritstone?) rubble and brick (Plates 4 and 5), though to the west there is evidence that it was constructed in ashlar (see below). The entrance to this structure was via a door way set into the northern end of wall 137 and defined by two sandstone blocks 136 with recesses cut to receive timber jambs. Wall 203 showed evidence of extensive repointing and may have been totally rebuilt, there being a slight discrepancy between the alignment of the wall and its foundations.

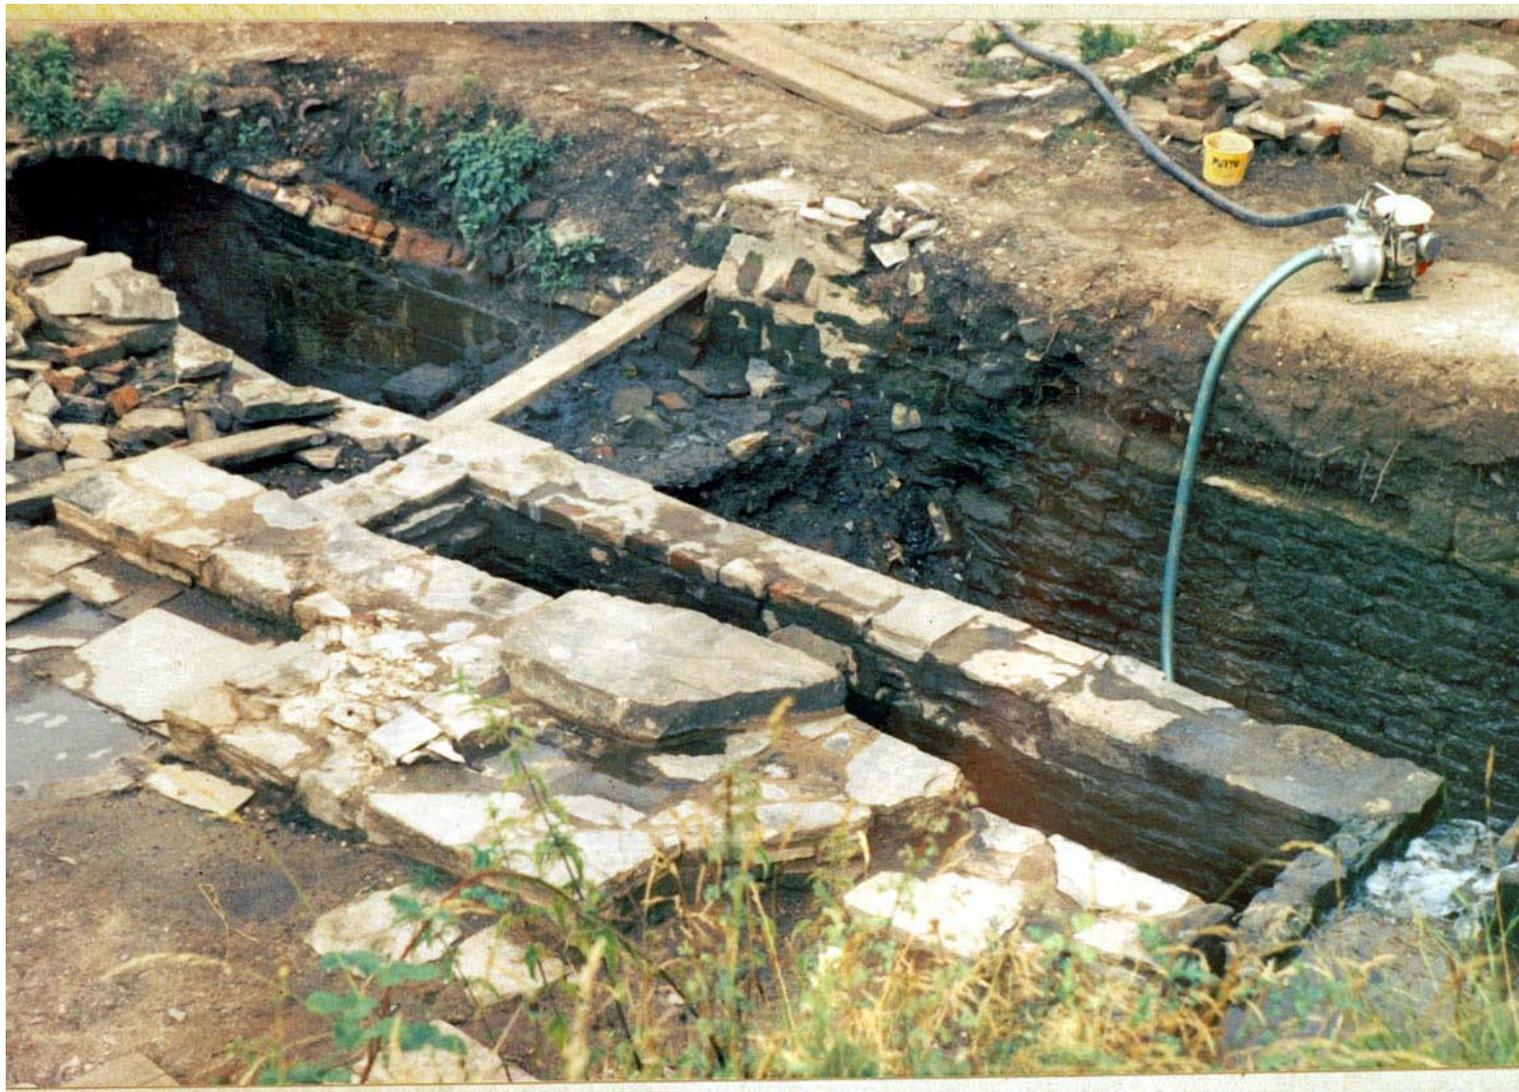
Plate 4. The northern wheel pit under excavation in 1982-3. Ashlar masonry is just visible at the west end of the north wall. The junction with coursed rubble to the east is obscured by *in situ* deposits, but may coincide with the intersection with wall 137 which is just visible behind the yellow bucket. The brick vaulting appears to have extended over the ashlar section. The chamber for the pit wheel is situated in the foreground. Photo D. Knowles.

The northern wheel pit excavated in the 1980s was not investigated on this occasion but has been designated Structure 3 to assist interpretation. The plan shown in Fig. 3 is based partly upon photographic evidence from the 1982-3 excavation (e.g. Plates 4, 5, 6) and partly upon the layout of other water-powered mills. The waterwheel for the slitting mill was probably situated within the linear feature which is now culverted over in brick at its western end (Plate 4) and is now visible as an arm extending west from the pond on this portion of the site. The brick vault which culverts the tail race is probably an addition or partial rebuild dating to the conversion to a corn mill. The justification for this interpretation is that the opening to the tail race to the west is in stone and both walls within the wheel pit at this point are in red sandstone ashlar (Plate 4) in a very similar style to that used in the southern wheel pit. The outlet to the tail race in the southern wheel pit is arched in stone and it would seem unlikely that different materials would be used in the original construction. There is a change in materials at some point along the northern wall to coursed (gritstone?) rubble at the eastern end, though unfortunately the junction between the two elements is obscured on the available photographic evidence. The extreme eastern end of the north wall is in brick (Plate 5). The reason for these rebuilds is unclear but is likely to be related to the conversion to grinding corn. One possibility is that the slitting mill wheel was set further to the west, this would explain the need to culvert over what was once an open wheel pit, and that on conversion to corn it was moved east closer to the dam. However, there is no obvious evidence on the available

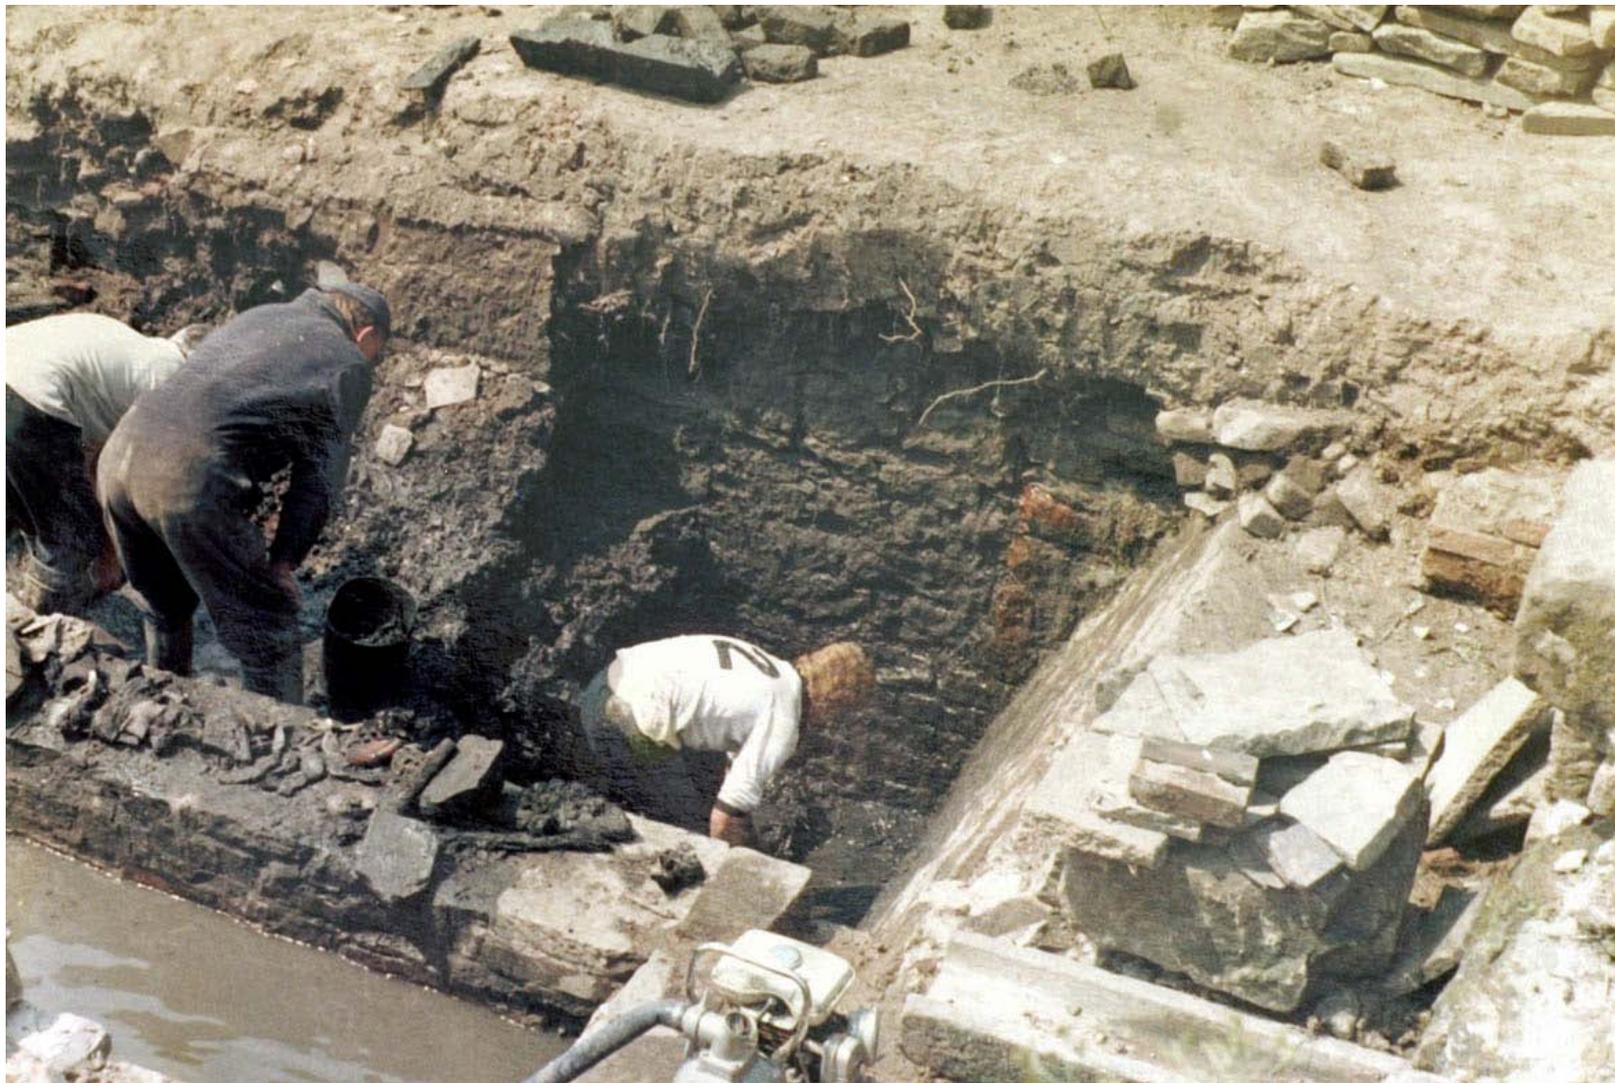
Plate 5. The northern wheel pit under excavation in 1982-3. This view shows the apparent junction between coursed rubble and brickwork at the eastern end. The even slope of the breastwork is visible on the right. . Photo D. Knowles.

The breastwork for the wheel at the upstream end (Plates 5 and 6) is in brick and has a slight batter suggesting that the wheel was over shot or pitch back, there being no close fitting curve for the wheel as found in breastshot wheels.

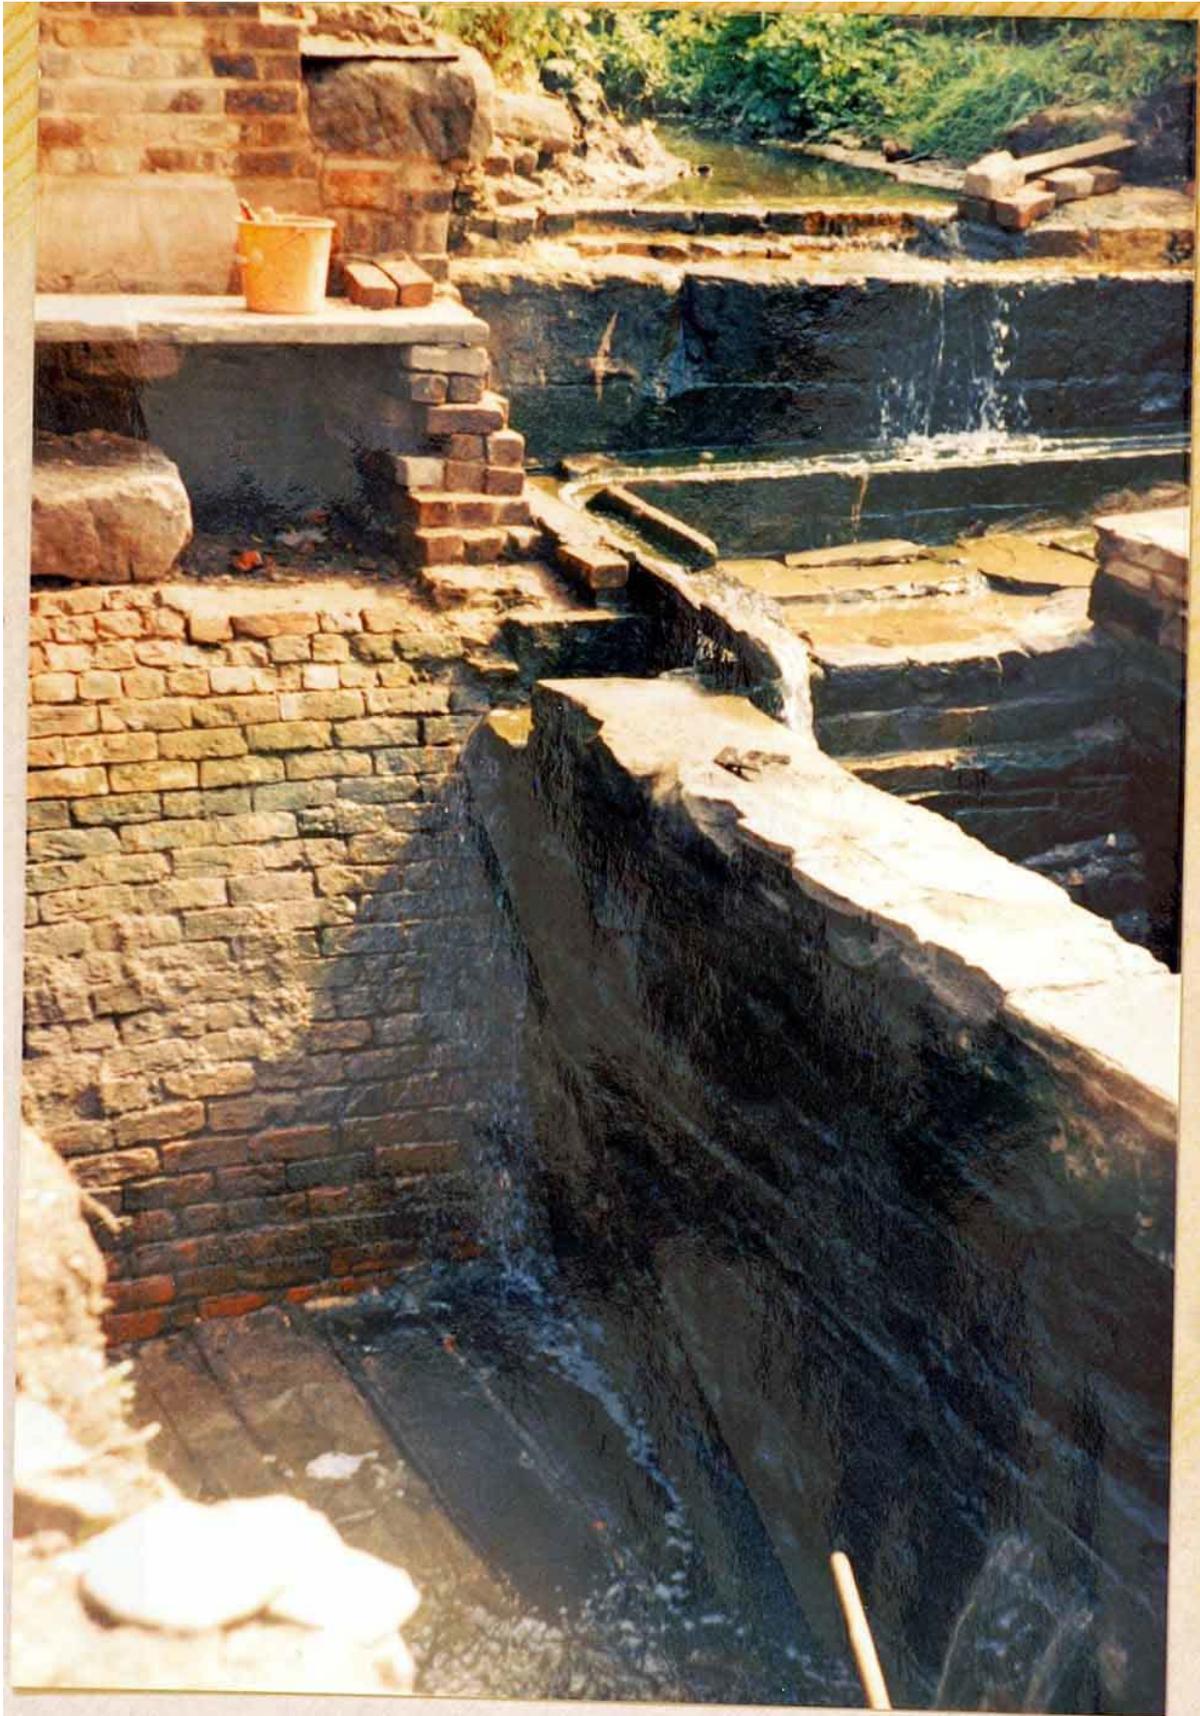
Plate 6. Detail of east end of northern wheel pit (Structure 3) from the north-west. Although the southern wall is in shadow it appears to be constructed in coursed gritstone rubble similar to that used for the north wall. The timber flooring can be seen at the base of the pit. . Photo D. Knowles.

Little detail is available of the construction of the south side of the wheel pit (Plate 6), though the materials used to construct the pit wheel chamber to its south (Plate 7) suggest that the eastern end was constructed in a similar manner to the north. This feature would probably have held the pit wheel on the grounds that there appears to have been no provision for the outflow of water. The western end seems to have been constructed in red sandstone ashlar, though the sole evidence for this is a very underexposed photograph from the 1982-3 archive.

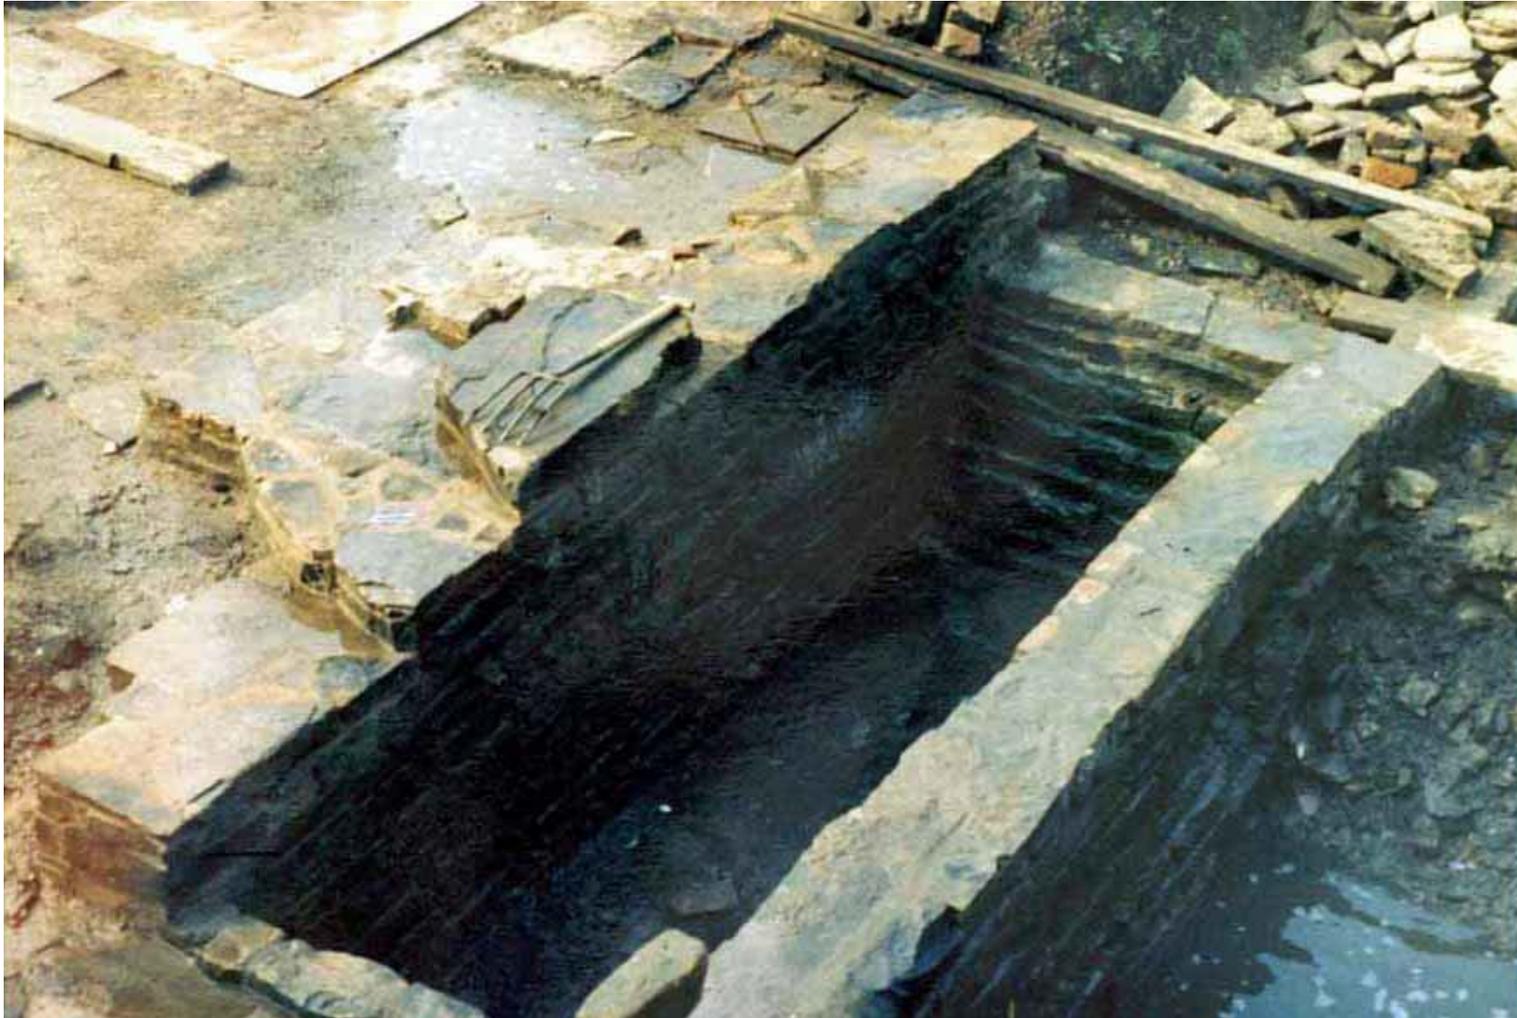
Plate 7. Setting for the pit wheel (Structure 3) from the north-east. This section is entirely in coursed rubble and has no outlet for water. . Photo D. Knowles.

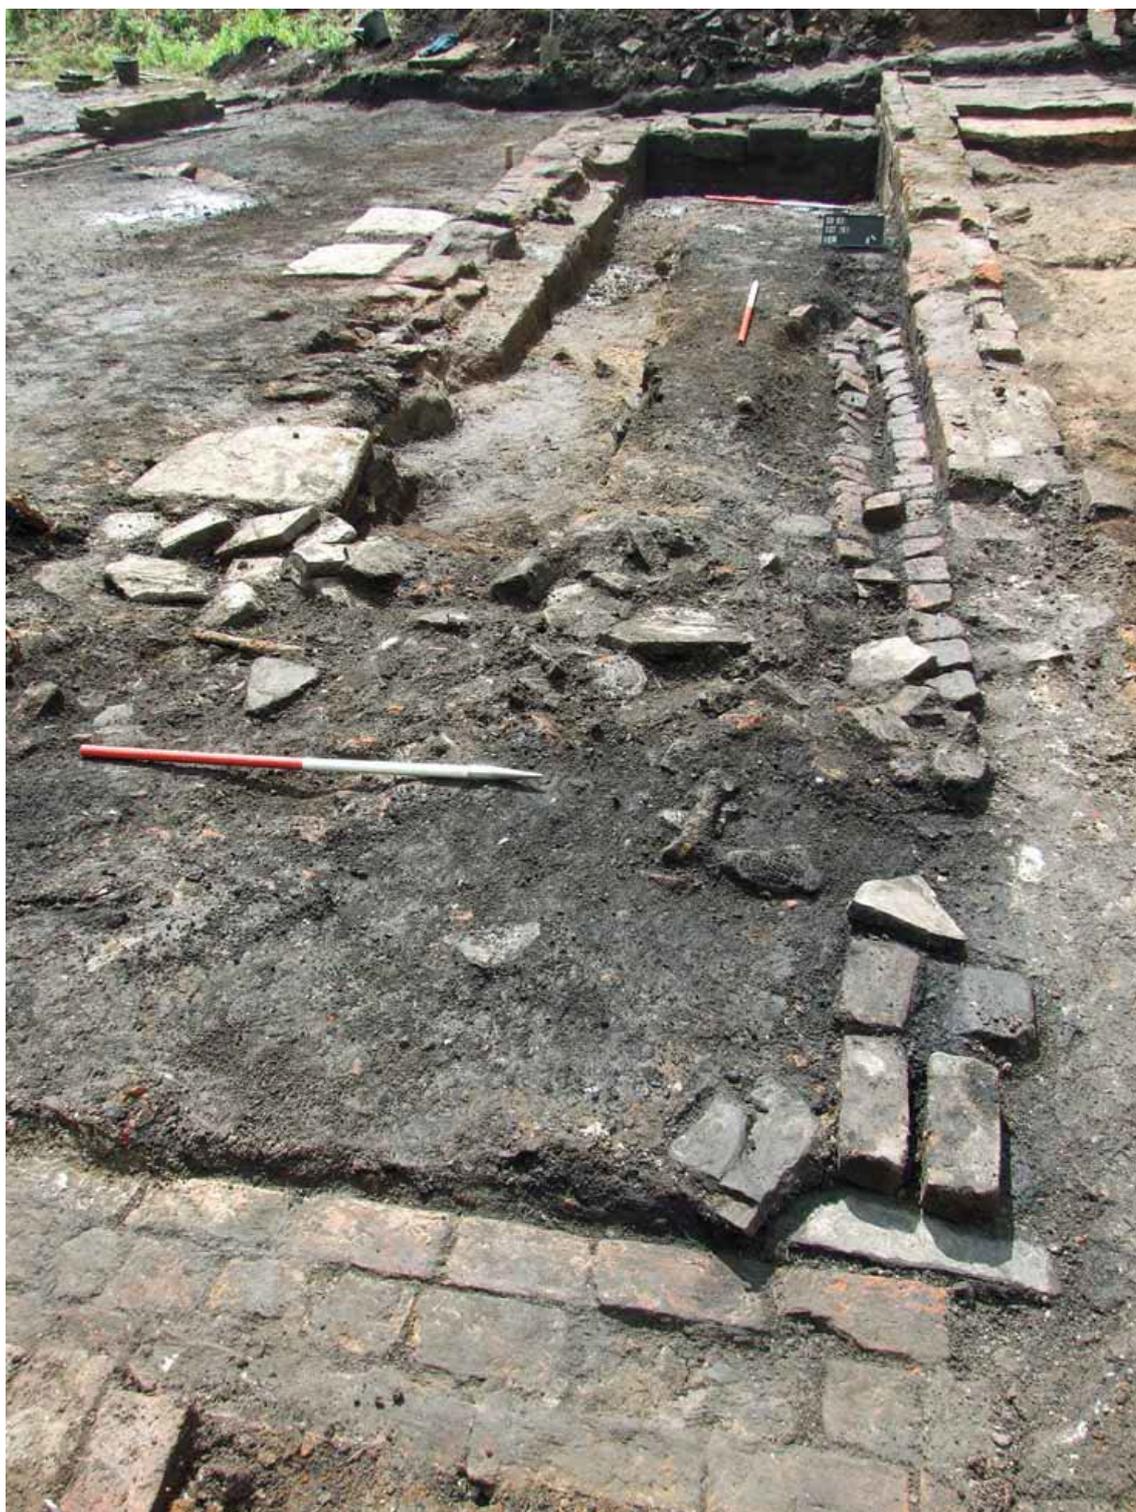
Plate 8. View of southern wheelpit (Structure 4) from the west showing drains for the 19th century corn mill set into the infill.

To the south of this area a complex of structures was revealed. Perhaps the most significant of these was Structure 4, the southern wheelpit, which to date is the only excavated feature which can be positively associated with the slitting mill phase (Fig. 5). It was sealed by brick built drains (Plate 8) relating to the corn mill which prove that it was filled in upon once iron slitting ceased on the site between 1800 and 1824, though no finds evidence was recovered from the fill (predominantly clay) to confirm this.

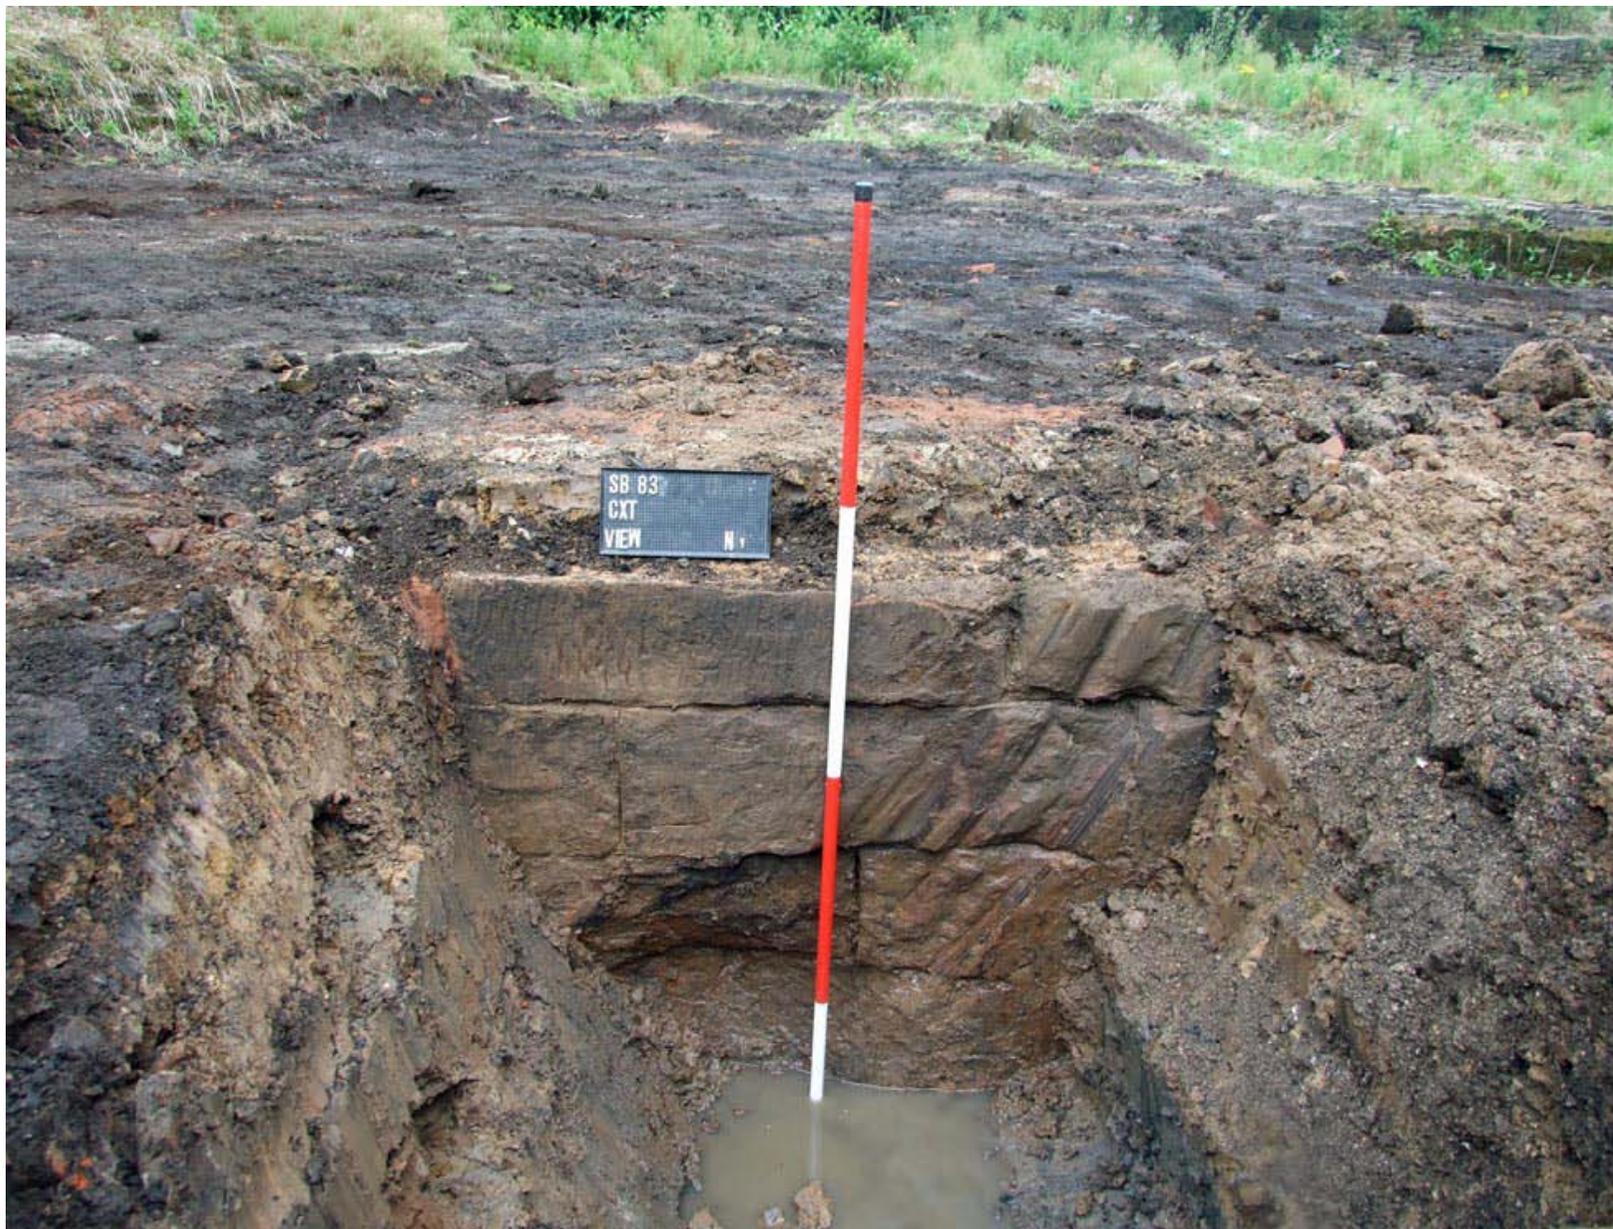
Plate 9. Southern wall (168) of south wheel pit (Structure 4) showing scars from the waterwheel.

The southern and northern walls (168 & 154) of the wheel pit were constructed in red sandstone ashlar (Plates 9 & 10) with the upper 2-3 courses of 154 in hand-made red brick. It is likely that the brick courses represent rebuilding during conversion to a corn mill as they do not appear sufficiently substantially to support the wheel being only two bricks thick.

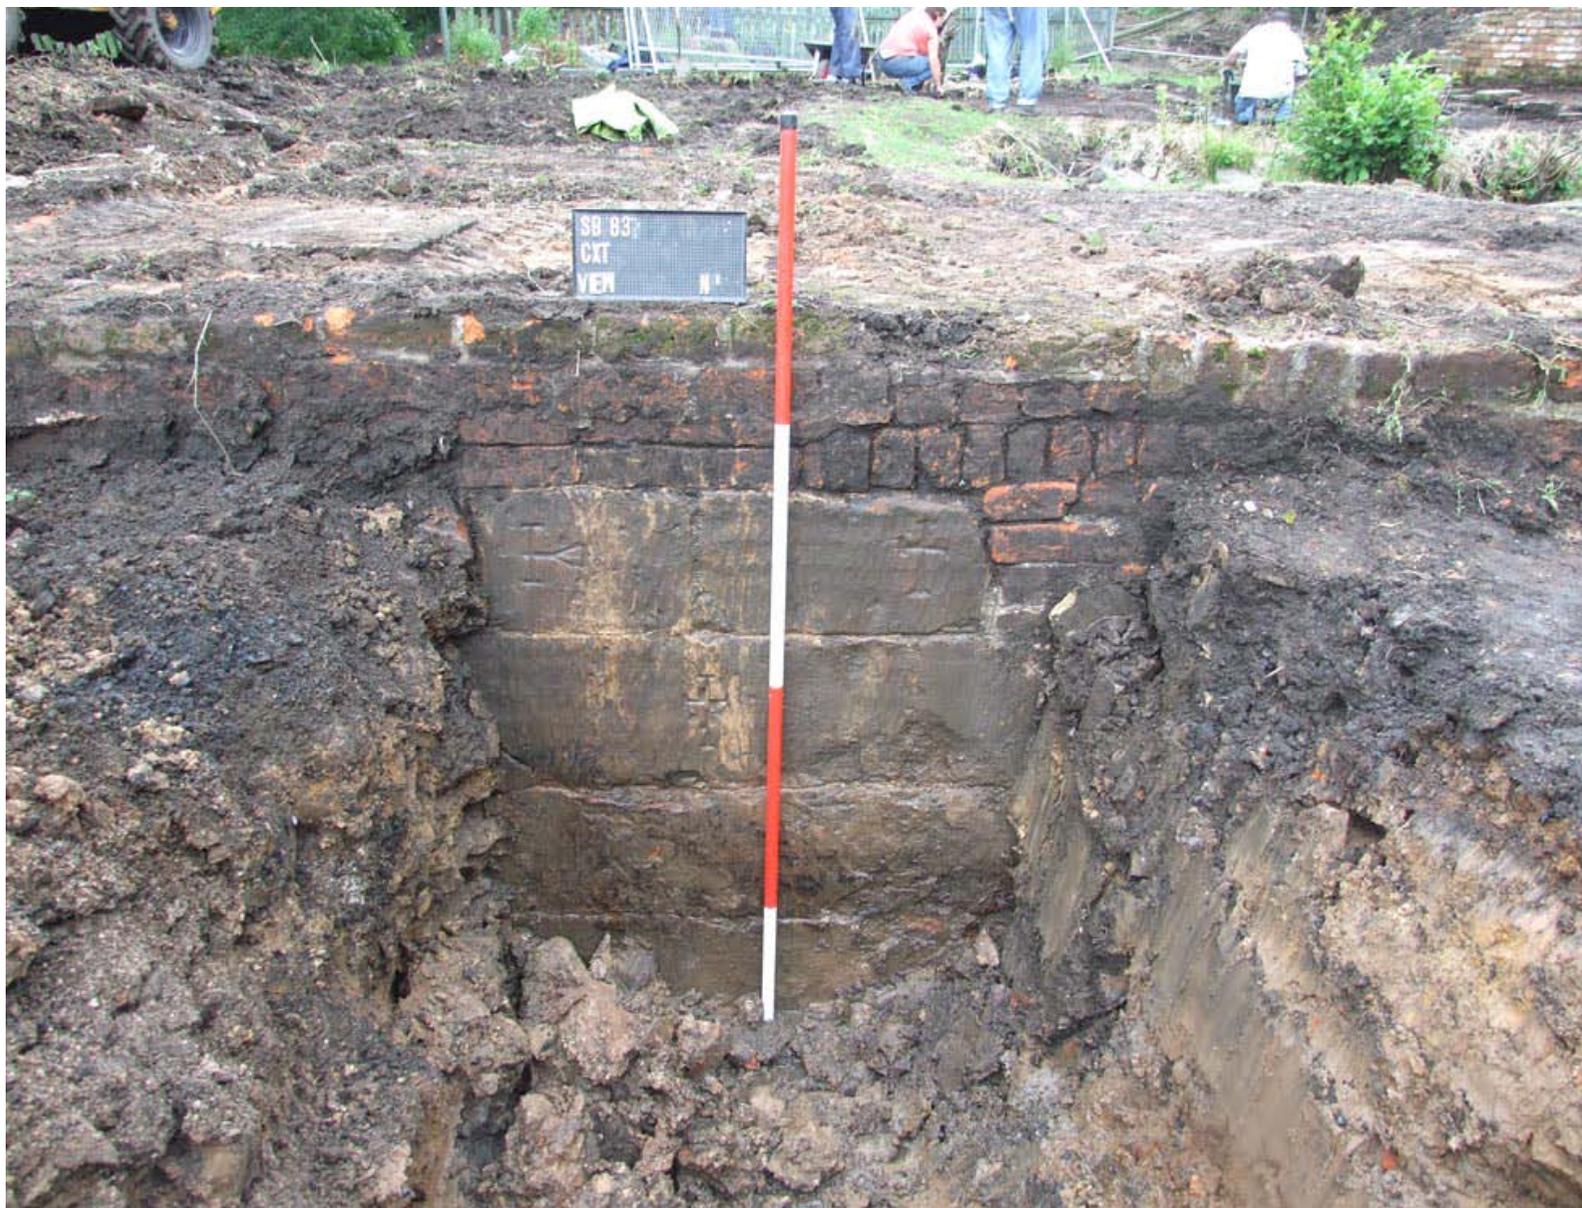
Plate 10. Northern wall (154) of south wheel pit (Structure 4) showing mason's marks and upper courses rebuilt in brick.

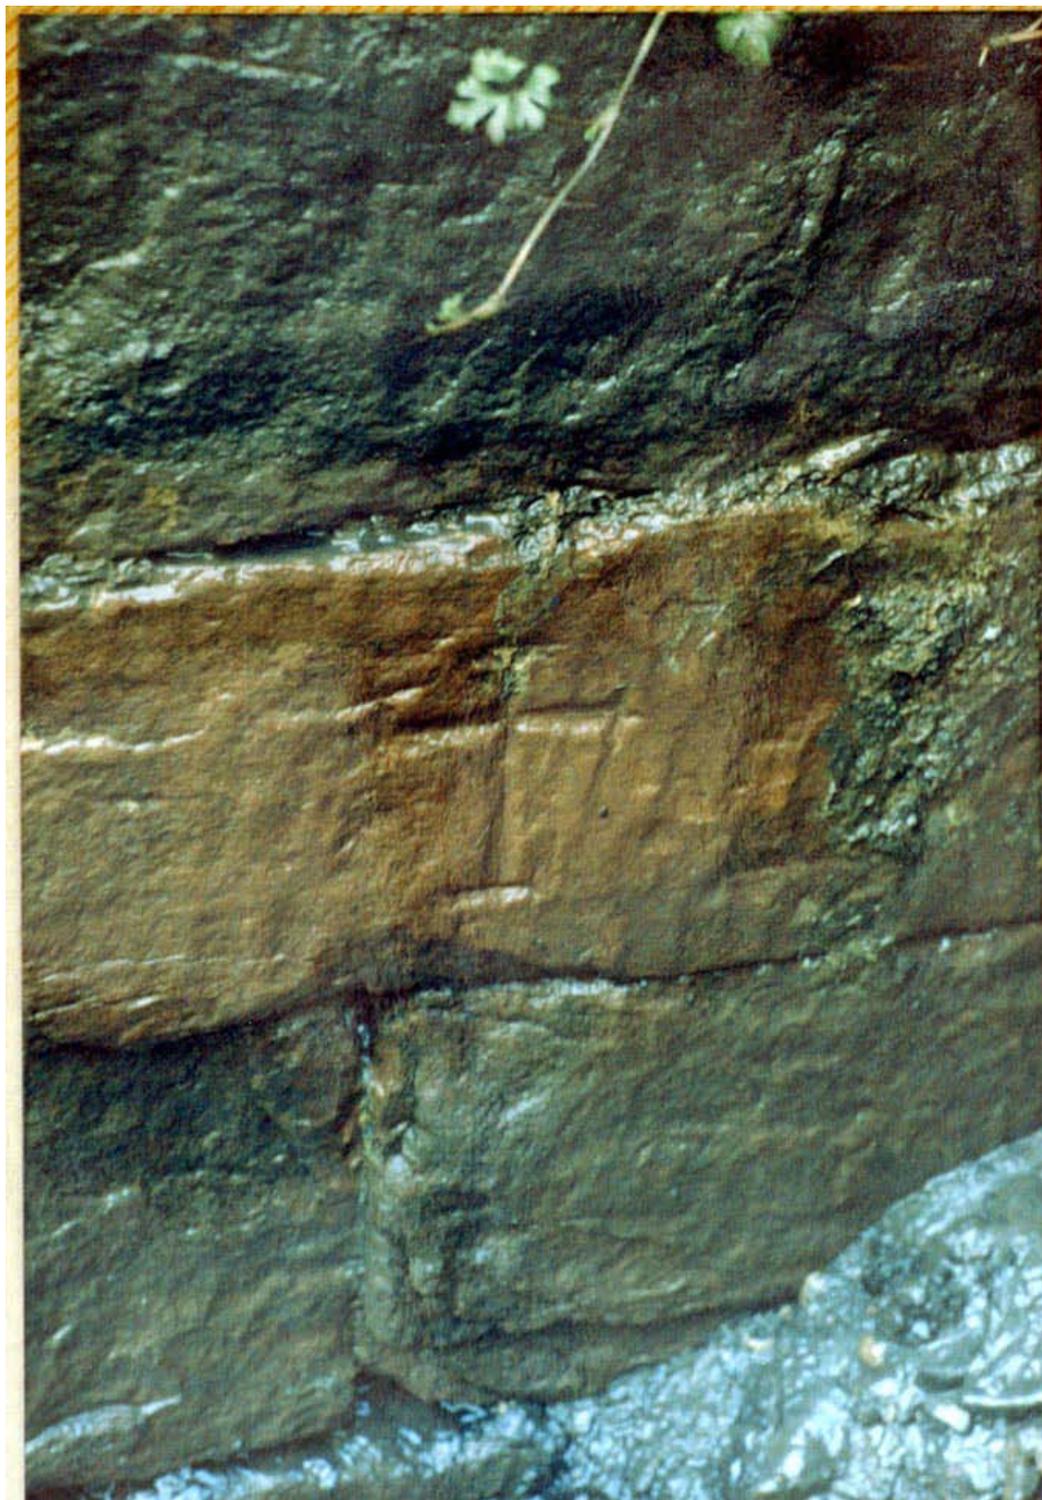
Plate 11. Mason's mark recorded on sandstone wall of Structure 3. Photo D. Knowles.
