An Archaeological Excavation at Stanley Bank, St Helens, Merseyside

March 2009

Produced for St Helens MBC

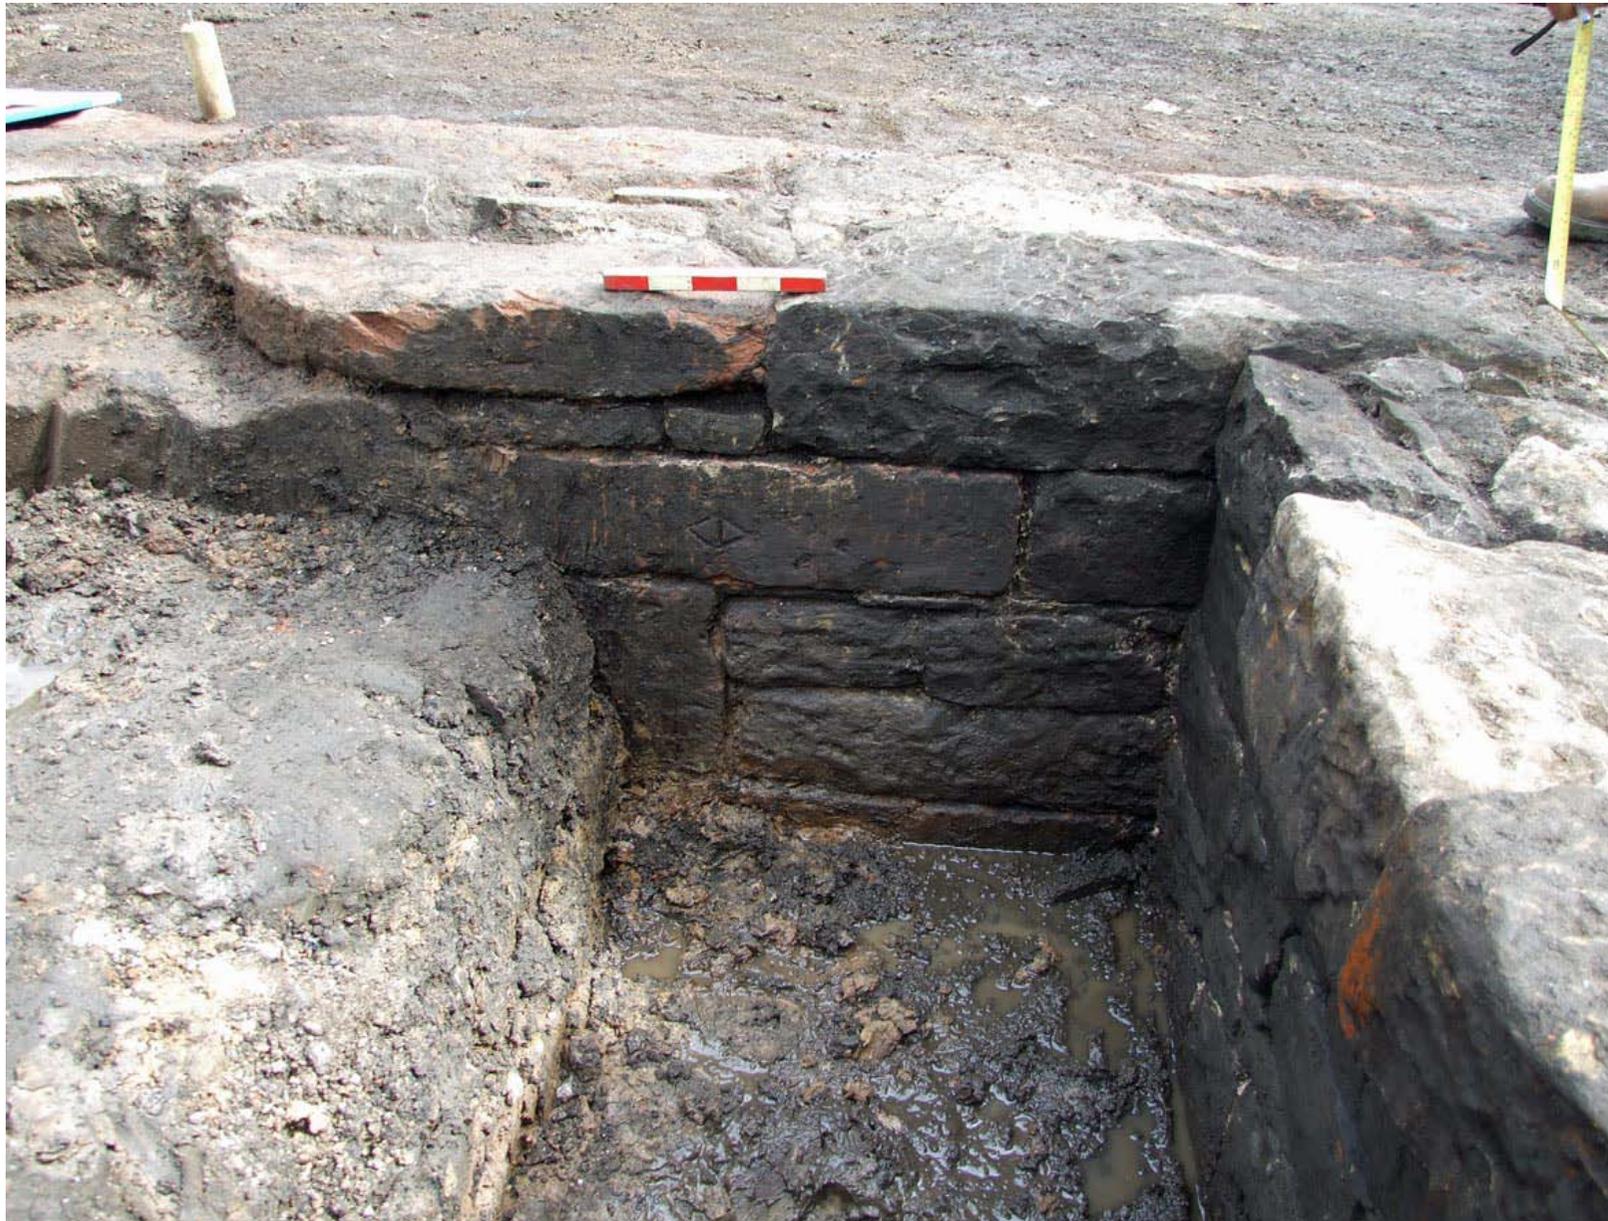
Plate 12. Structure 4, detail of bonding between walls 168 and 186. View looking south.

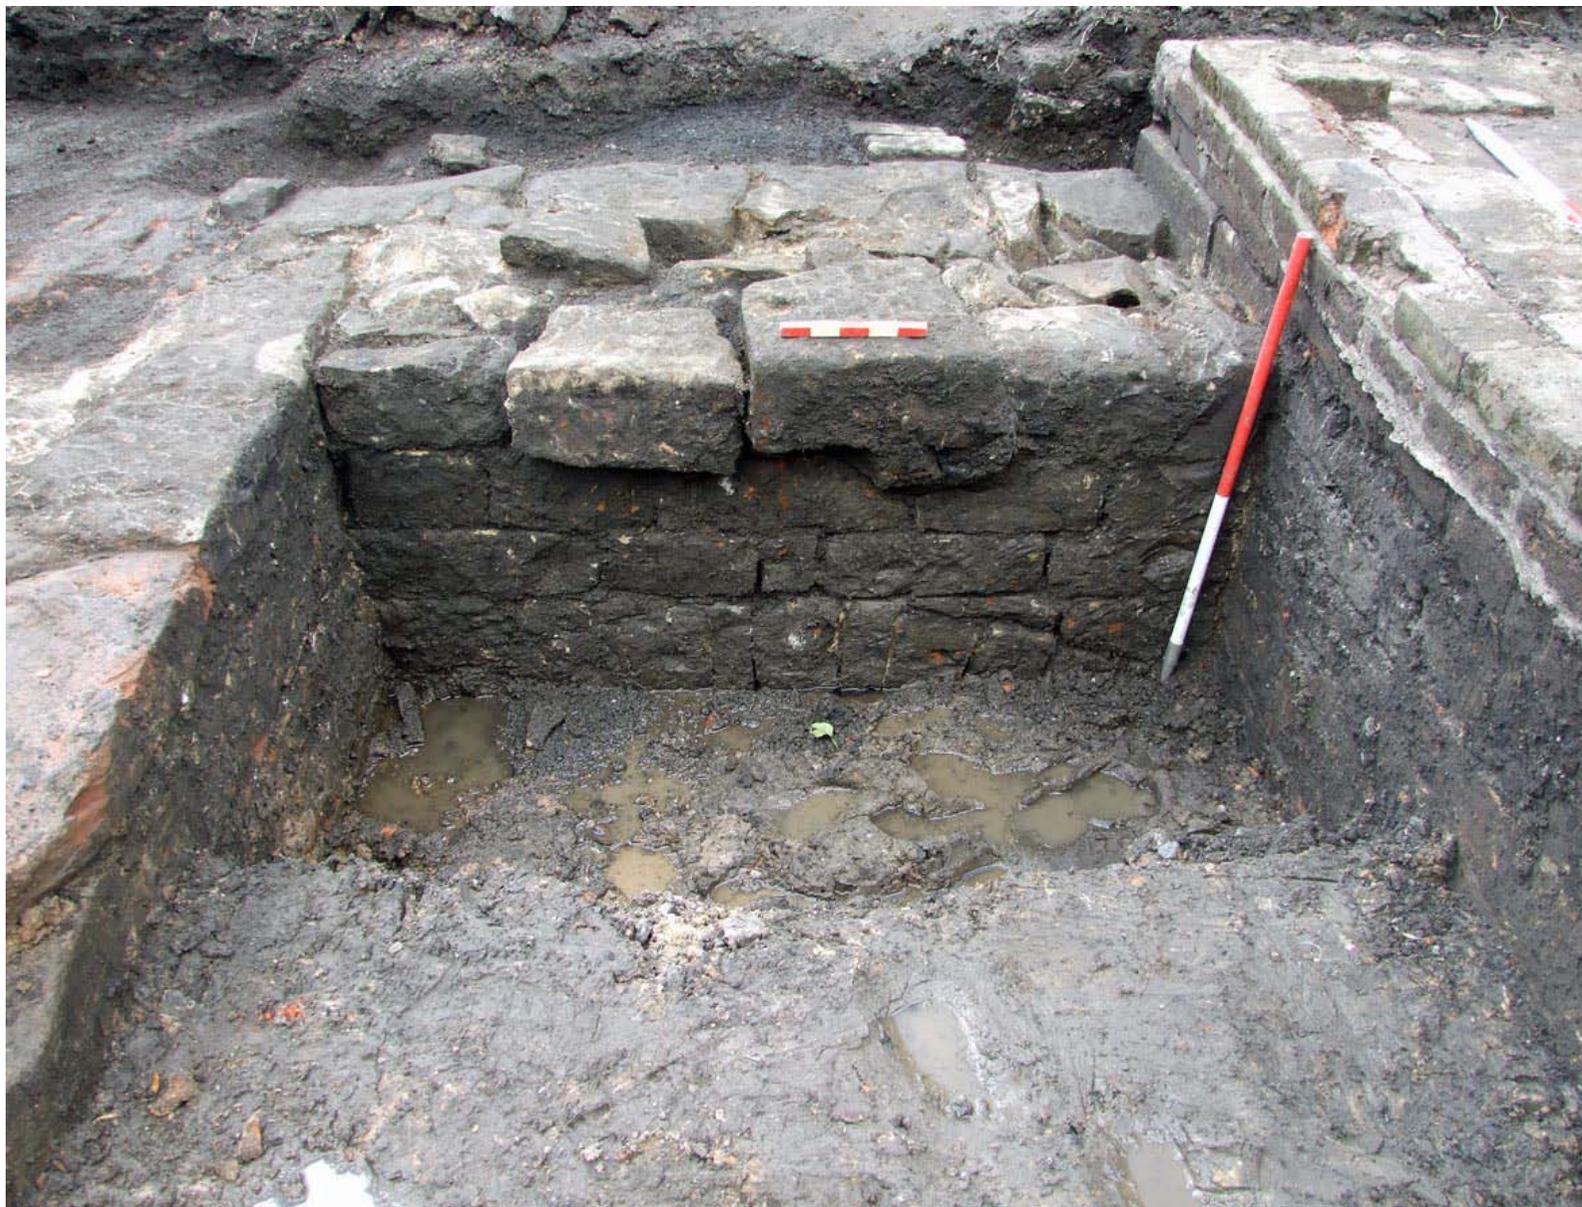
Plate 13. East facing elevation of wall 186, the top of the arch to the tailrace is visible at the base of the section.

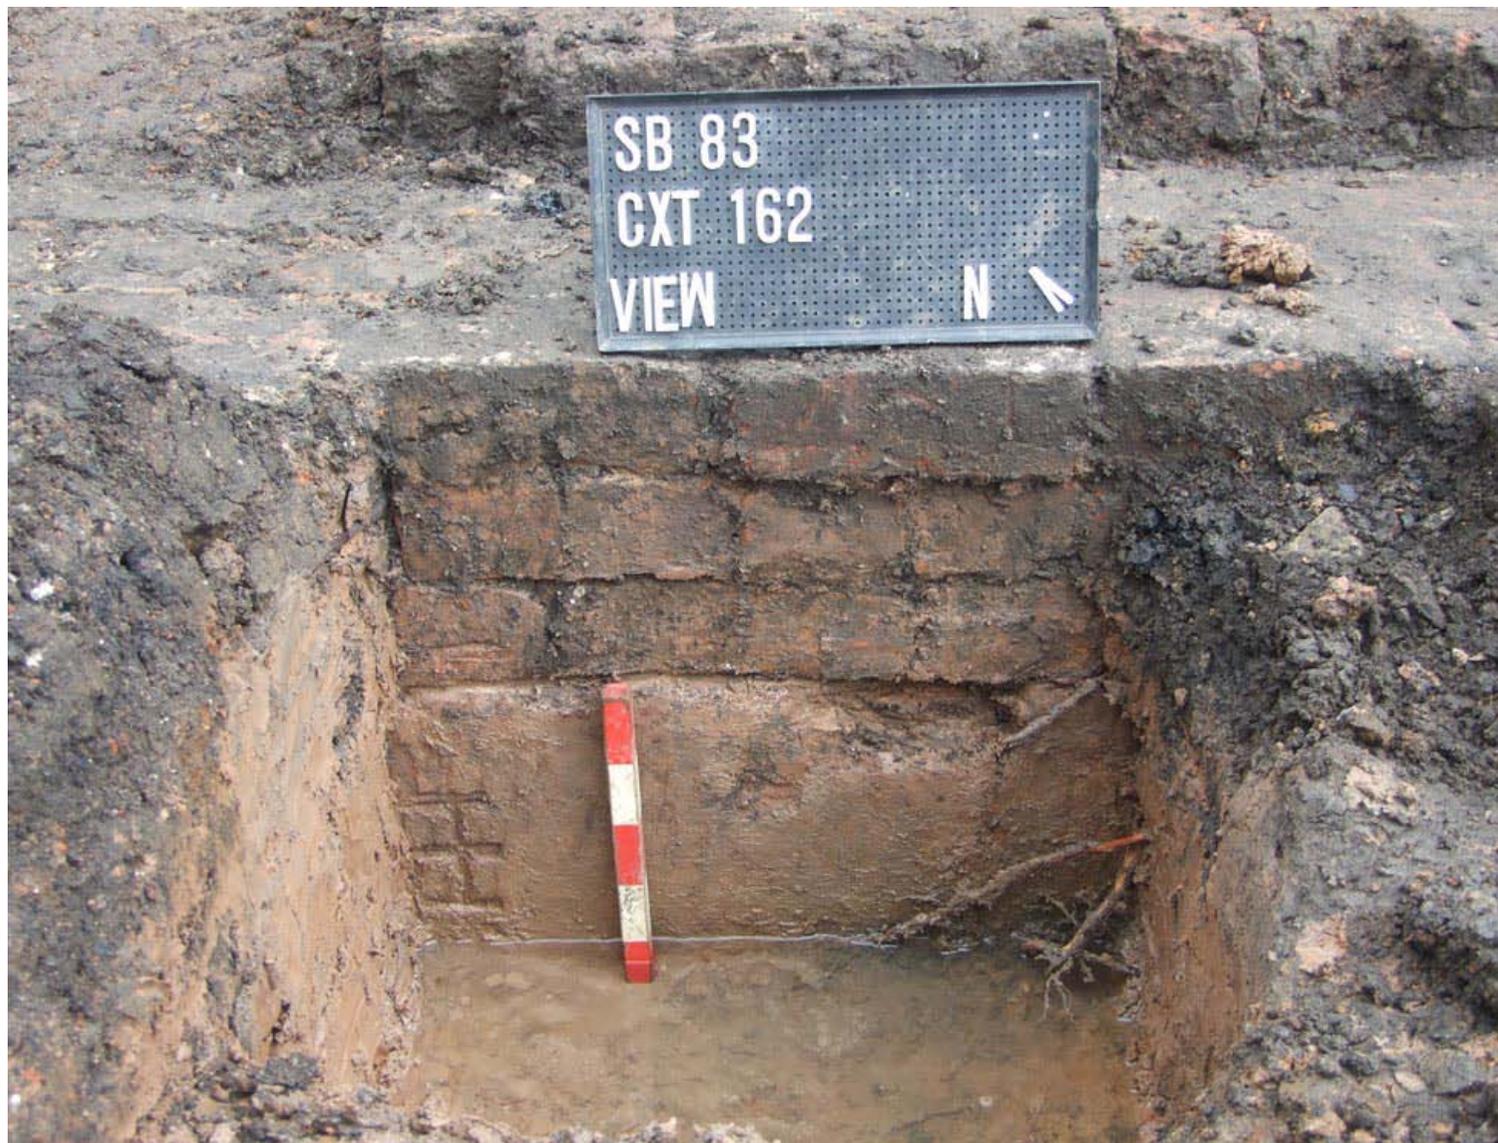
Plate 14. Detail of section excavated against east wall of southern wheel pit showing 19th century brickwork over red sandstone masonry. The incised mark is a mason's mark.

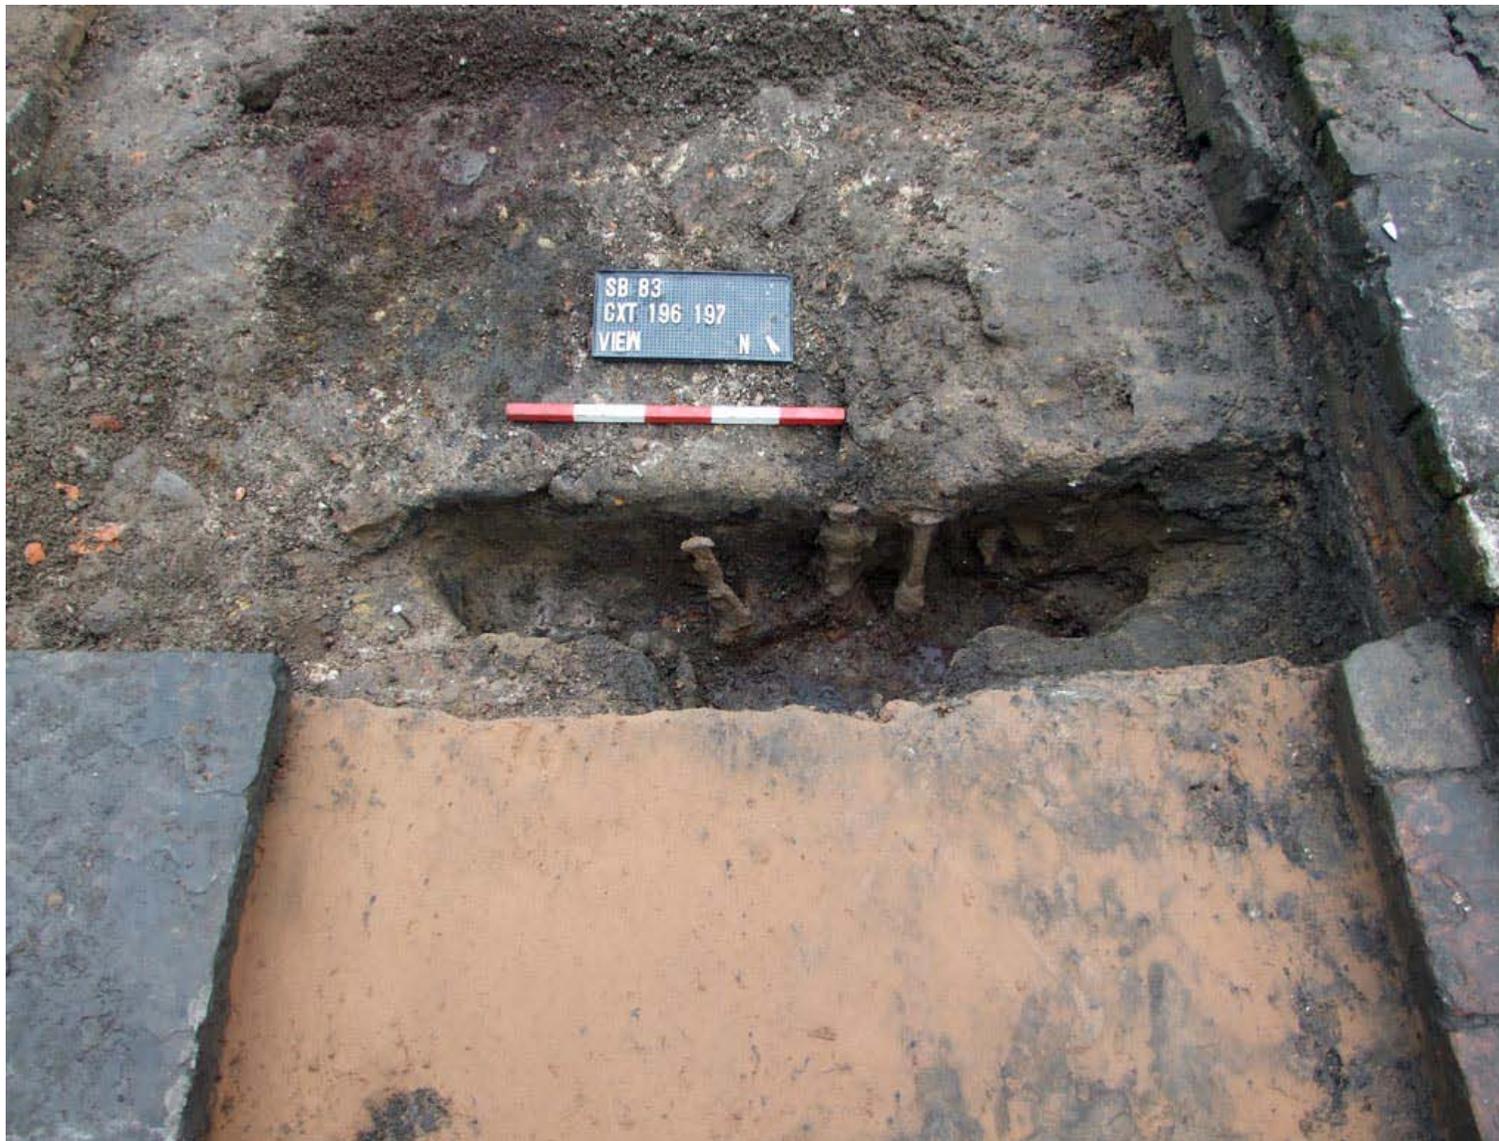
Plate 15. Part of iron and wood lantern gear(?) 197 exposed with sand layer 196. The red sands in the foreground are bedding for flag stones relaid in the early 1990s.
